CLEANING AND SUBSEQUENT COATING OF A SECTION OF PENZANCE PROMENADE

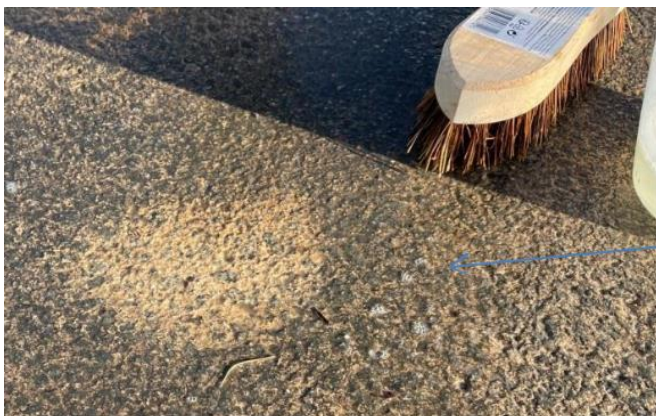
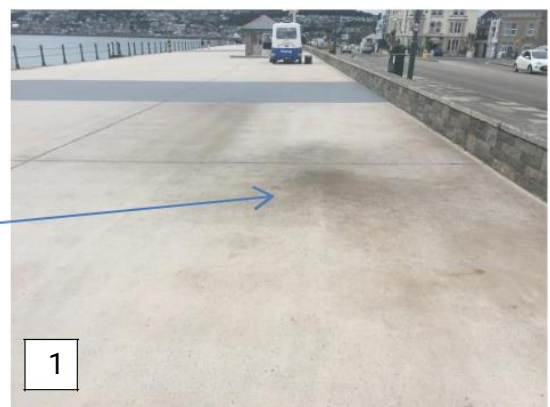
There was heavy staining around the site of the Burger Van. Refer to image 1

Unlike the oil staining from the previous oil spill, the staining which was encountered on this occasion would appear to have been a mixture of oils and various other staining agents. This resulted in deeper penetration into the promenade structure. The cleaning process was ultimately successful. (CCM's Biosativa® Bio Cleaner was the stain removal agent for this project.)

Cleaning with BioSativa® -Trial on area prior to full cleaning process

All stains were cleaned with Biosativa and the whole of the target area was scrubbed and pressure washed.

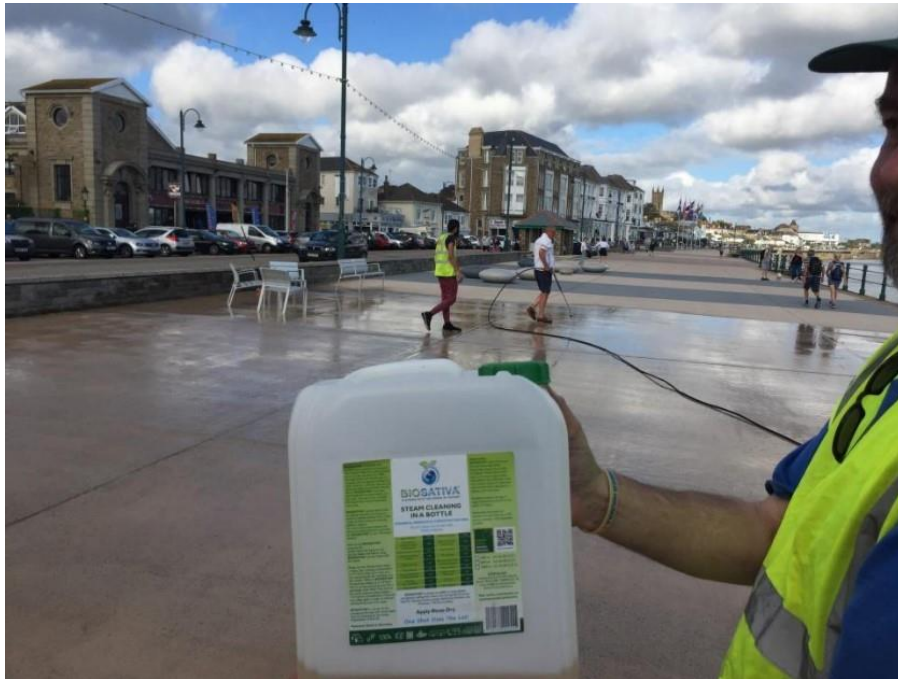
The team from LGS were approached by numerous members of the public who asked about which cleaner was being used. The fact that the cleaner was a Bio cleaner was very important to them.

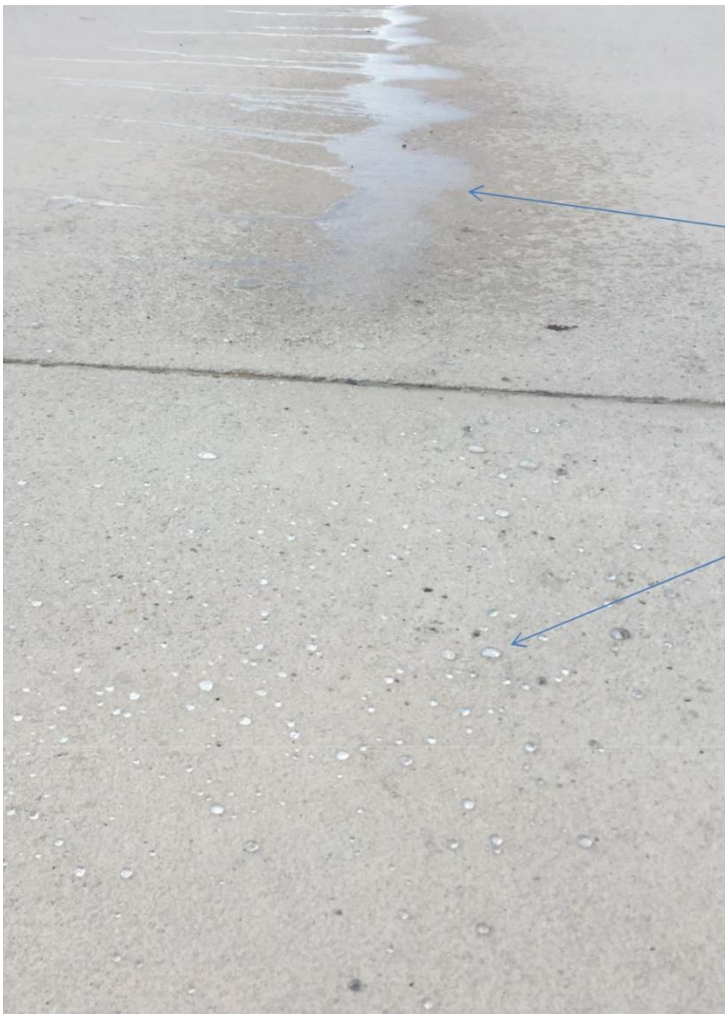
Comparison of coated and no coated areas.

Please refer to the image below.

Not protected with 7620.
Water easily penetrates the surface.

Area coated with 7620.
Water "beads" on the surface due to
Strong hydrophobicity / oleophobicity.

The attached images show that after 14 hours the protected area was hydrophobic. Full curing takes approximately 48 hours.
