# **DLTB BUS COMPANY**

**Windshield, side and rear windows  
Mockup**

DLTB BUS COMPANY is in need of a new solution to minimize maintenance cost of cleaning bus windshields, side and rear windows.

Use nanofied coatings to protect windshields, side and rear windows from glass corrsions like watermarks, water stains and scaling.

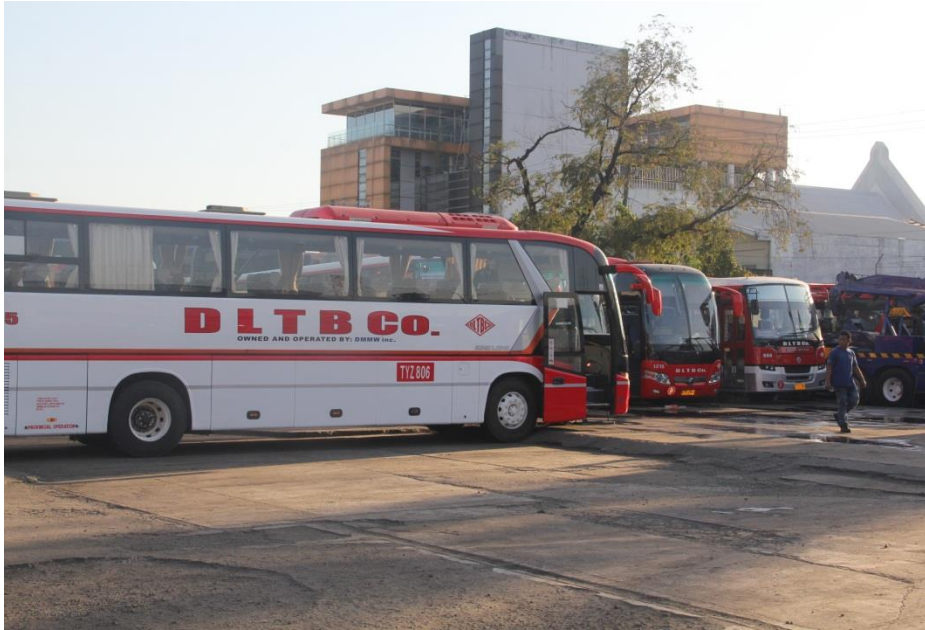
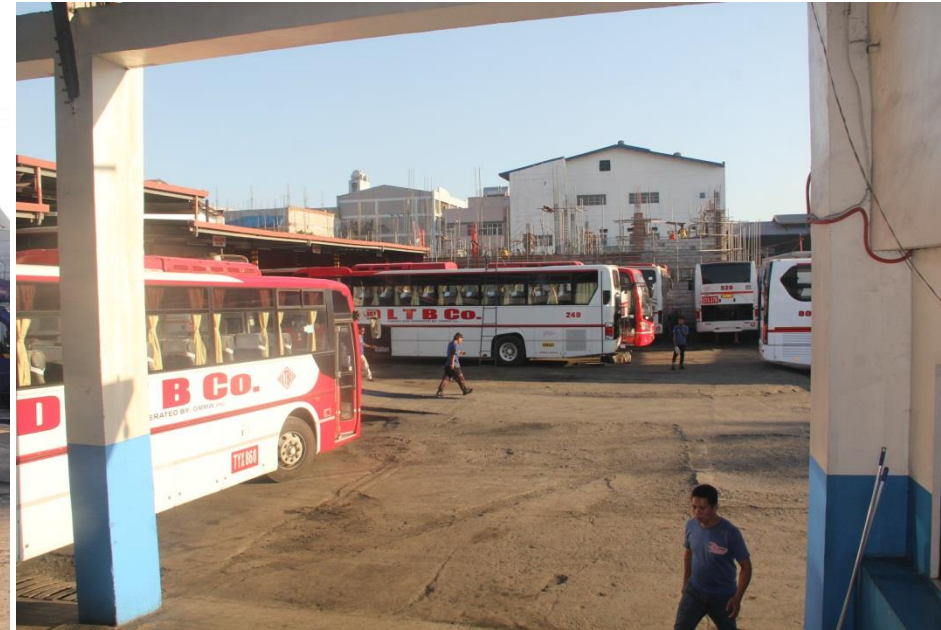
### PROBLEM:

New business solution to minimize maintenance cost of cleaning windshields, side and rear windows.

### SOLUTION:

- Remove watermarks, scaling, dirt, oil and other contaminants from windshields, side and rear windows
- Coat windshield with nanofied High Performance Coating for extreme protection against glass corrosion
- Coat side and rear windows with nanofied Specialized Coating for Glass to protect from glass corrosion

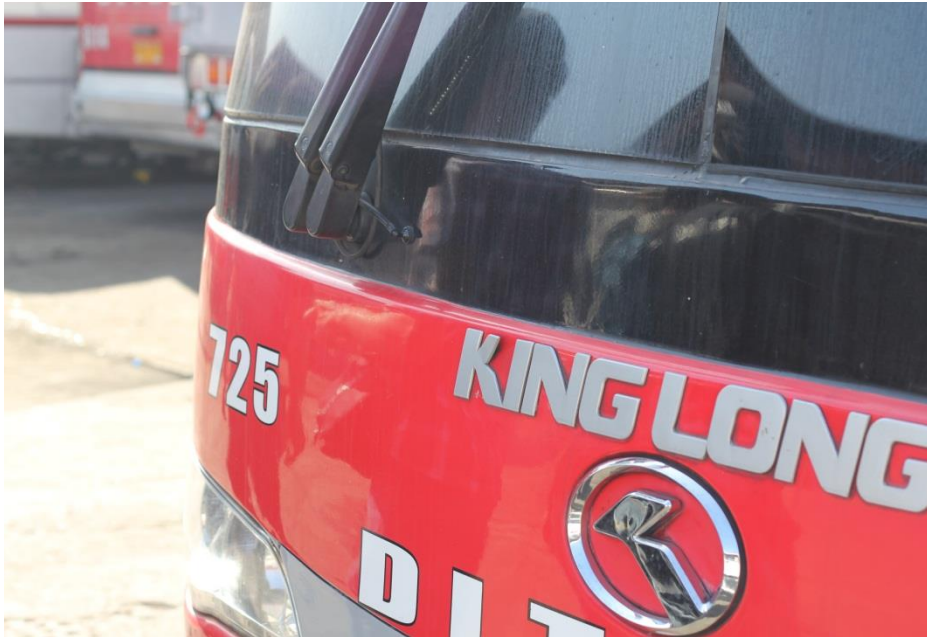
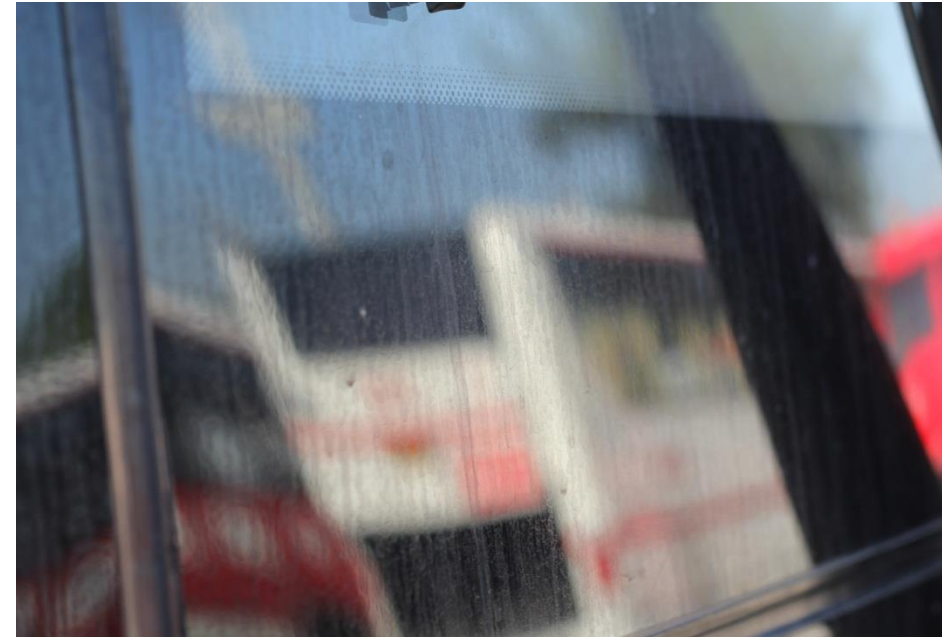
## DLTB BUS WINDSHIELD BEFORE CLEANING AND PROTECTION

### HEAVY SCALING AND WATERMARKS ON DLTB BUS WINDSCREEN

Glass corrosions like watermarks and scaling are caused by calcium left behind by water after it evaporates. These watermarks and scaling when not given proper attention will be very difficult to remove or sometimes may cause damage to glass. Other causes of glass corrosions are : acid rain, bird droppings, tree saps and pollution. Removing watermarks and scaling is very time consuming, expensive and sometimes impossible. Nanofied coatings helps prevent these kinds of glass corrosions by repelling the main causes of corrosions by protecting and sealing the surface.

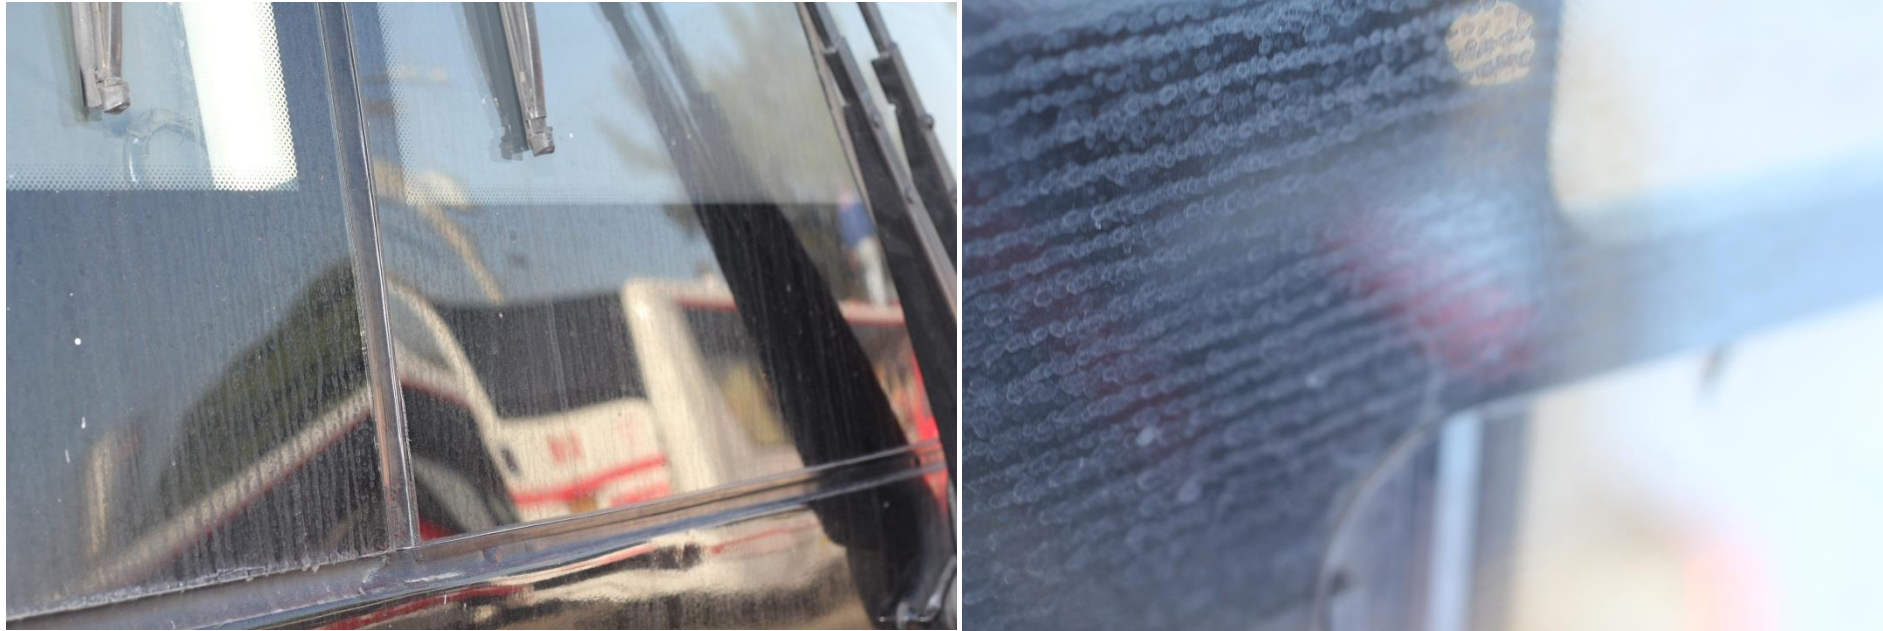
## DLTB BUS WINDSHIELD BEFORE CLEANING AND PROTECTION

### HEAVY SCALING AND WATERMARKS ON DLTB BUS WINDSCREEN

Glass corrosions like watermarks and scaling are caused by calcium left behind by water after it evaporates. These watermarks and scaling when not given proper attention will be very difficult to remove or sometimes may cause damage to glass. Other causes of glass corrosions are : acid rain, bird droppings, tree saps and pollution. Removing watermarks and scaling is very time consuming, expensive and sometimes impossible. Nanofied coatings helps prevent these kinds of glass corrosions by repelling the main causes of corrosions by protecting and sealing the surface.

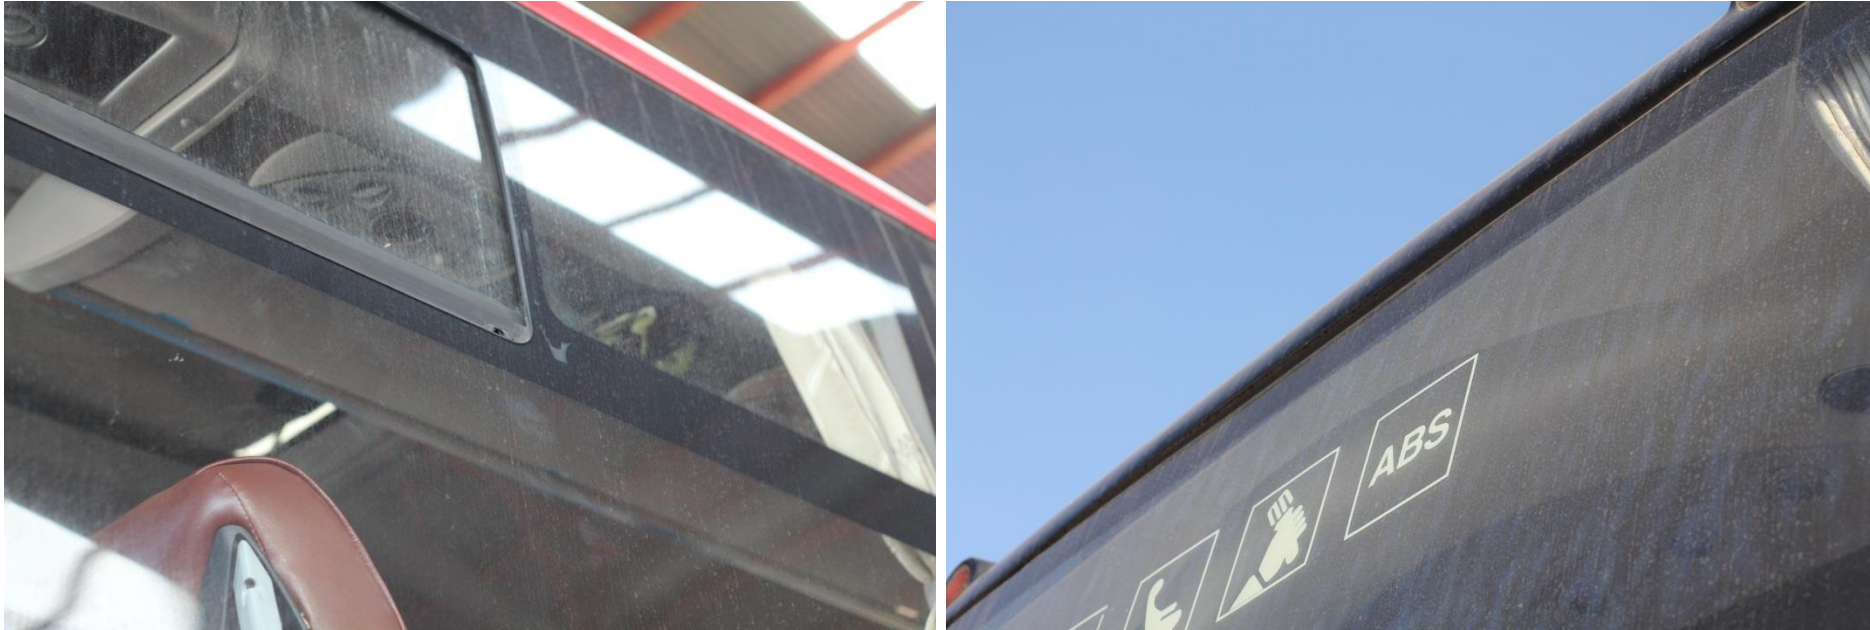
## DLTB BUS SIDE WINDOWS BEFORE CLEANING AND PROTECTION

### HEAVY SCALING AND WATERMARKS ON DLTB BUS SIDE AND REAR WINDOWS

Glass corrosions like watermarks and scaling are caused by calcium left behind by water after it evaporates. These watermarks and scaling when not given proper attention will be very difficult to remove or sometimes may cause damage to glass. Other causes of glass corrosions are : acid rain, bird droppings, tree saps and pollution. Removing watermarks and scaling is very time consuming, expensive and sometimes impossible. Nanofied coatings help prevent these kinds of glass corrosions by repelling the main causes of corrosions by protecting and sealing the surface.

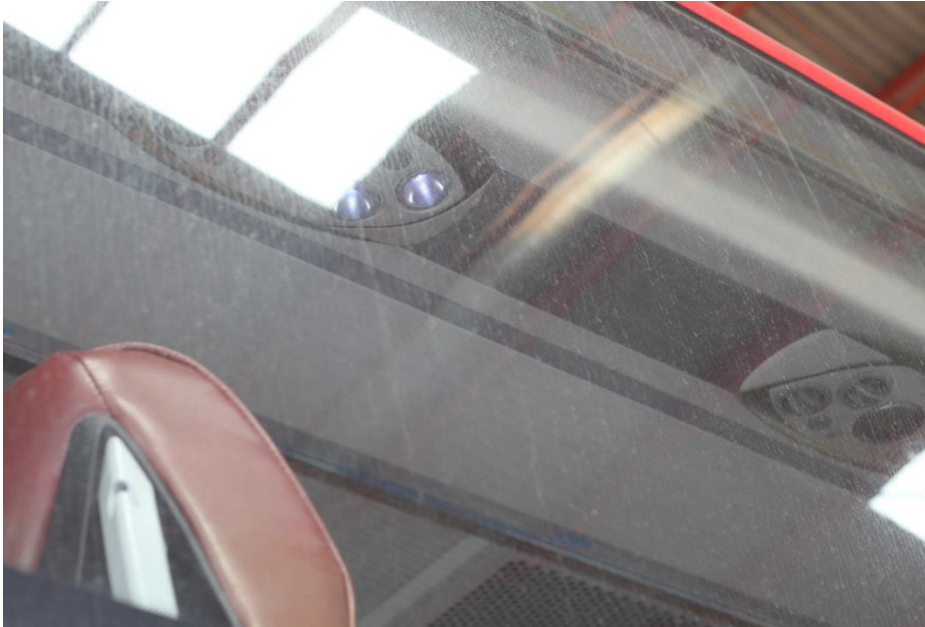
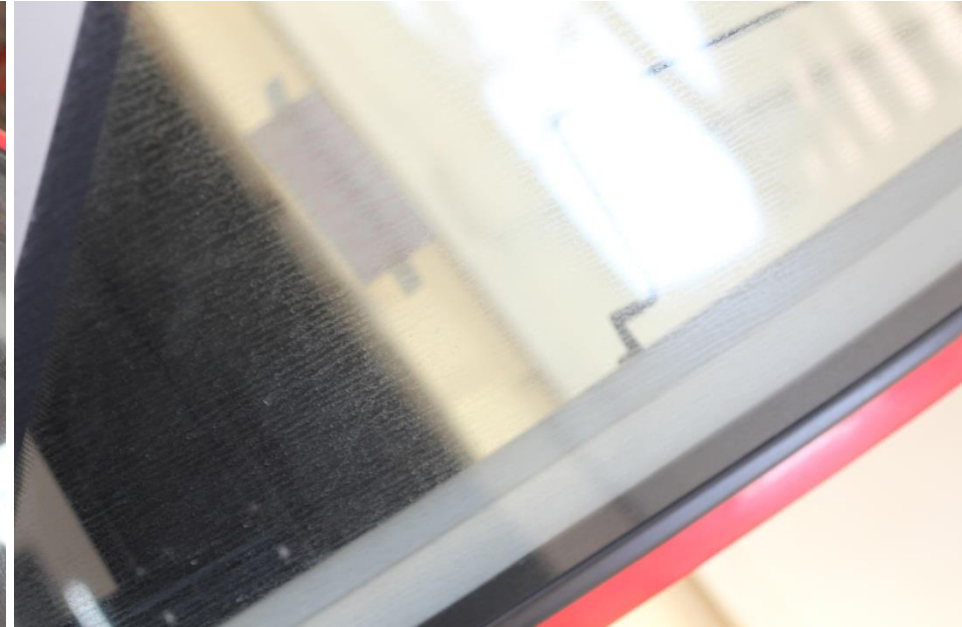
## DLTB BUS SIDE WINDOWS BEFORE CLEANING AND PROTECTION

### HEAVY SCALING AND WATERMARKS ON DLTB BUS SIDE AND REAR WINDOWS

Glass corrosions like watermarks and scaling are caused by calcium left behind by water after it evaporates. These watermarks and scaling when not given proper attention will be very difficult to remove or sometimes may cause damage to glass. Other causes of glass corrosions are : acid rain, bird droppings, tree saps and pollution. Removing watermarks and scaling is very time consuming, expensive and sometimes impossible. Nanofied coatings helps prevent these kinds of glass corrosions by protecting and sealing the glass by repelling the main causes of glass corrosions.

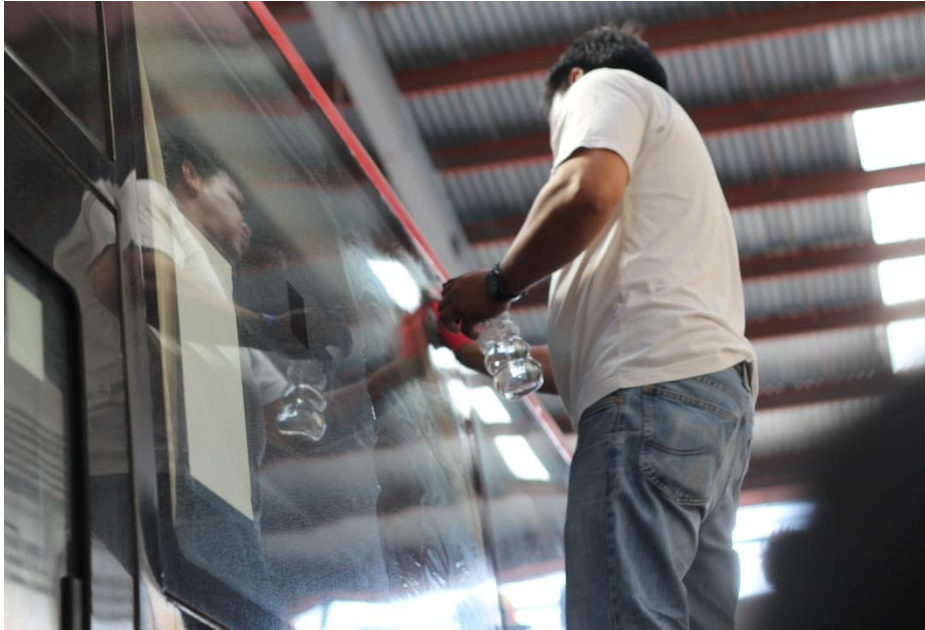
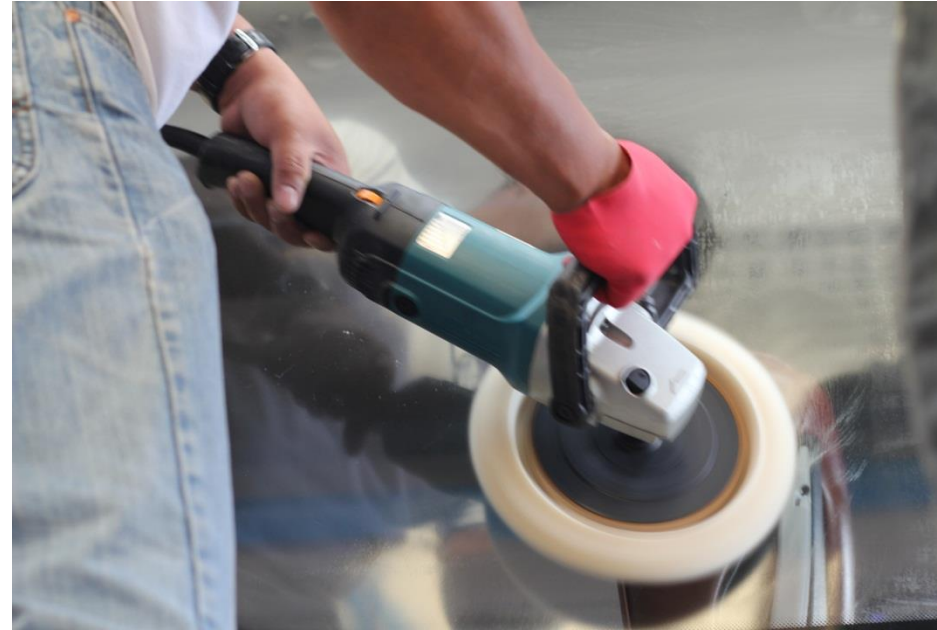
## DLTB BUS WINDSHIELD AND SIDE WINDOWS CLEANING

### REMOVING GLASS CORROSIONS : WATERMARKS AND SCALING

Removing glass corrosions like watermarks and scaling is very time consuming, expensive, requires additional manpower and sometimes impossible. Some glass corrosions requires special equipment to remove. Nanofied coatings helps prevent these kinds of glass corrosions by repelling the main causes of corrosions by protecting and sealing the surface.

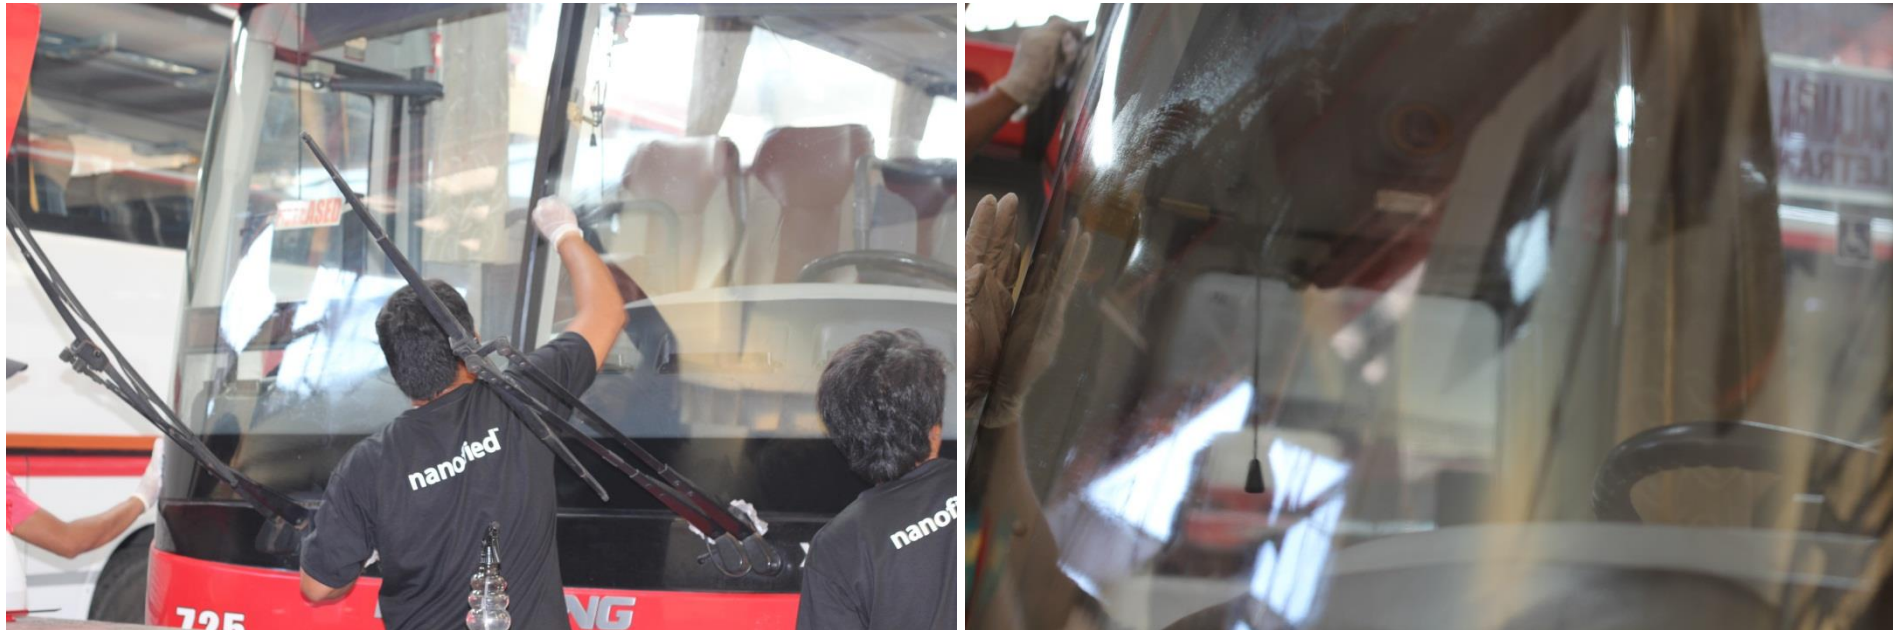
## DLTB BUS WINDSHIELD AND SIDE WINDOWS CLEANING

### REMOVING GLASS CORROSIONS : WATERMARKS AND SCALING

Removing glass corrosions like watermarks and scaling is very time consuming, expensive, requires additional manpower and sometimes impossible. Some glass corrosions requires special equipment to remove. Nanofied coatings helps prevent these kinds of glass corrosions by repelling the main causes of corrosions by protecting and sealing the surface.

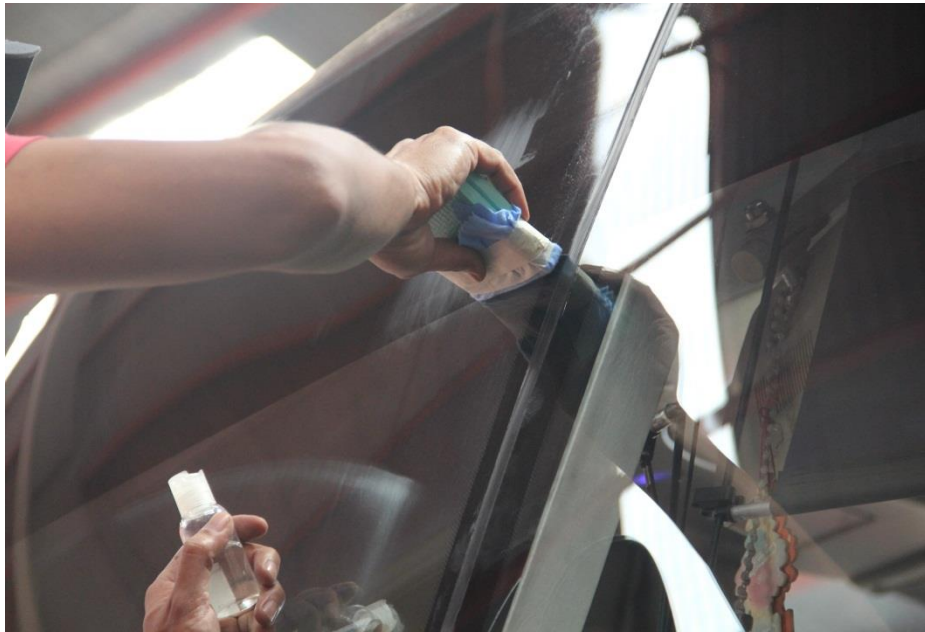
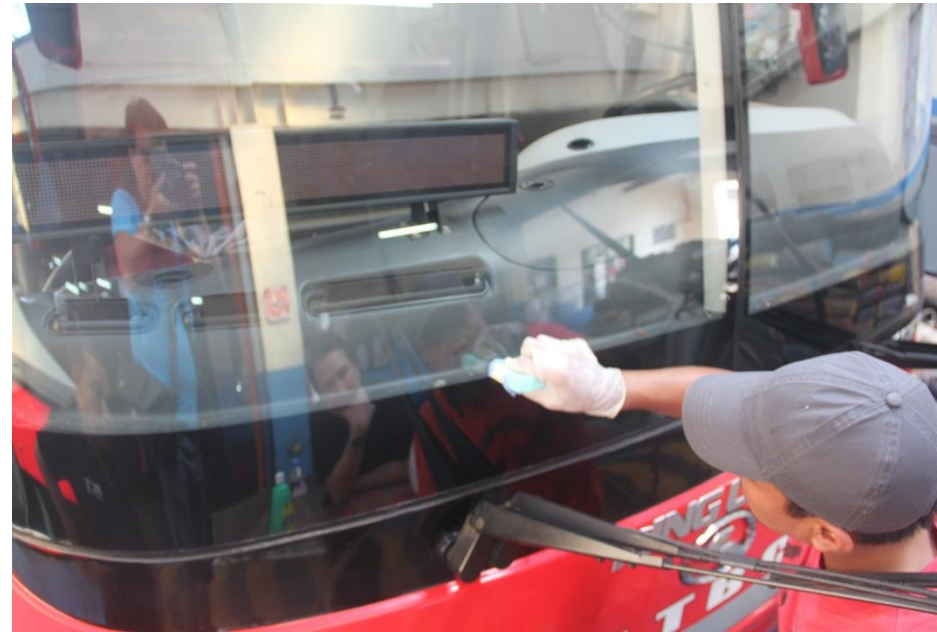
## DLTB BUS WINDSHIELD COATING APPLICATION

### APPLICATION OF NANOFIED HIGH PERFORMANCE COATING ON WINDSHIELD

After removing glass corrosions, windshield is coated with nanofied High Performance Coating for extreme protection against any kinds of corrosion with maximum durability. The coating will seal the glass and repel corrosions like hard water minerals, acid rain, UV rays, dust, dirt, salty water, salty air and other harmful pollutants. Nanofied High Performance Coating's Superphobic properties will help repel water and oil from adhering to the surface of the glass.

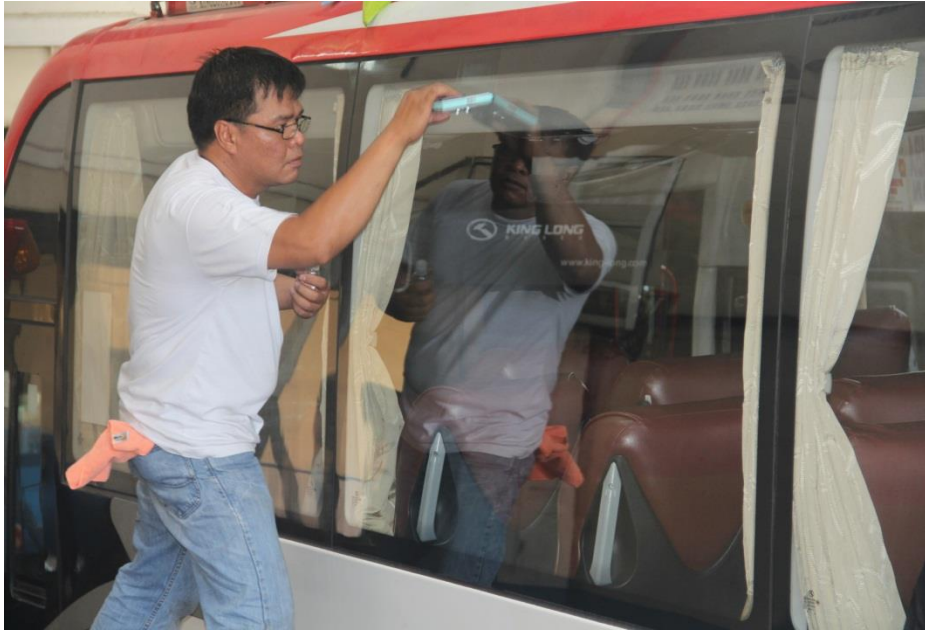
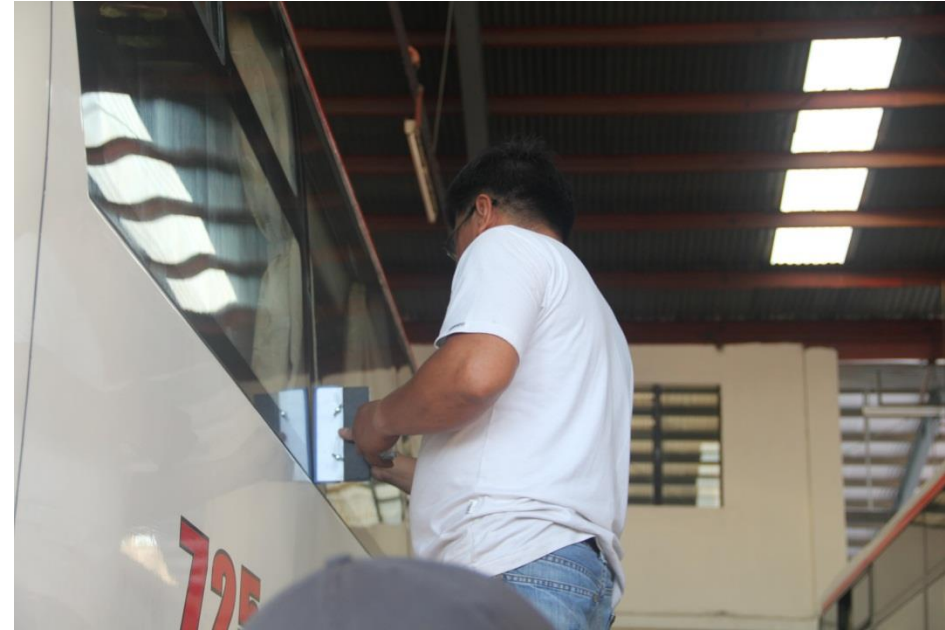
## DLTB BUS WINDSHIELD COATING APPLICATION

### APPLICATION OF NANOFIED SPECIALIZED COATING FOR GLASS ON SIDE AND REAR WINDOWS

After removing glass corrosions, side and rear window is coated with nanofied Specialized Coating for Glass. The coating will seal the glass and repel corrosions like hard water minerals, acid rain, UV rays, dust, dirt, salty water, salty air and other harmful pollutants. Nanofied Specialized Coating for Glass Superphobic properties will help repel water and oil from adhering to the surface of the glass.

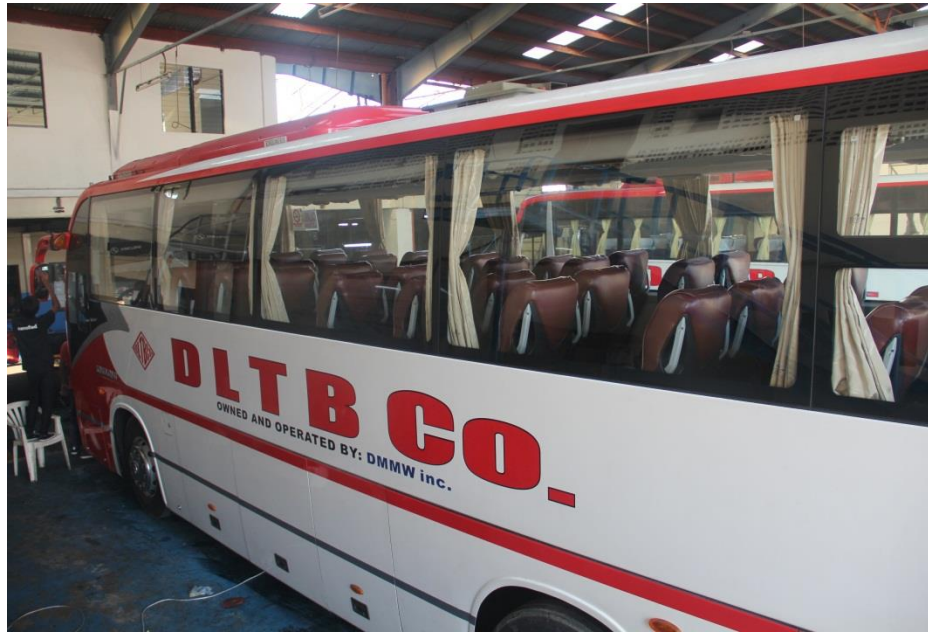
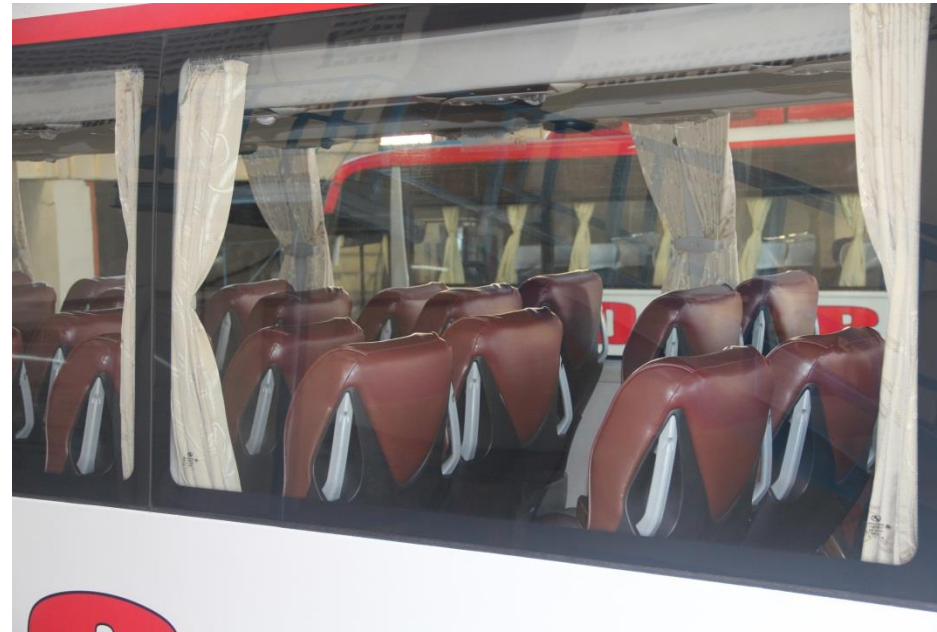
## DLTB BUS AFTER CLEANING AND COATING APPLICATION

### SIDE WINDOWS CLEANED AND PROTECTED WITH NANOFIED SPECIALIZED COATING FOR GLASS

After side windows is cleaned and protected, side windows is noticeably clearer, brighter and cleaner. Nanofied Specialized Coating for Glass will protect side windows from watermarks, scaling and other glass corrosions for months, minimizing maintenance and cleaning costs.

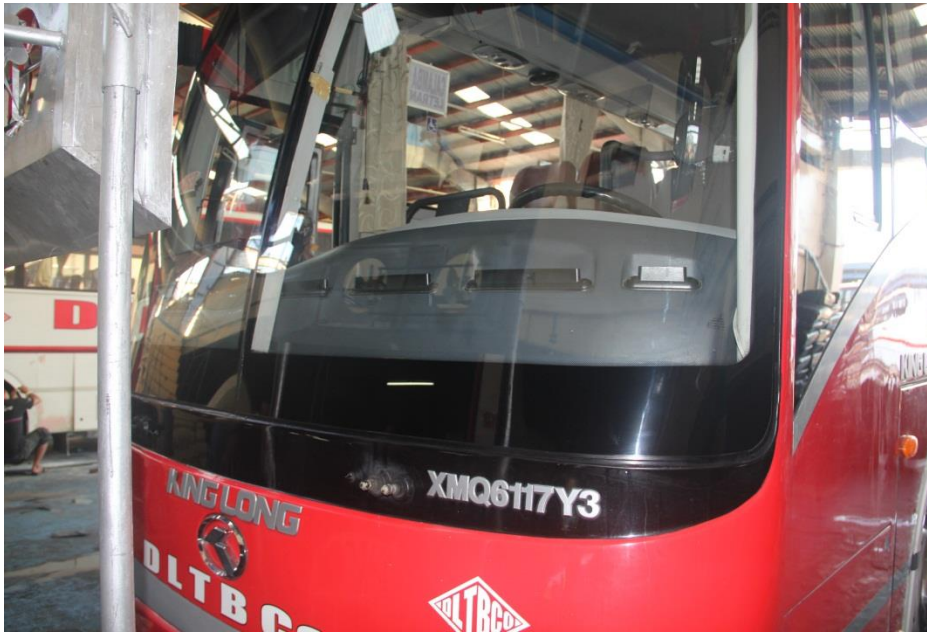
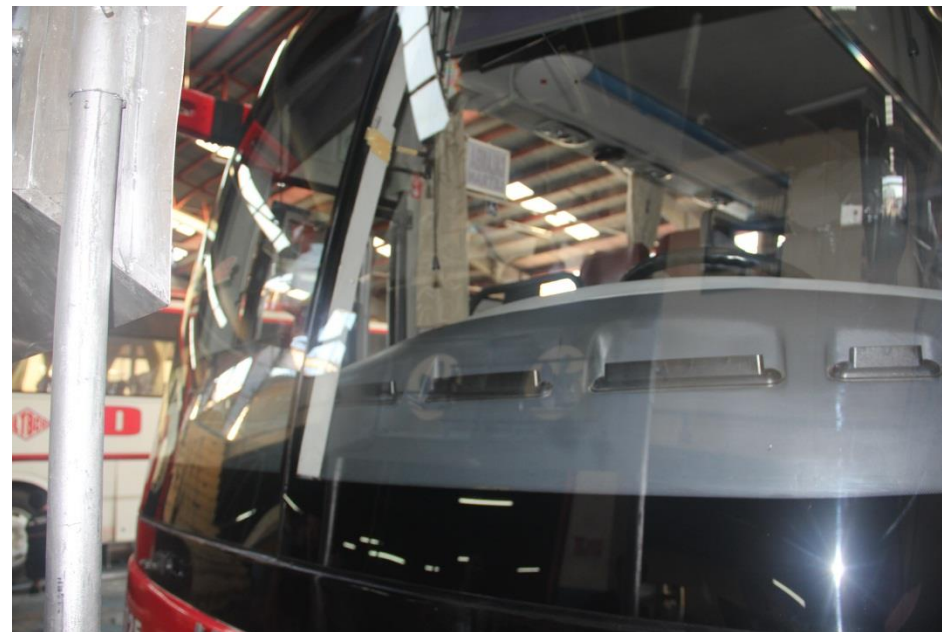
## DLTB BUS AFTER CLEANING AND APPLICATION

### WINDSHIELD CLEANED AND PROTECTED WITH NANOFIED HIGH PERFORMANCE COATING

After side windows is cleaned and protected, side windows is noticeably clearer, brighter and cleaner. Nanofied High Performance Coating will provide extreme protection for windshield against watermarks, scaling and other glass corrosions for months, minimizing maintenance and cleaning costs.

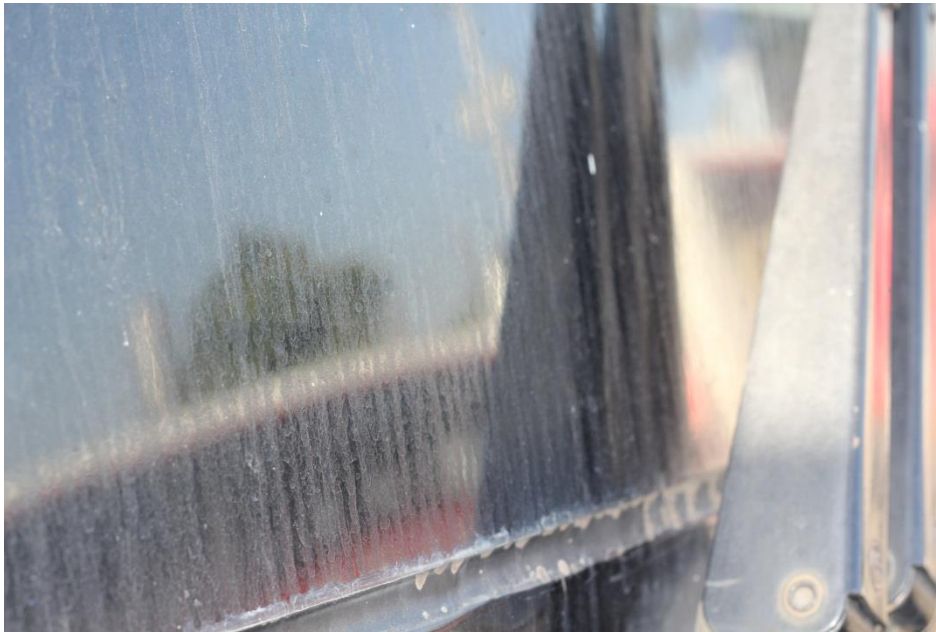
**WINDSHIELD BEFORE**

Heavy watermarks and scaling is very noticeable on windshield

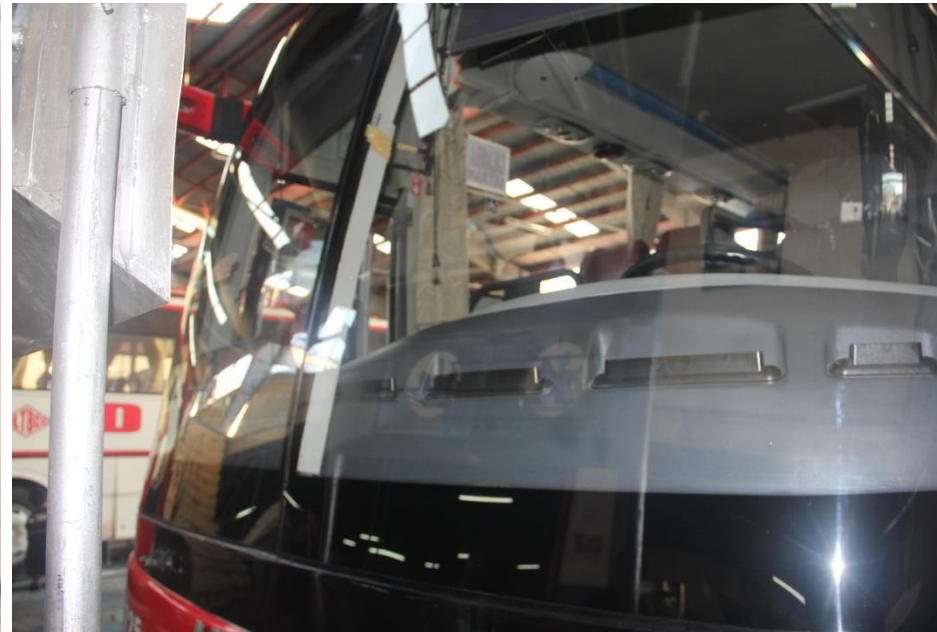
**WINDSHIELD AFTER**

Watermarks and scaling is removed, windshield is coated with nanofied High Performance Coating for extreme protection against glass corrosion

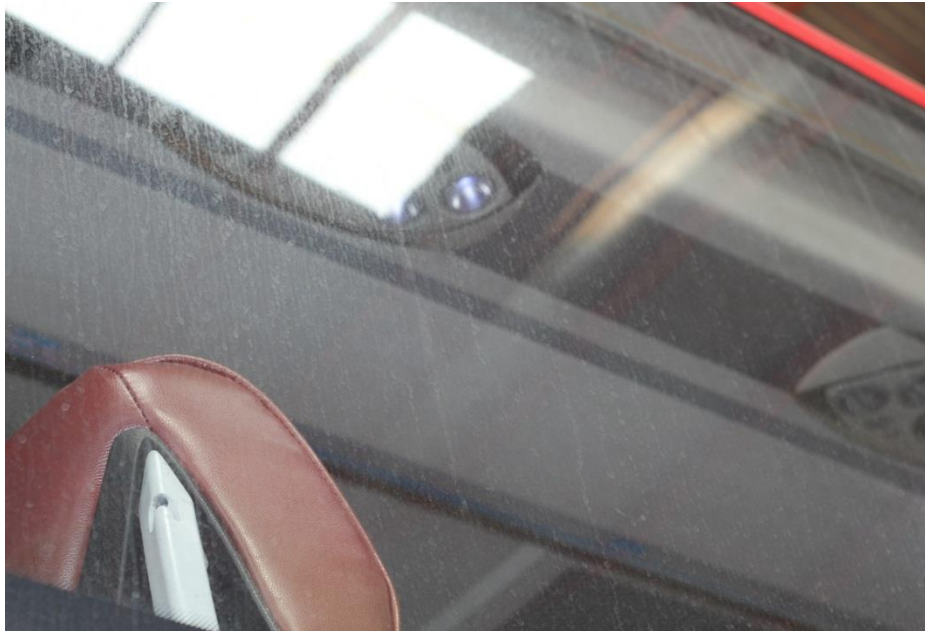
**SIDE WINDOWS BEFORE**

Heavy watermarks and scaling is very noticeable on windshield

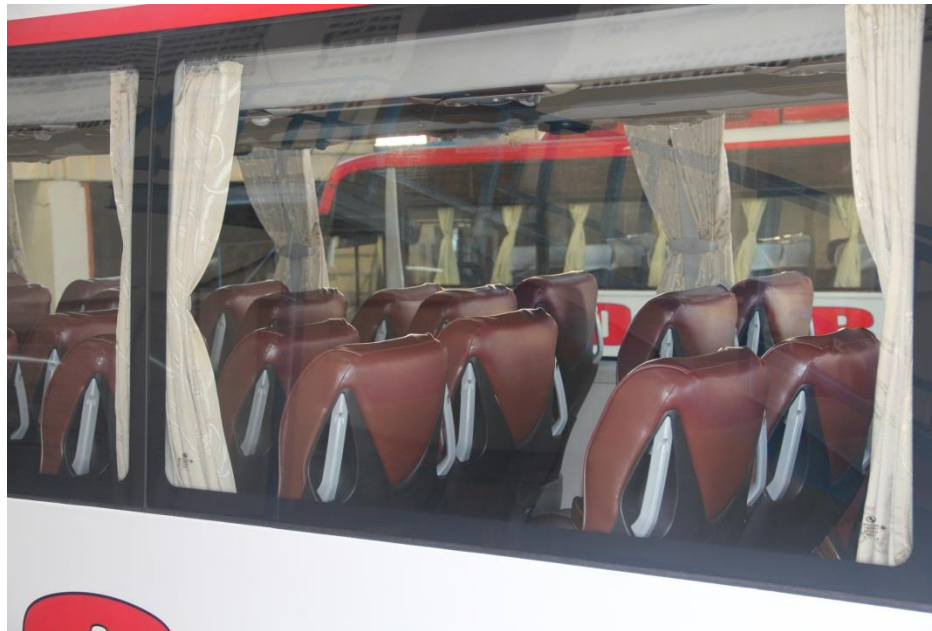
**SIDE WINDOWS AFTER**

Watermarks and scaling is removed, side windows is coated with nanofied Specialized Coating for Glass protection against glass corrosion
