MAX'S RESTAURANT

Glass Panels
Mockup

MOCKUP : **MAX'S RESTAURANT (ATC Branch)**
Mockup Details : **8 pieces glass panels (front)**
Cleaning : **Biosativa**
Coating : **Nanofied Specialized Coating for Stone**

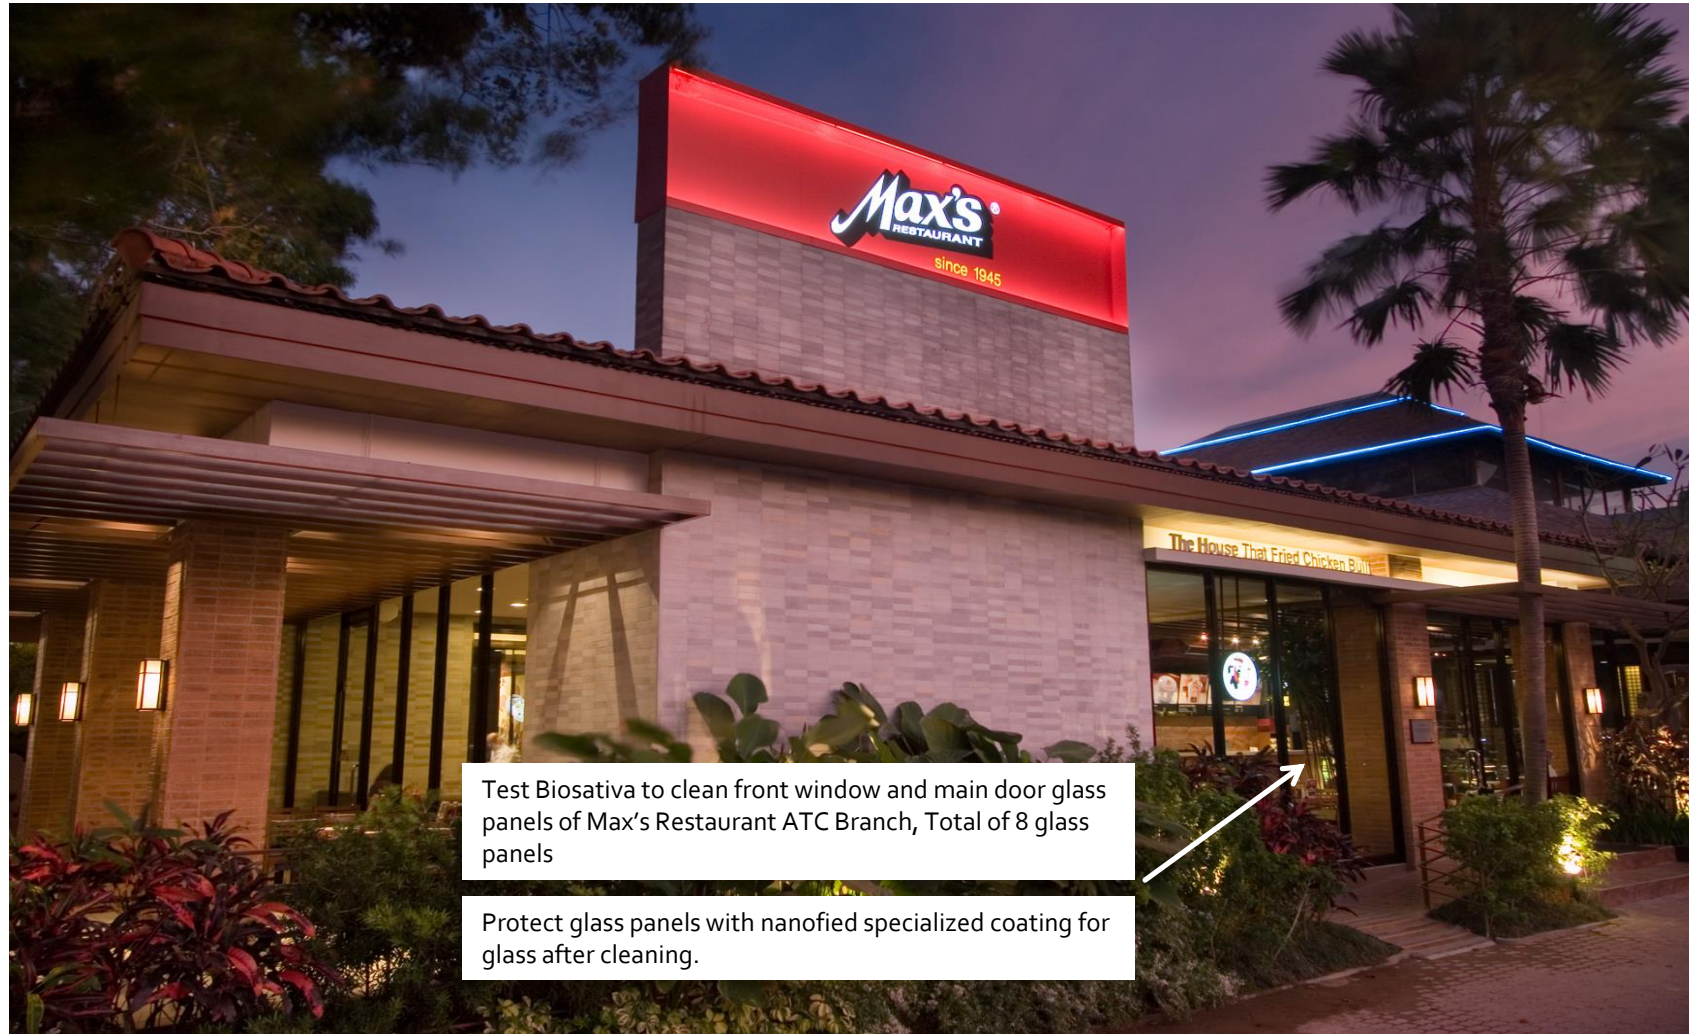
Test Biosativa to clean front window and main door glass panels of Max's Restaurant ATC Branch, Total of 8 glass panels

Protect glass panels with nanofied specialized coating for glass after cleaning.

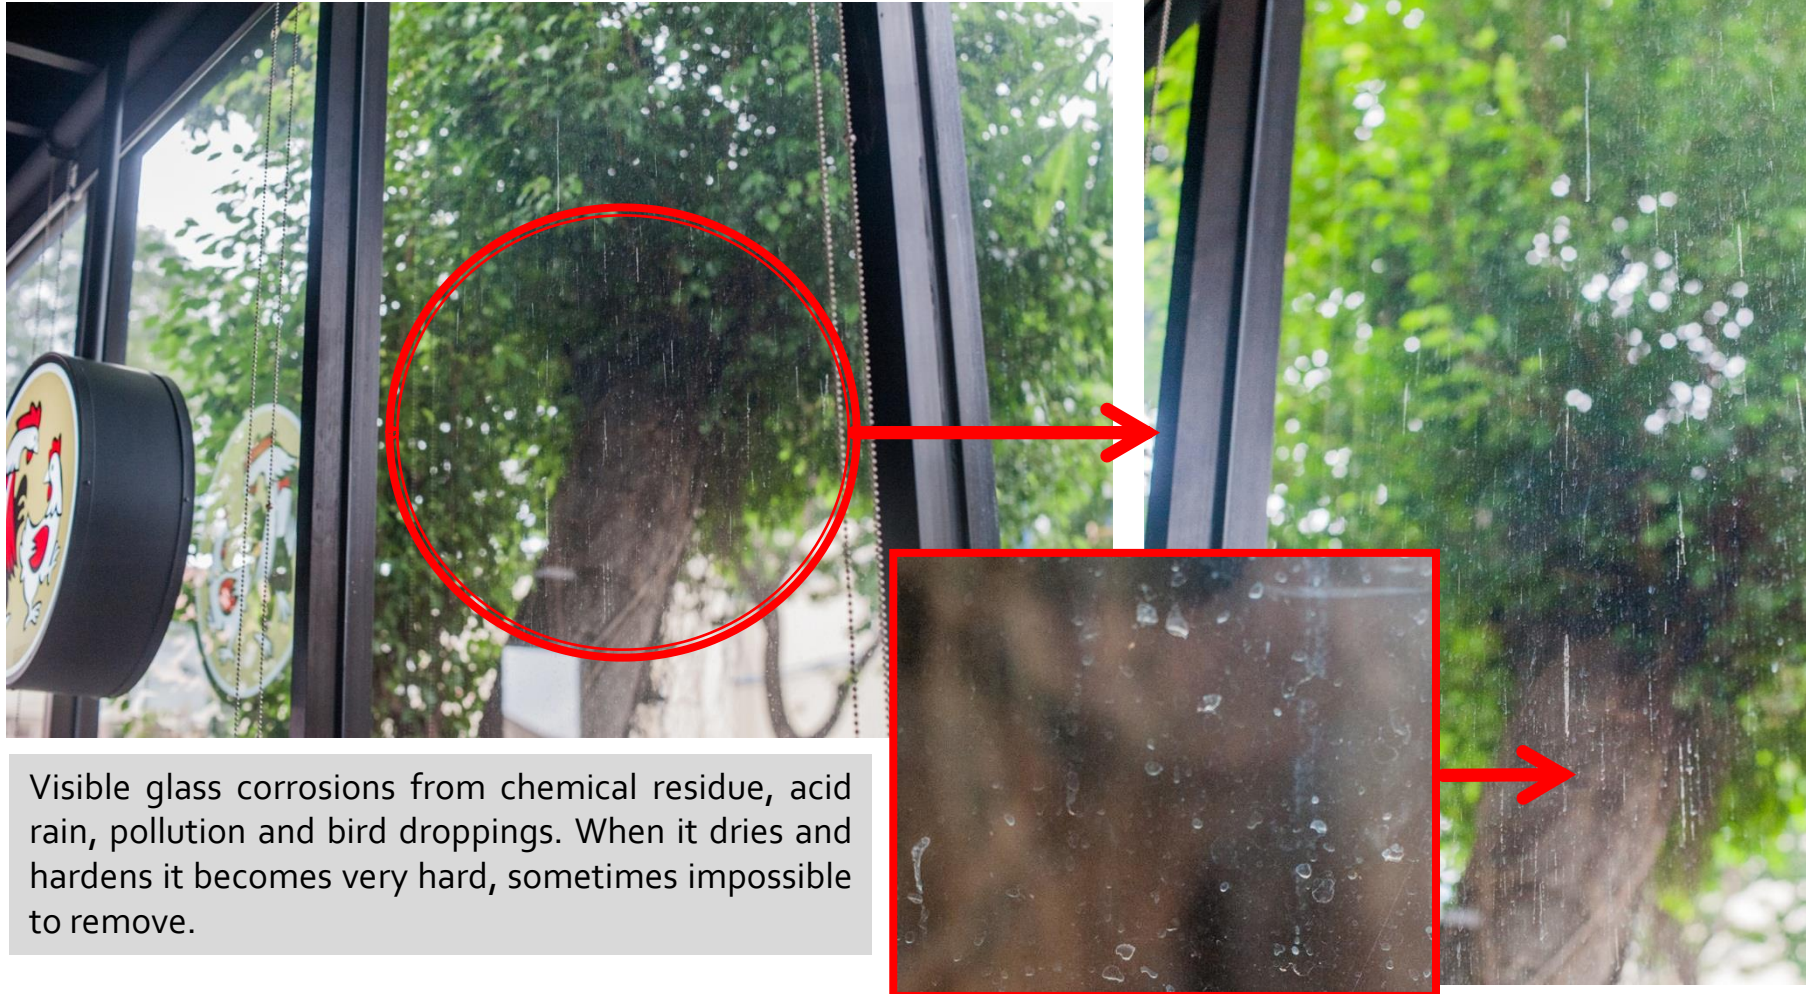
GLASS PANEL BEFORE MOCKUP

Visible glass corrosions from chemical residue, acid rain, pollution and bird droppings. When it dries and hardens it becomes very hard, sometimes impossible to remove.

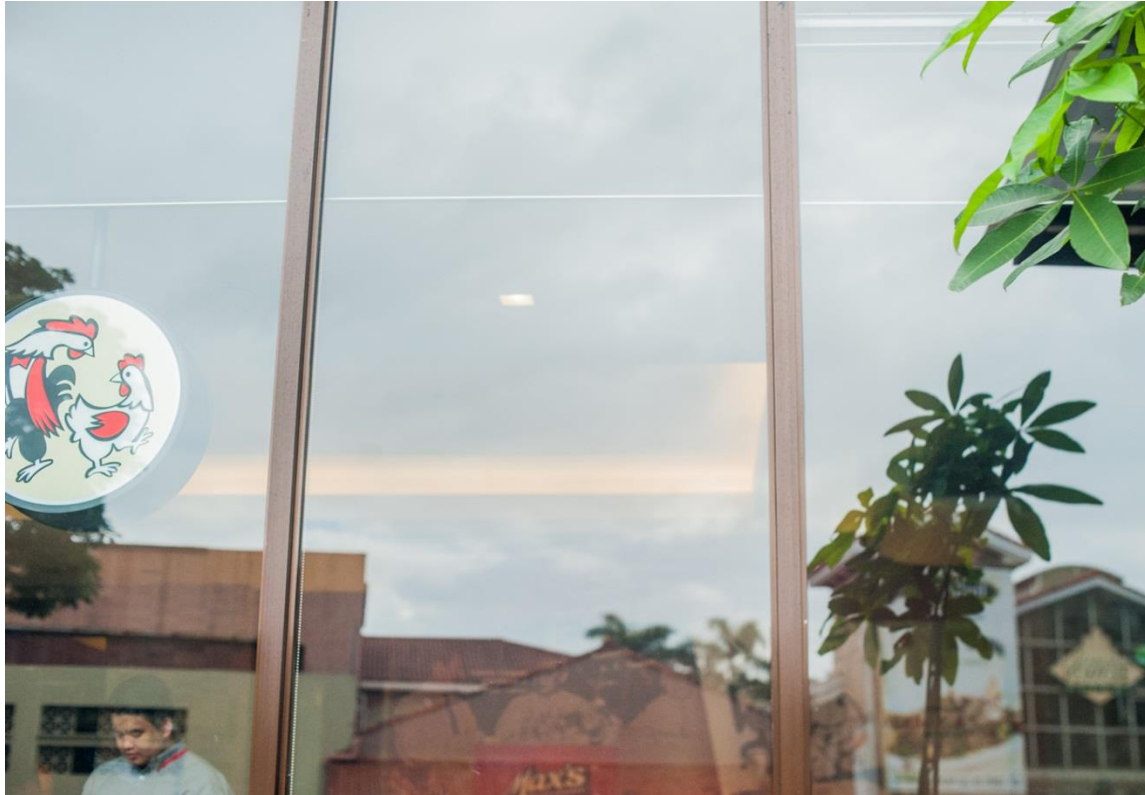
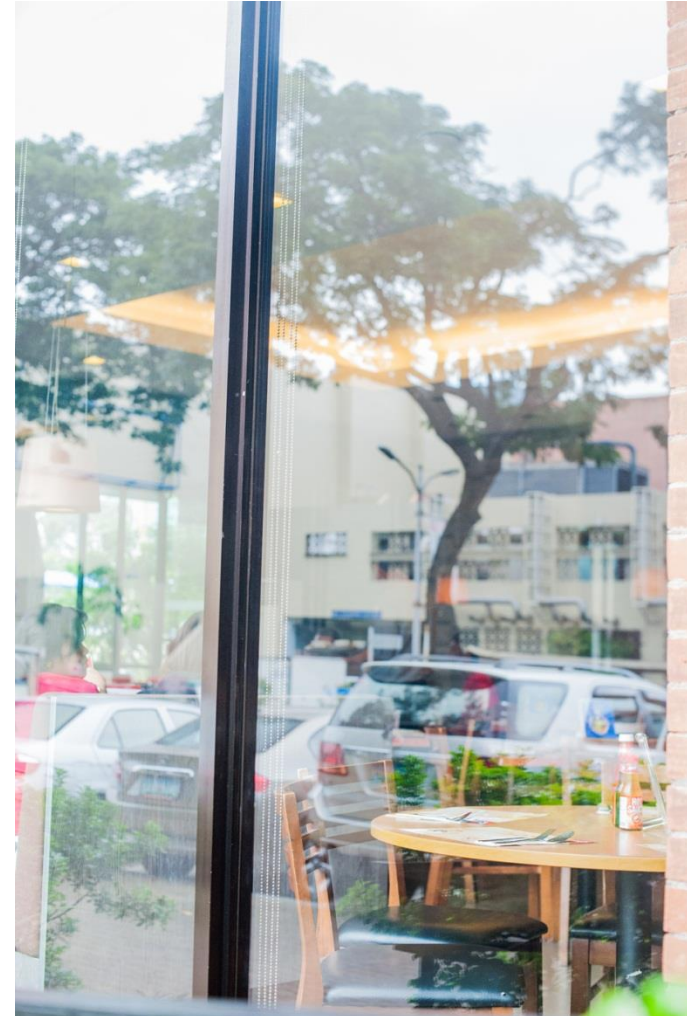
GLASS PANEL AFTER CLEANING AND PROTECTION (1 MONTH AFTER)

After 1 month we revisited the cleaned and coated glass panels. Glass panels are brighter, clearer and cleaner compared to uncoated glass panels.
