# Westfield London Shopping Centre

Roof cleaning and coating with SiO<sup>2</sup> / Stone coating / tile coating

Follow up meeting 4-4-14 Westfield London Roof Cleaning and Protection Project.

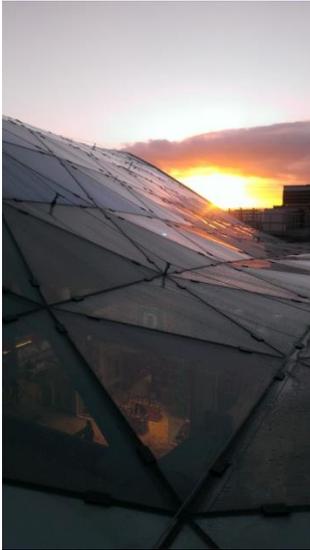
The aim of this project will be the application of Liquid Glass coatings in order to make the surface less prone to soiling build-up and to make them significantly easier to clean.

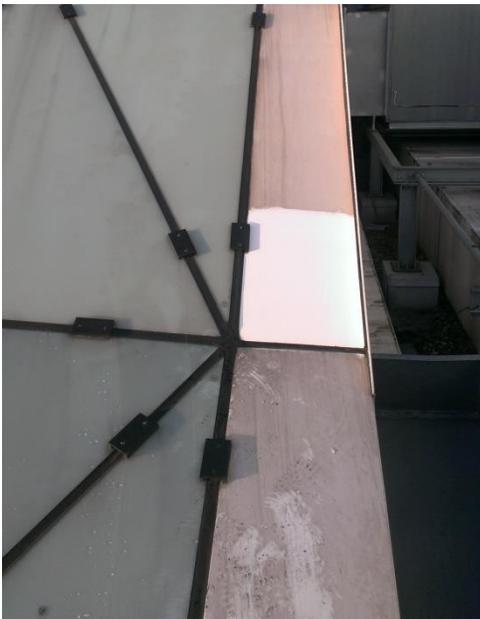
Plastic fascias and soffits

These surfaces are highly soiled.

After cleaning it will be very easy to apply the coating.

The coating used for this trial was Universal Coating 673.

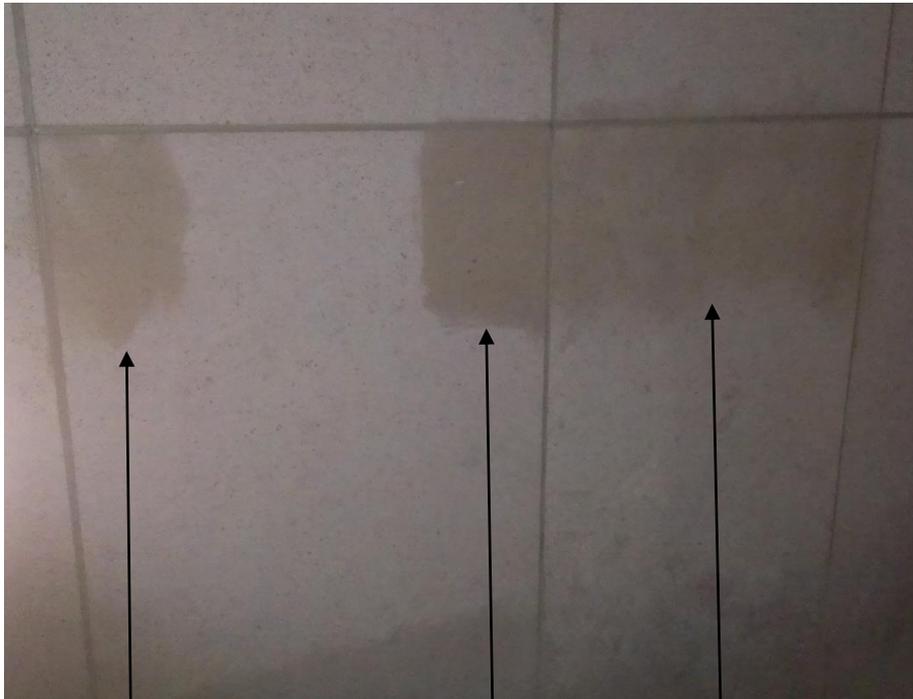
The “stone” would appear to be a hybrid stone coating. It is highly absorbent. (It would be necessary to know if this is a hybrid stone as we offer different coatings for such surfaces.)

The coatings used are undetectable and should not alter the tone/ appearance / texture of the stone. We can offer coatings which offer an anti graffiti/ glossy finish if required.

Universal 675

Universal Silane 673

Water based  
stone coating  
695

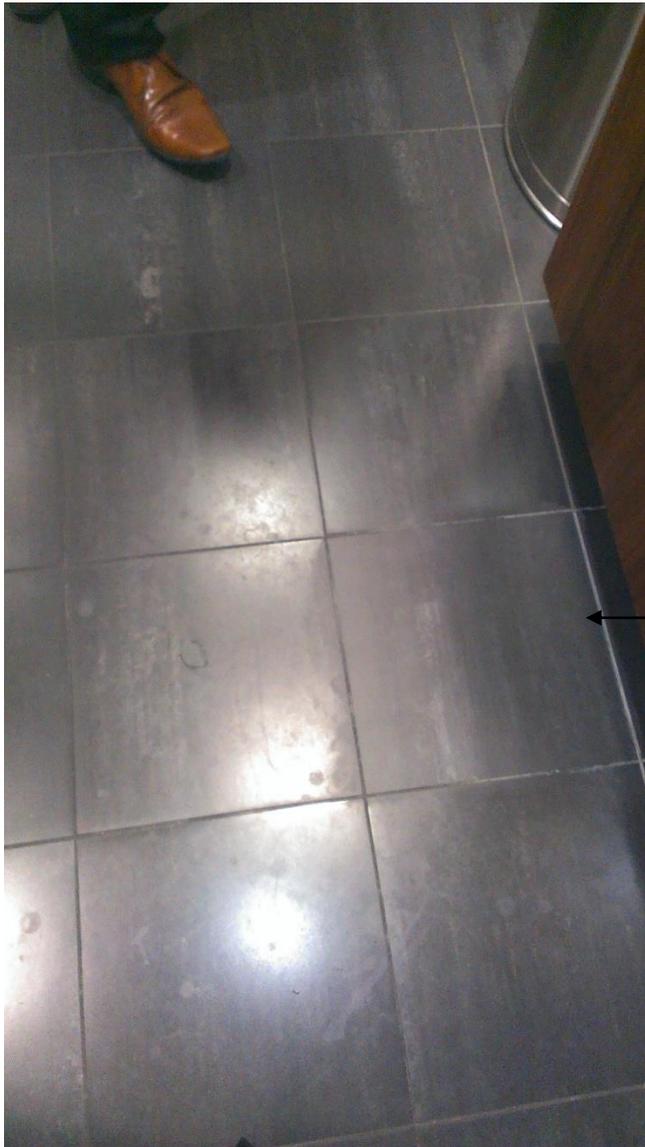
The image presented below shows an area which has been cleaned and the coated with universal coating 673. (The Universal 675 or a glass and ceramic coating may also be suitable)

It was apparent that the staining lay within the top coat of "polish". The staining was caused by a cleaning agent. A very mild abrasive agent, suitable for glass, was used to remove the staining.

Tile coated with universal 673.

After 4 (winter) months

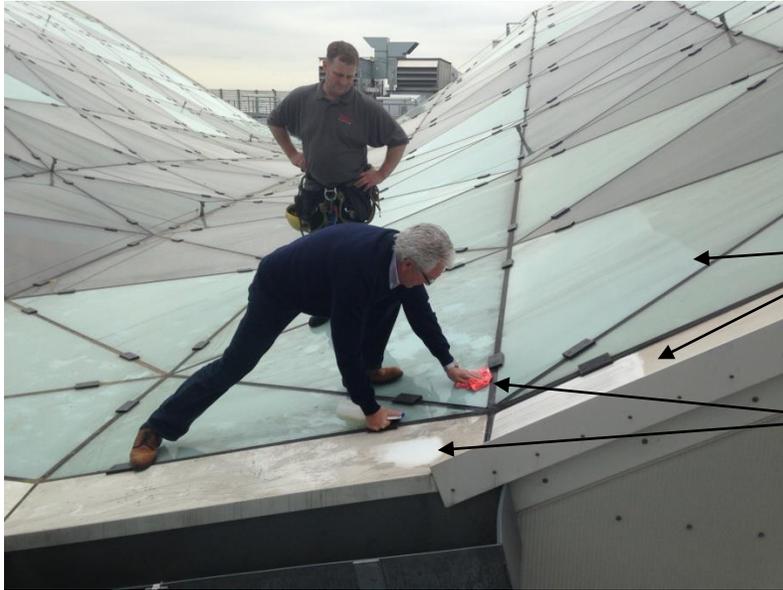
Area cleaned and protected some months before

Comparison of Biosativa® and detergent cleaning. Biosativa® was clearly more effective.

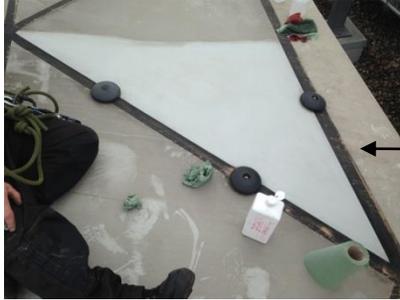
This area is a mixture of glass and acrylic panels. The acrylic panels are heavily soiled and require additional cleaning. Biosativa® cleans the area quite effectively as noted in the images, but cleaning the plastic/acrylic surface with stainless steel cleaner BLU1000 is probably required in order to provide a surface suitable for coating

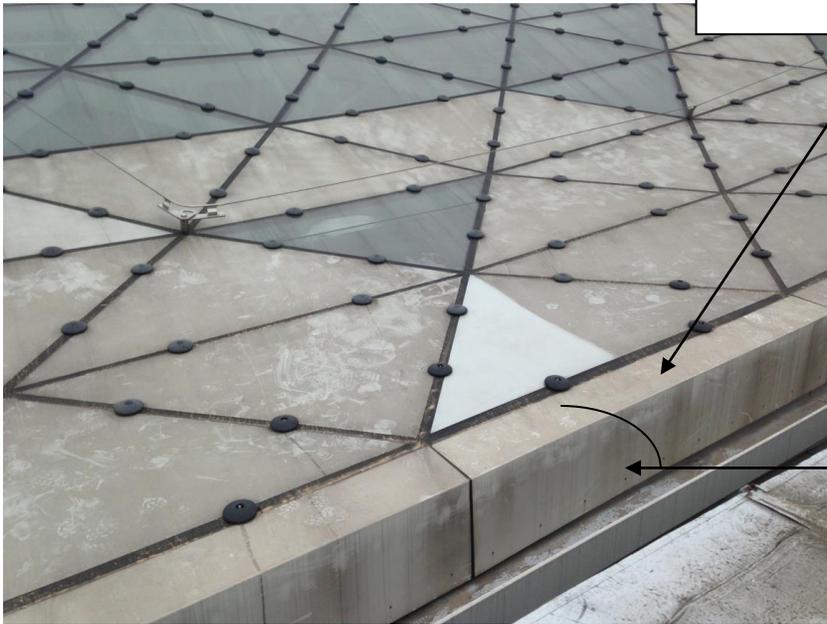
Area coated with universal SI coating 673

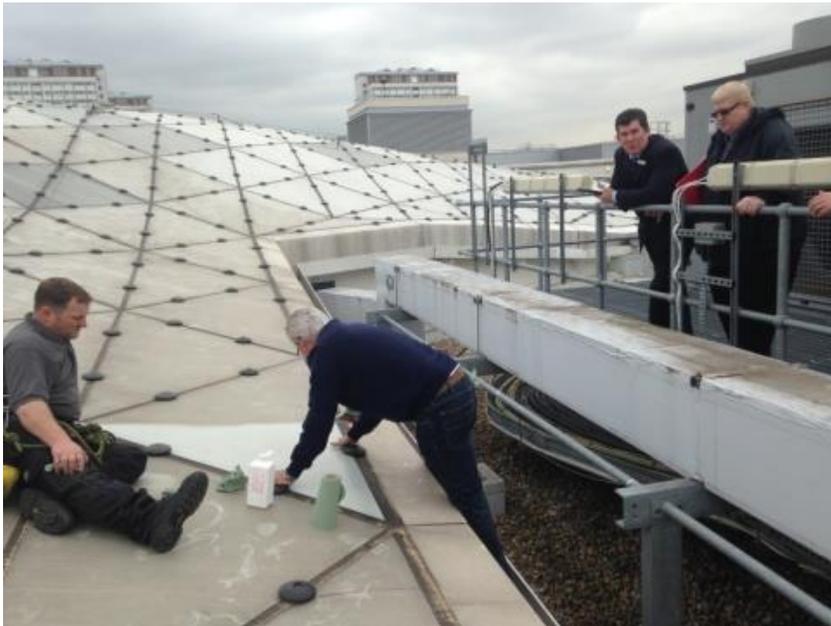
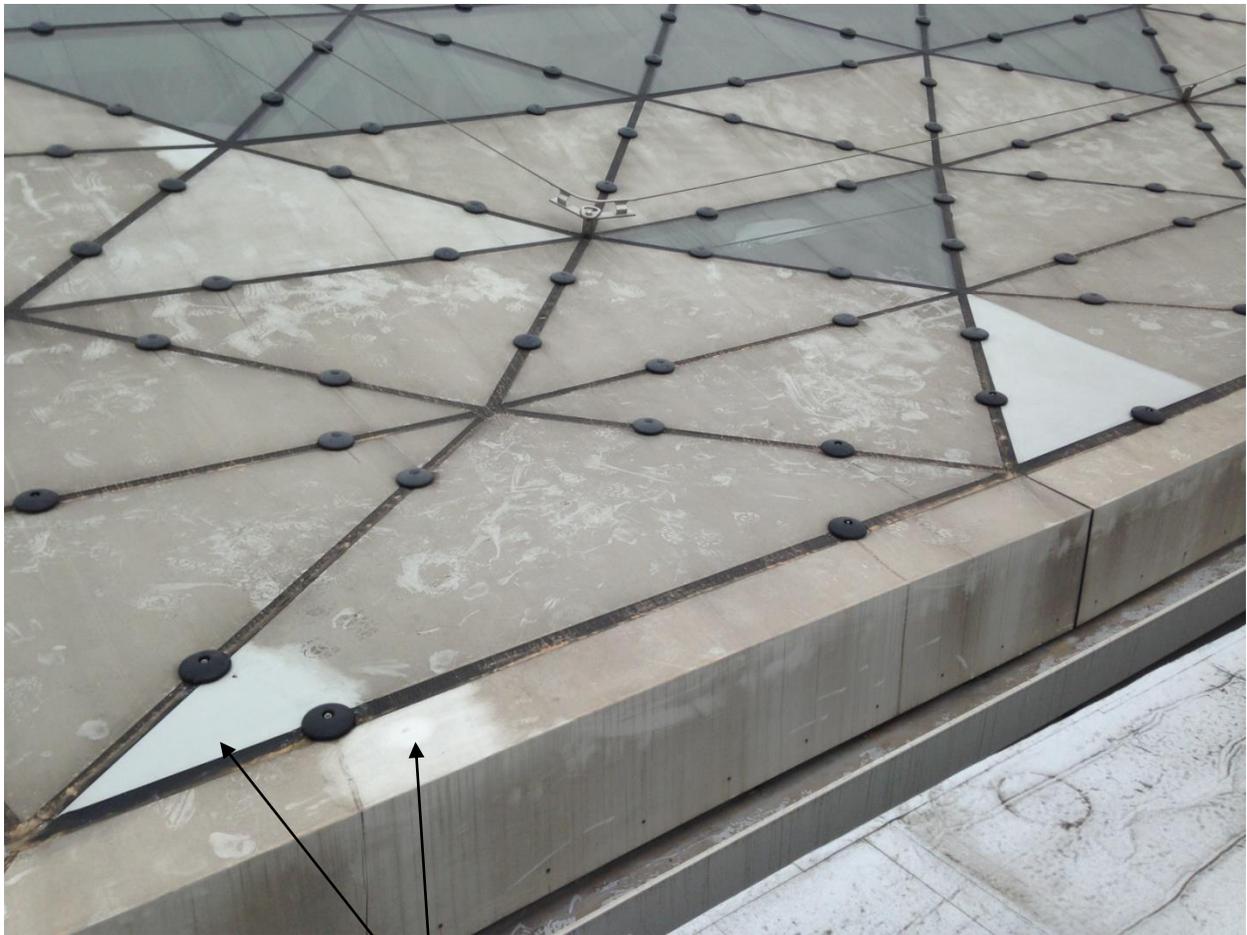
Acrylic area cleaned with stainless steel cleaner BLU1000. Note that it is brighter than the area cleaned with Biosativa® as the soiling is ingrained within the surface. Cleaning with this process creates an “as new” appearance but it will require more cleaning effort in the first instance.

This additional time would be offset by rapid cleaning in following years.
