CCM TO THE RESCUE

CCM was happy to solve a problem for the town of Penzance, Cornwall / UK. As the Image shows there was a very bad oil stain on the newly refurbished Penzance Promenade. An article in *Cornwall Live* highlighted the problem. In the article it was noted that attempts to clean the area had failed (<https://www.cornwalllive.com/news/cornwall-news/sorry-burger-van-owners-pay-5381687.amp>).

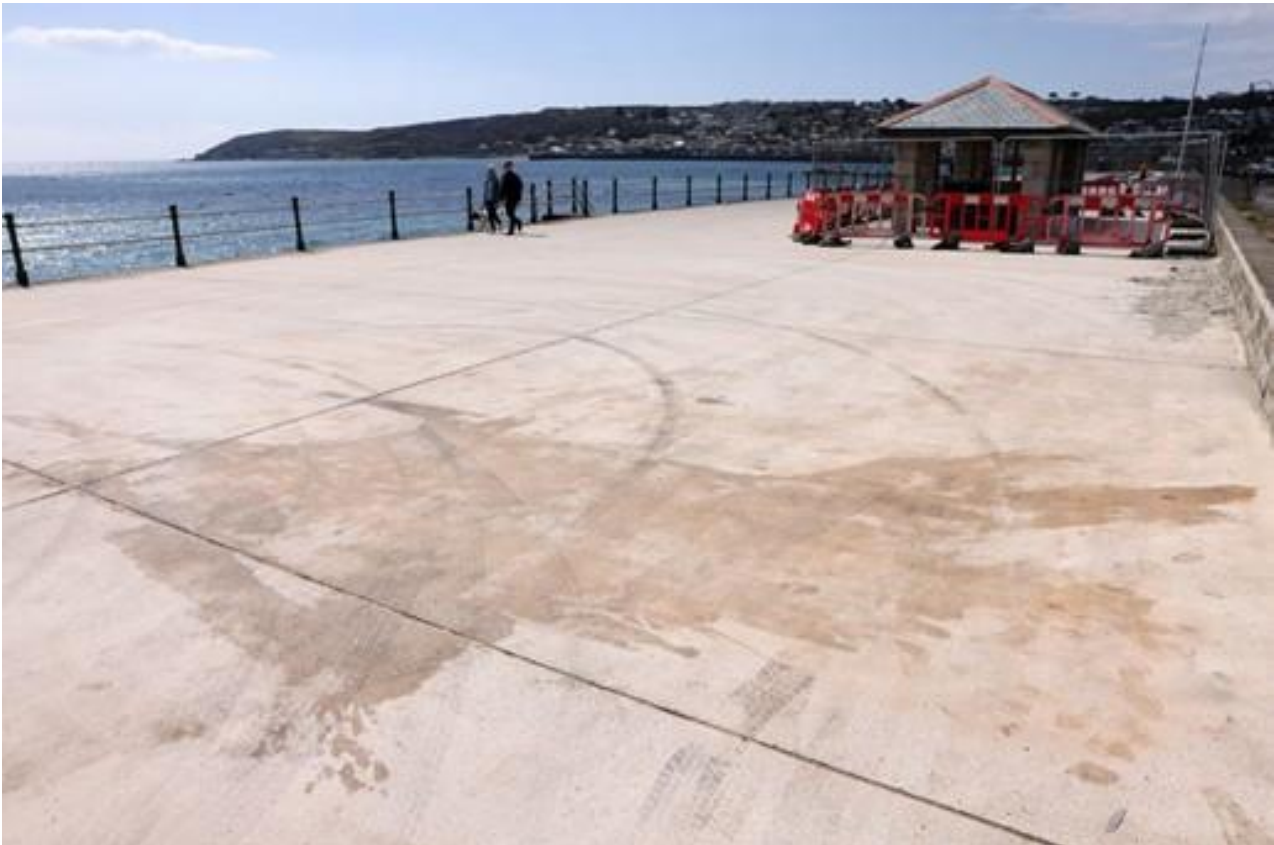
Staining prior to cleaning process

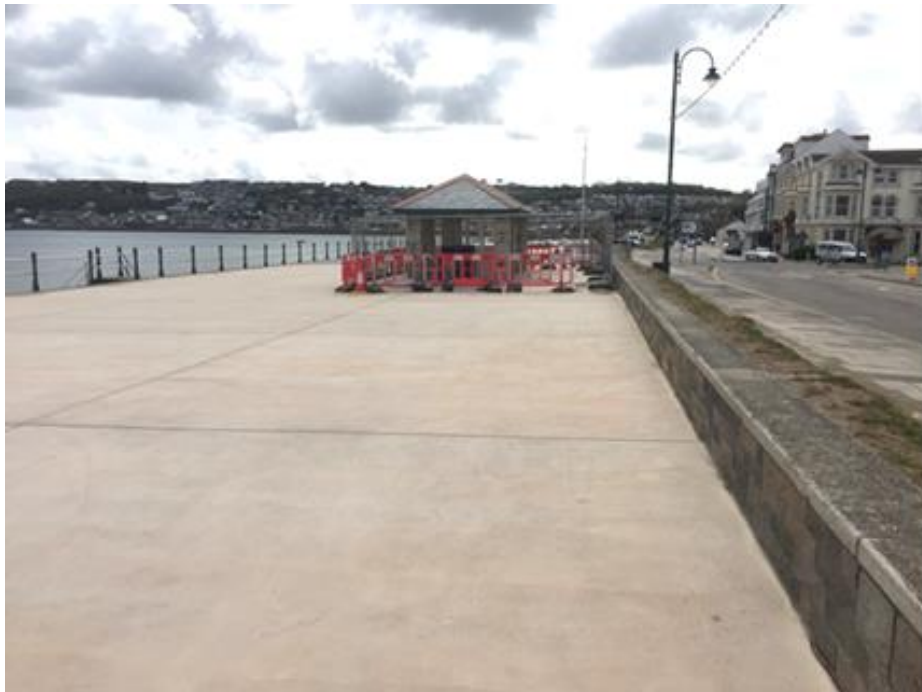
after pressure washing
