**Glass and Aluminum Cladding
Mockup**

DMCI
Cleaning and Protection of glass and aluminum cladding
Biosativa, Stainless Cleaner, Glass cleaners
Nanofied Specialized Coating for Glass and High Performance Coating

DMCI Building

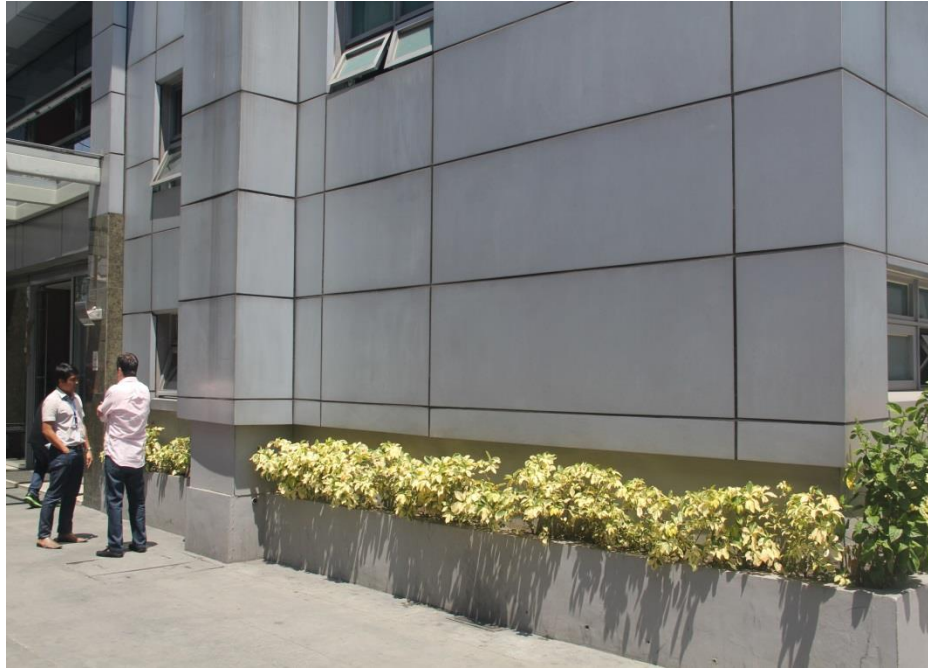
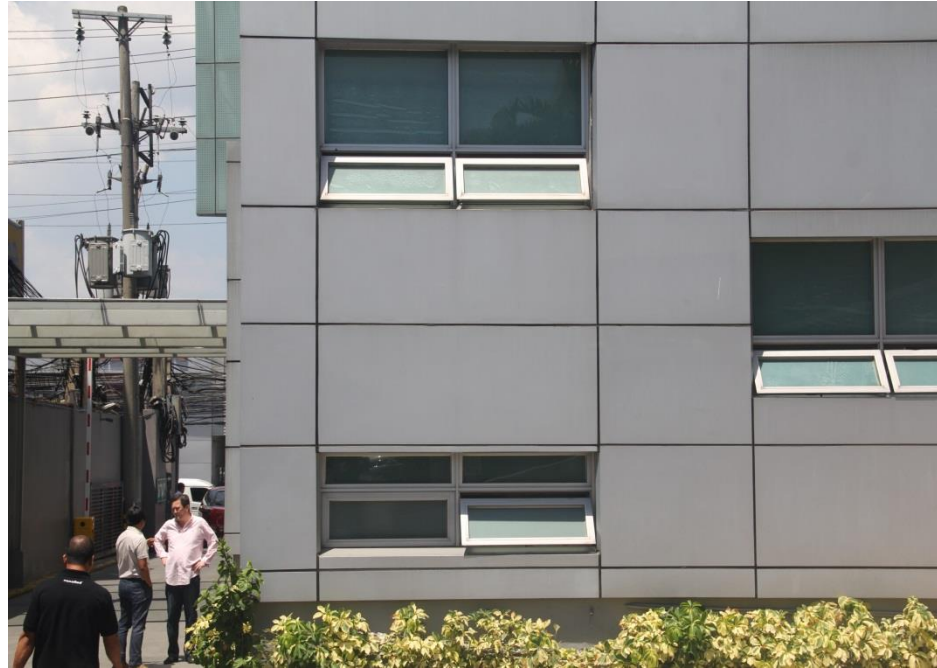
DMCI is looking for solutions to prevent staining and corrossions on aluminum cladding and glass

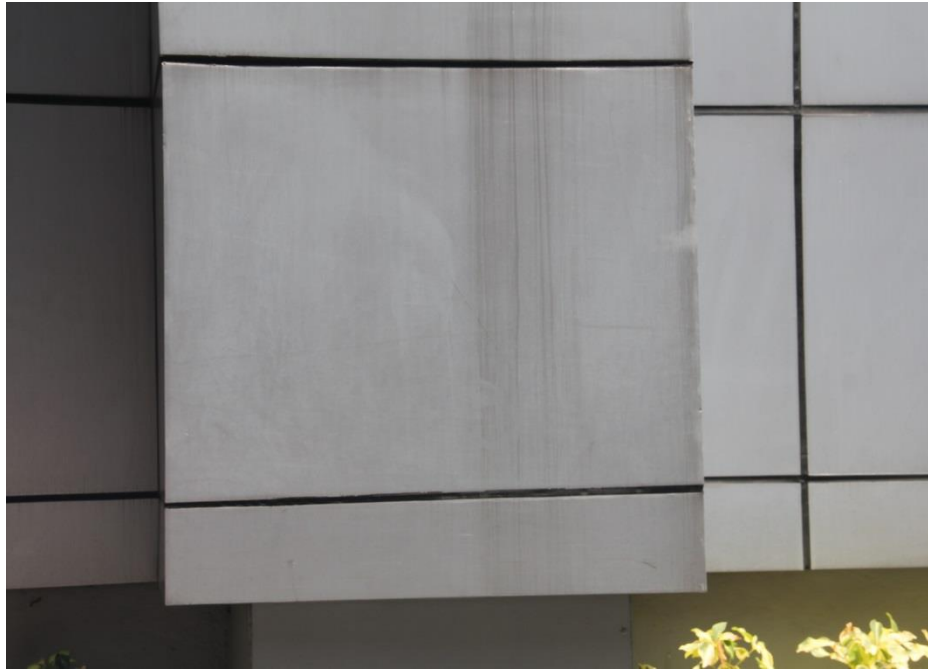
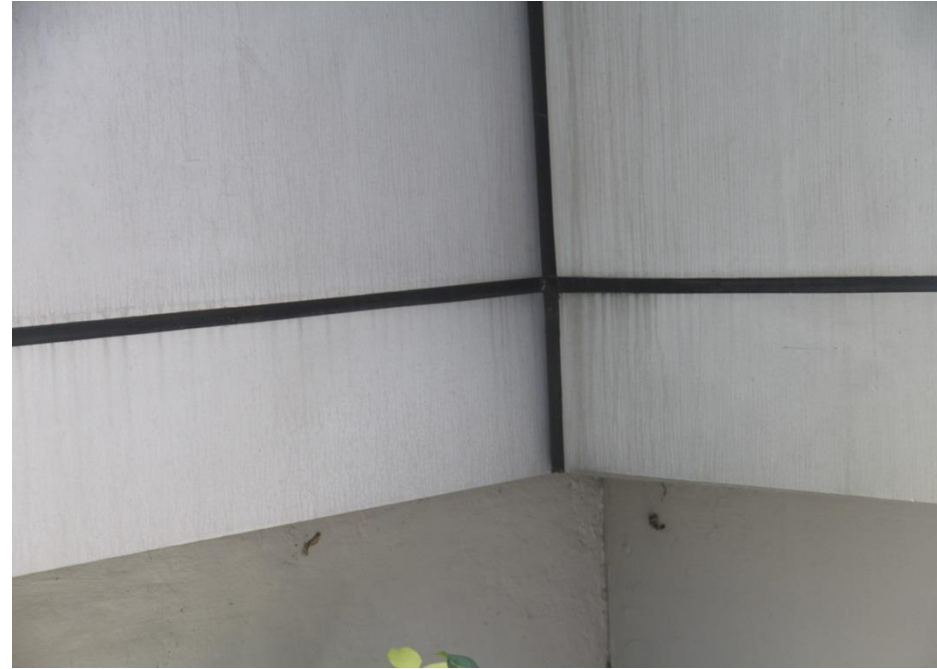
DMCI Building – Aluminum Cladding

DMCI Building aluminum cladding problems with staining and corrosions caused by acid rain, building runoff, oil, dirt, dust and other pollutants.

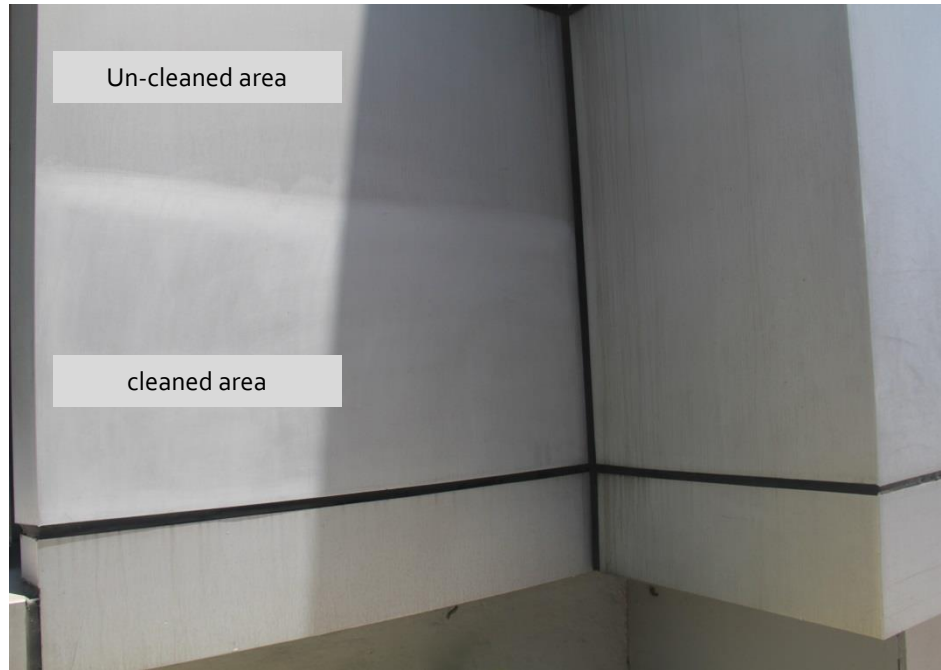
DMCI Building – Aluminum Cladding (Cleaning and Application)

Dust and dirt is removed from aluminum cladding

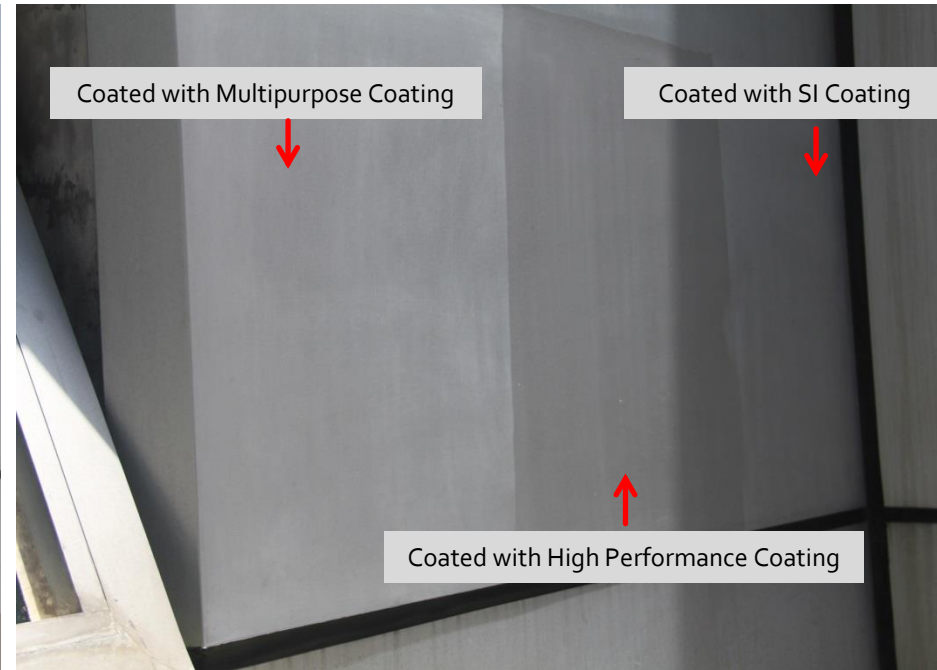
Aluminum cladding coated with multipurpose coating provide invisible protection against corrosions

Aluminum cladding coated with High Performance coating restores original appearance of surface and provides massive protection against corrosions

Aluminum cladding coated with SI coating provide invisible protection against corrosions

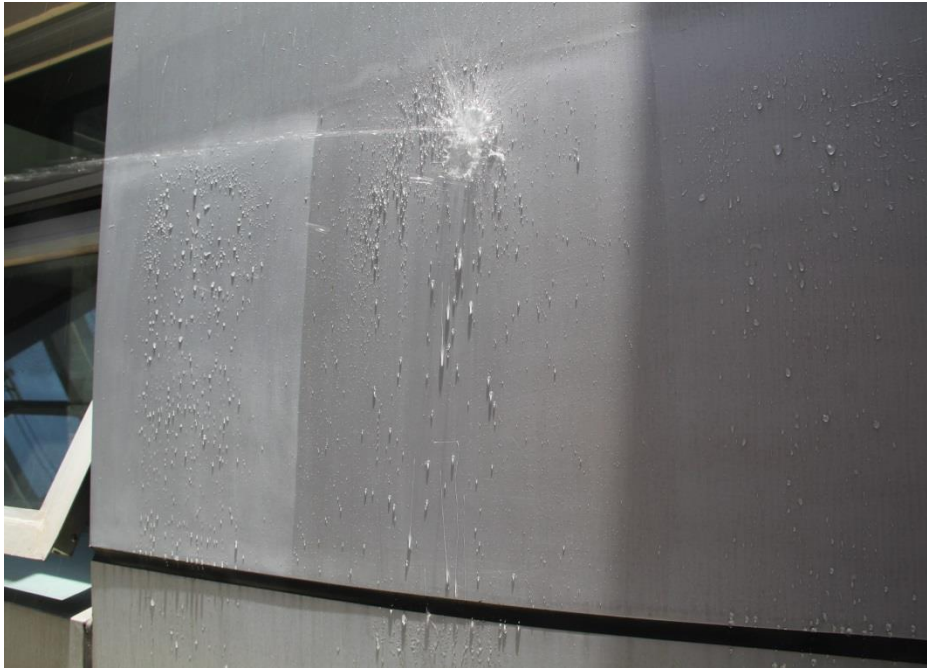
DMCI Building – Aluminum Cladding after 1 week and testing

Coated aluminum cladding remains clean and without corrosion after 1 week, water is sprayed on aluminum cladding notice that water beads and is being repelled by the coating

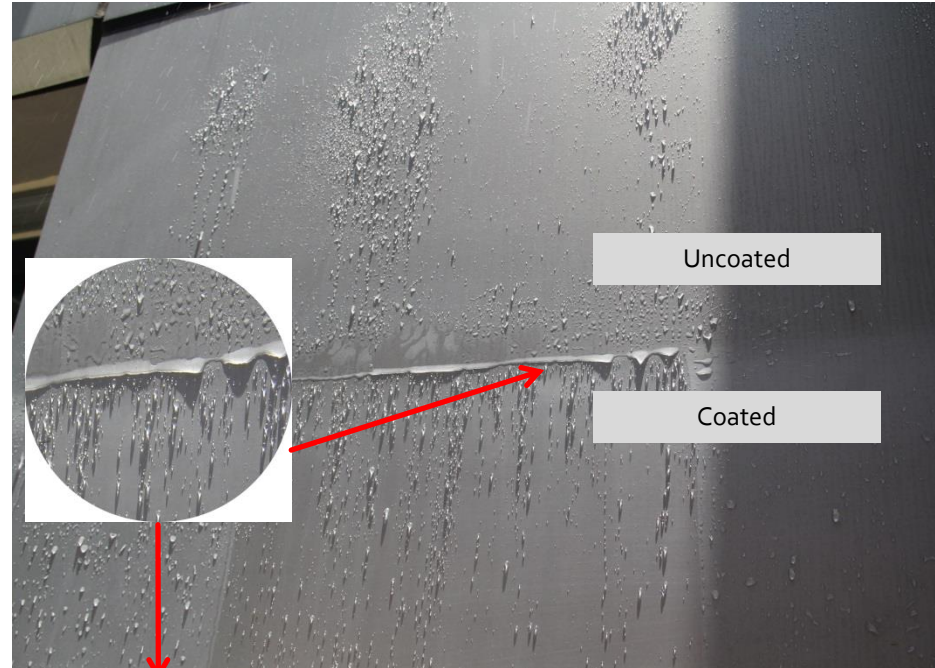
Water sprayed on uncoated area of the cladding is being repelled or not being allowed to roll off on coated aluminum cladding.

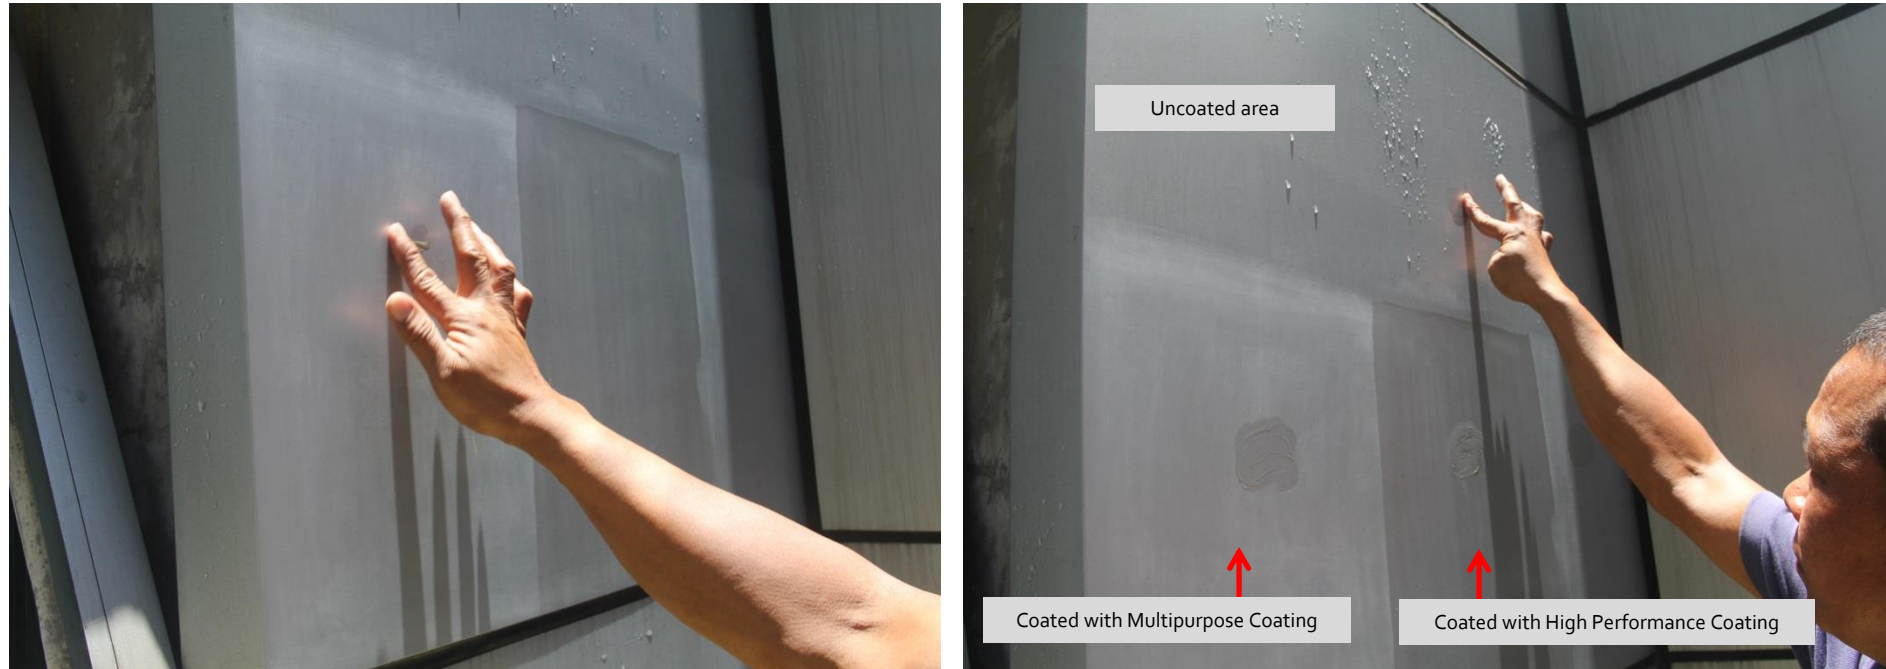
DMCI Building – Aluminum Cladding after 1 week and testing

Oil / Grease applied on coated and uncoated aluminum cladding

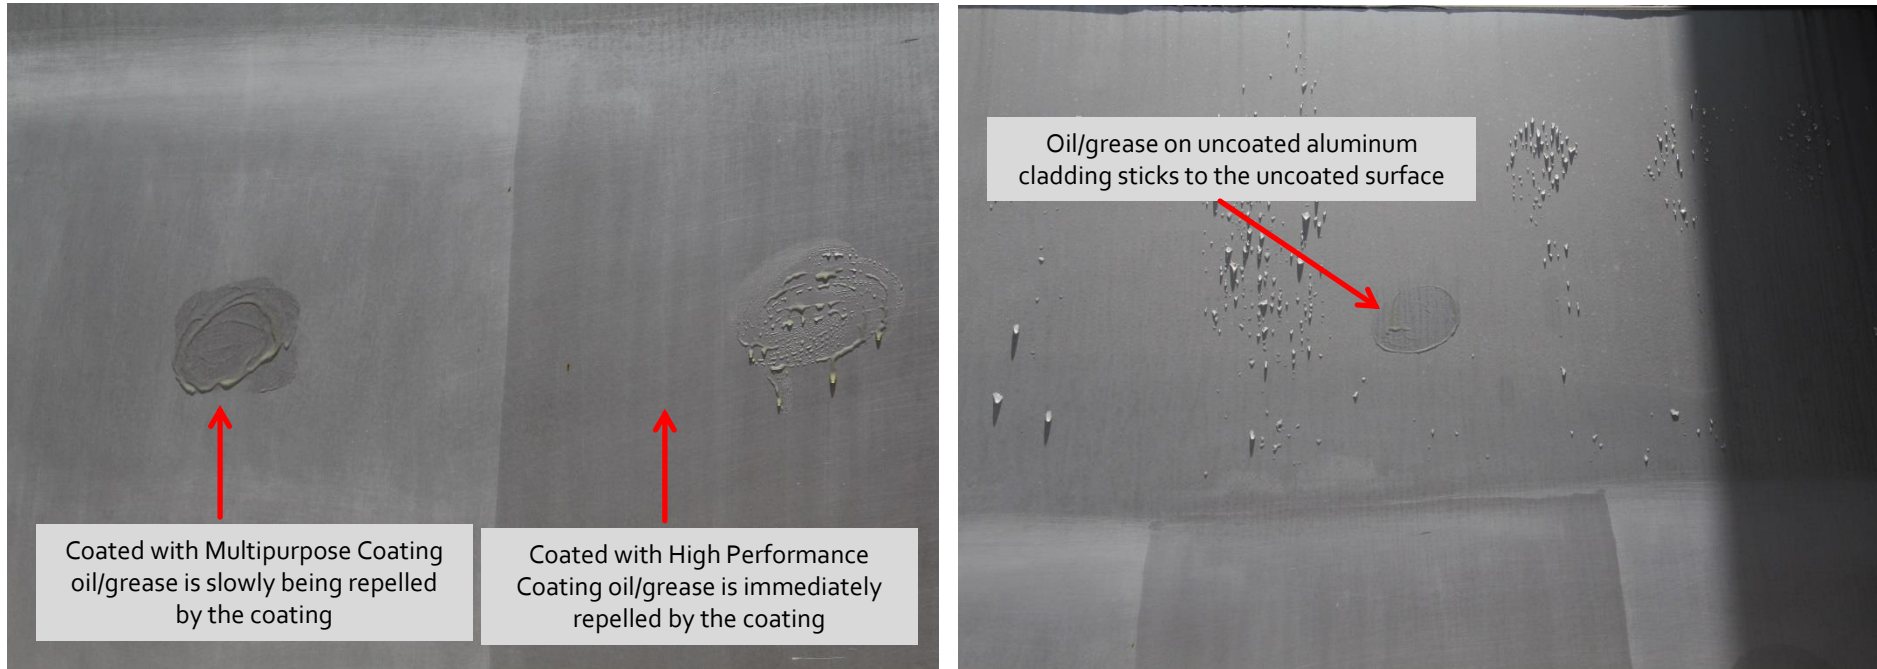
DMCI Building – Aluminum Cladding after 1 week and testing

Oil / Grease applied on coated and uncoated aluminum cladding. Images shows the Super Oleophobicity of the coated surface.

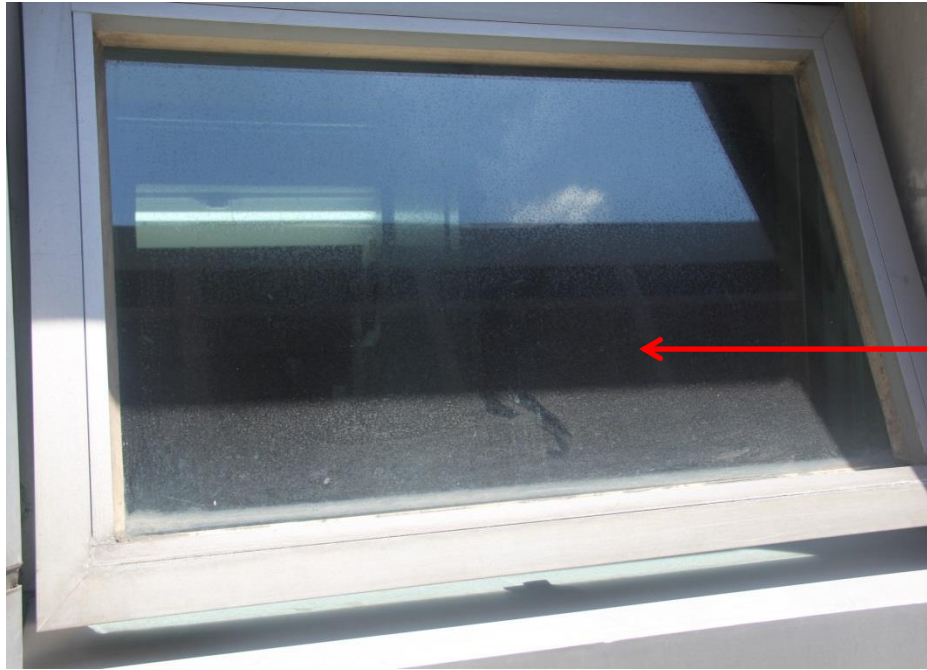
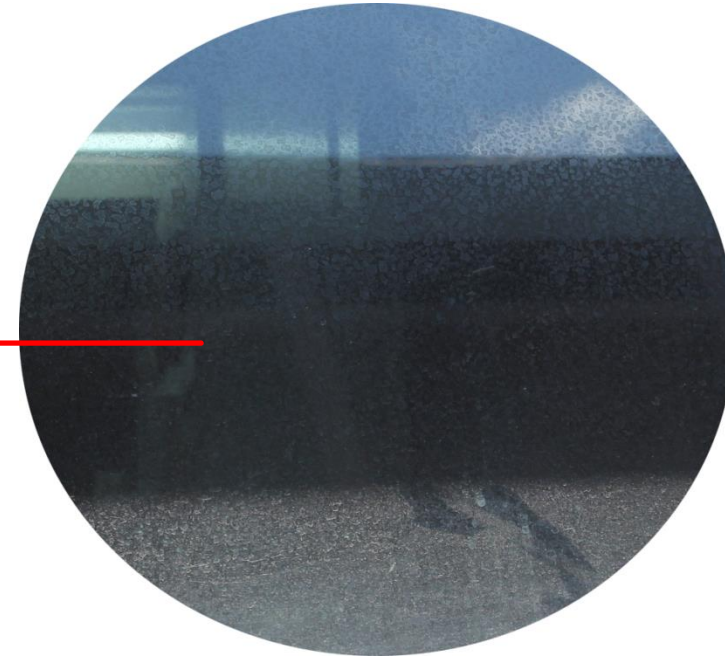
DMCI Building – Glass windows

DMCI Building Glass window problems with glass staining, watermarks, scaling and corrosions caused by acid rain, building runoff, oil, dirt, dust and other pollutants.

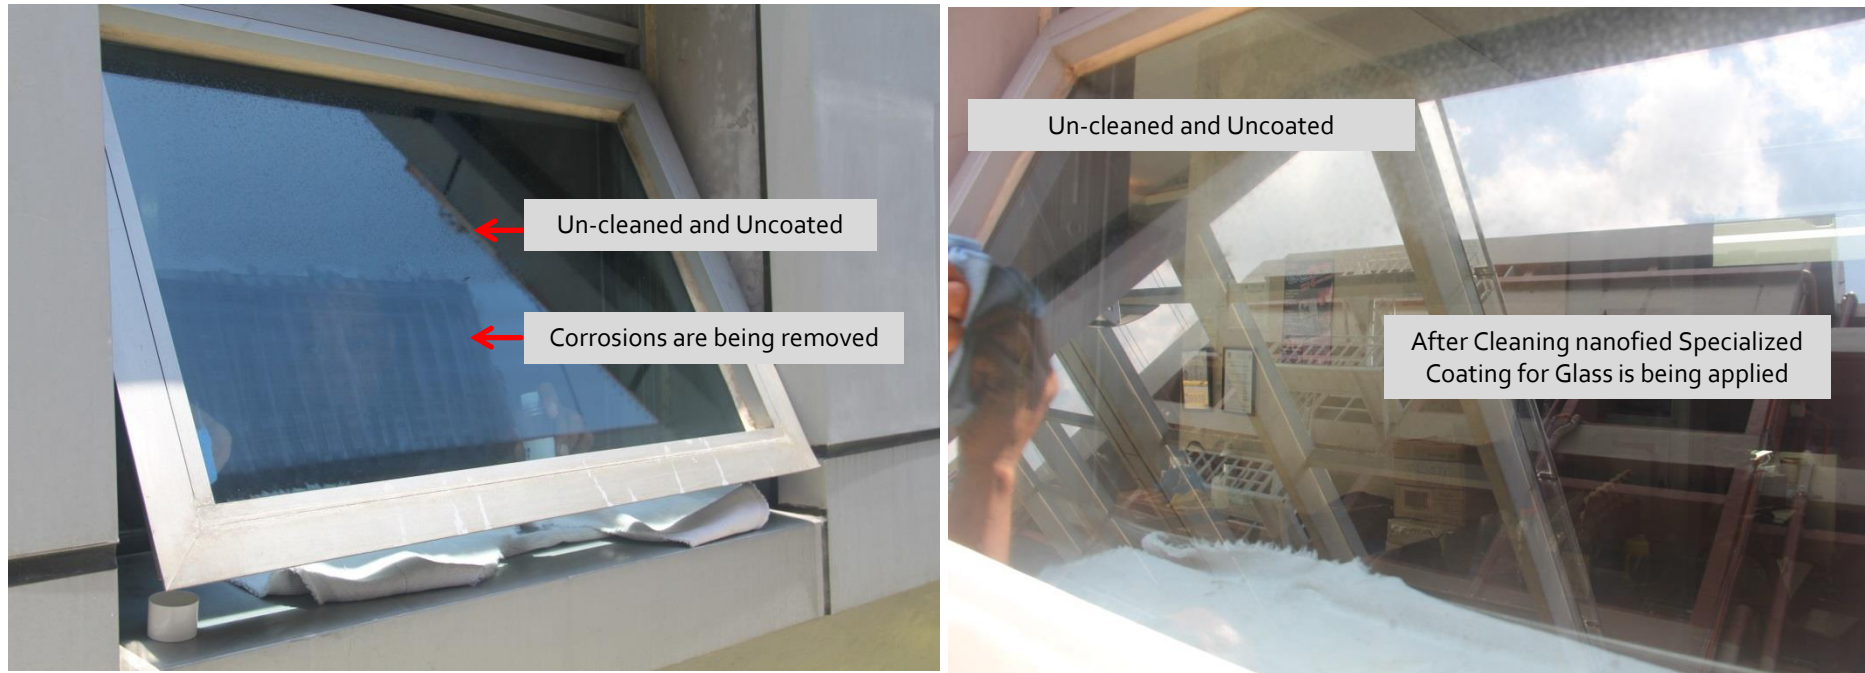
DMCI Building – Glass windows (Cleaning and Coating Application)

DMCI Building Glass window cleaned and protected with nanofied Specialized Coating for Glass

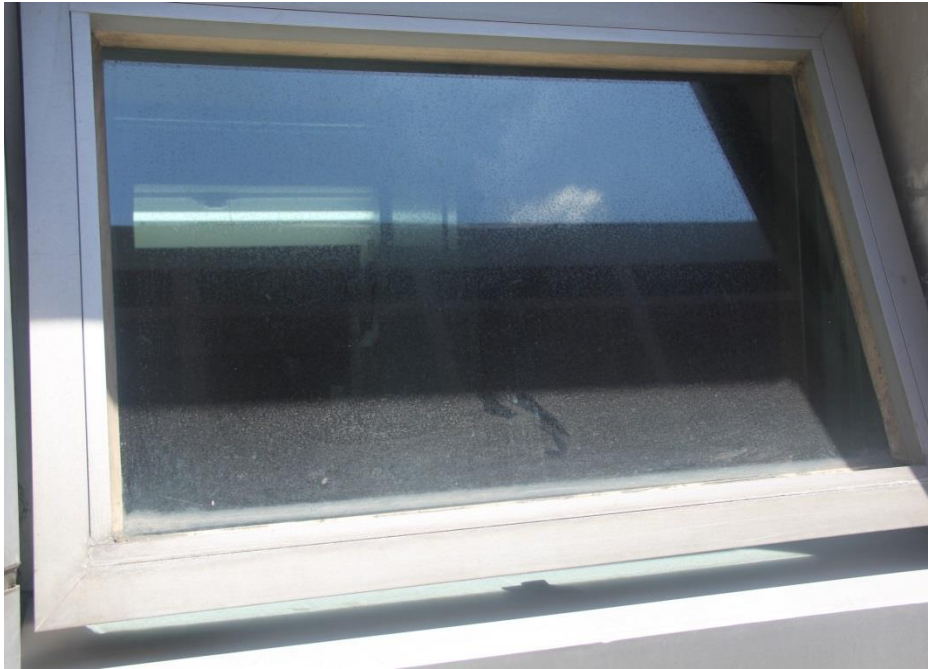
BEFORE

Heavy glass corrosion on windows like watermarks, scaling, dust and dirt

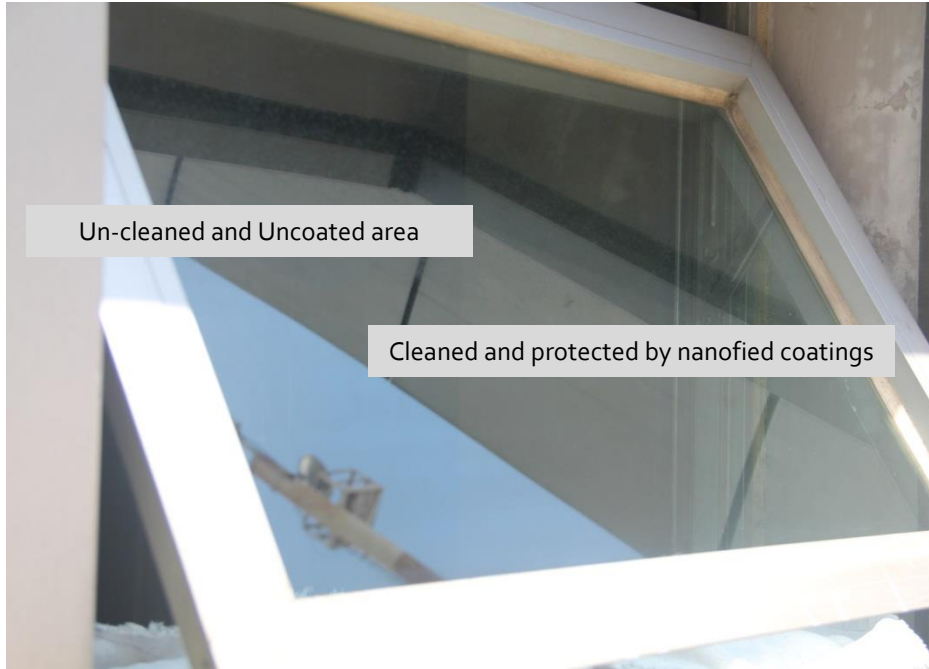
After 1 week

Heavy glass corrosion is removed from glass window and remains clean and corrosion free
