AMBASSADOR YUCHENGCO
HOUSE RESTORATION AND PROTECTION
Mockup

LANDEV - Ambassador Yuchengco's house restoration and protection

LANDEV is looking for new solutions for stone, glass and wood protection

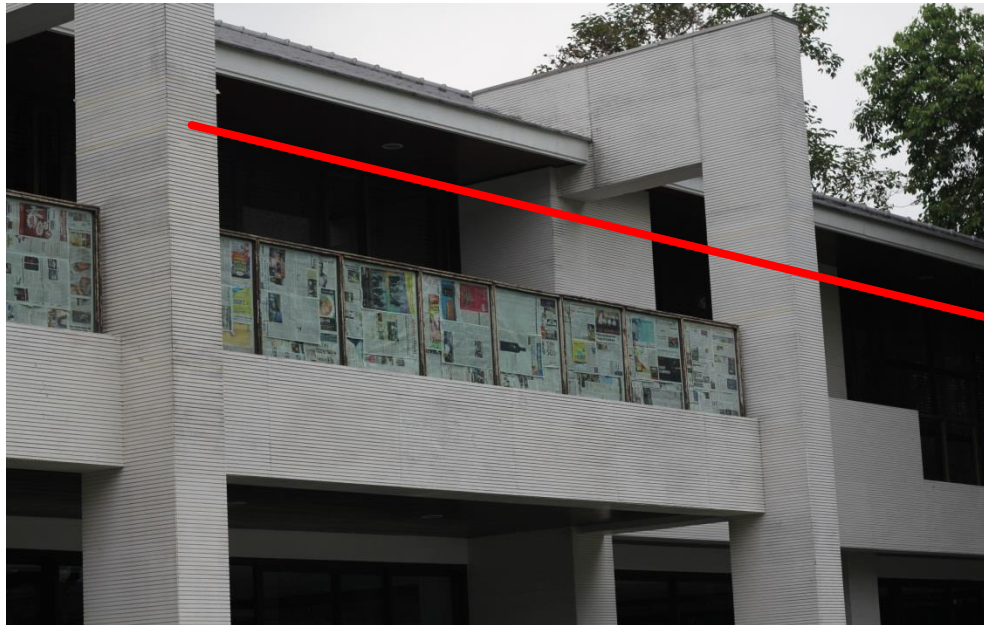
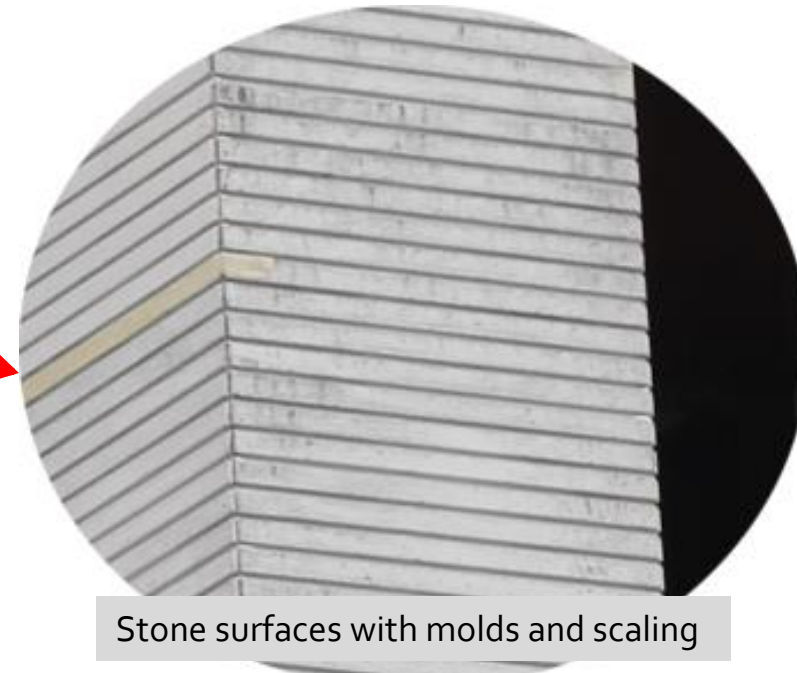
STONE WALL RESTORATION AND PROTECTION

Stone surfaces with molds and scaling

MOLDS, ALGAE, SCALING, STAINING AND DISCOLORATION ON STONE WALLS

Stone corrosions like molds, algae, scaling, and staining are result of moisture transmission through the stone that evaporates upon reaching the surface, leaving behind dissolved minerals and salts. Other causes of corrosions are UV Rays, acid rain, bird droppings, tree sap and pollution. Nanofied coatings helps prevent these kinds of stone corrosions by repelling the main causes of stone corrosions by protecting and sealing the stone.

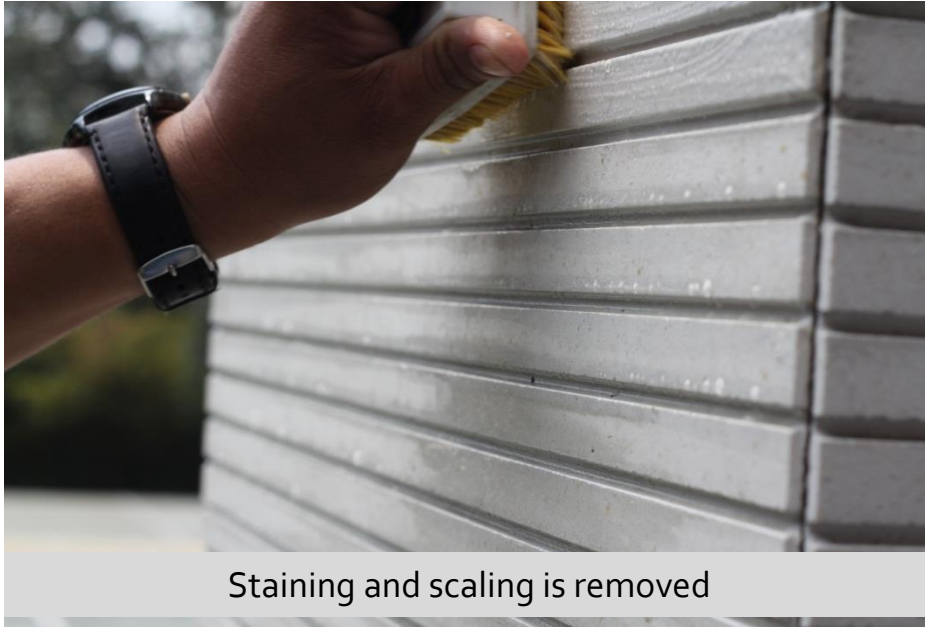
Staining and scaling is removed

Removing stone corrosions like watermarks and scaling is very time consuming, expensive, requires additional manpower and sometimes impossible to remove. Some stone corrosions requires special equipment and toxic chemicals to remove. Nanofied coatings helps prevent these kinds of stone corrosions by repelling the main causes of stone corrosions by protecting and sealing the stone.

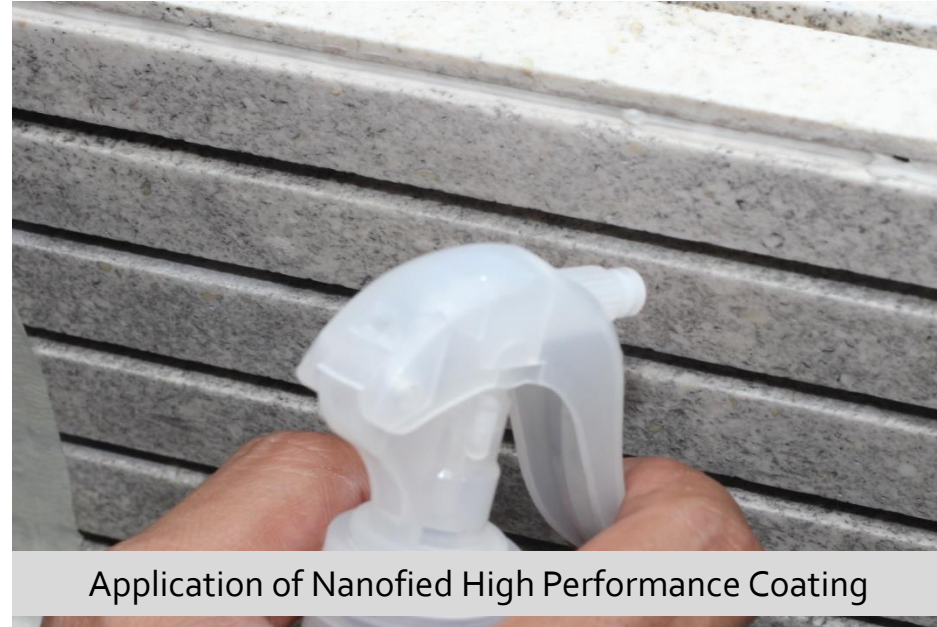
Application of Nanofied High Performance Coating

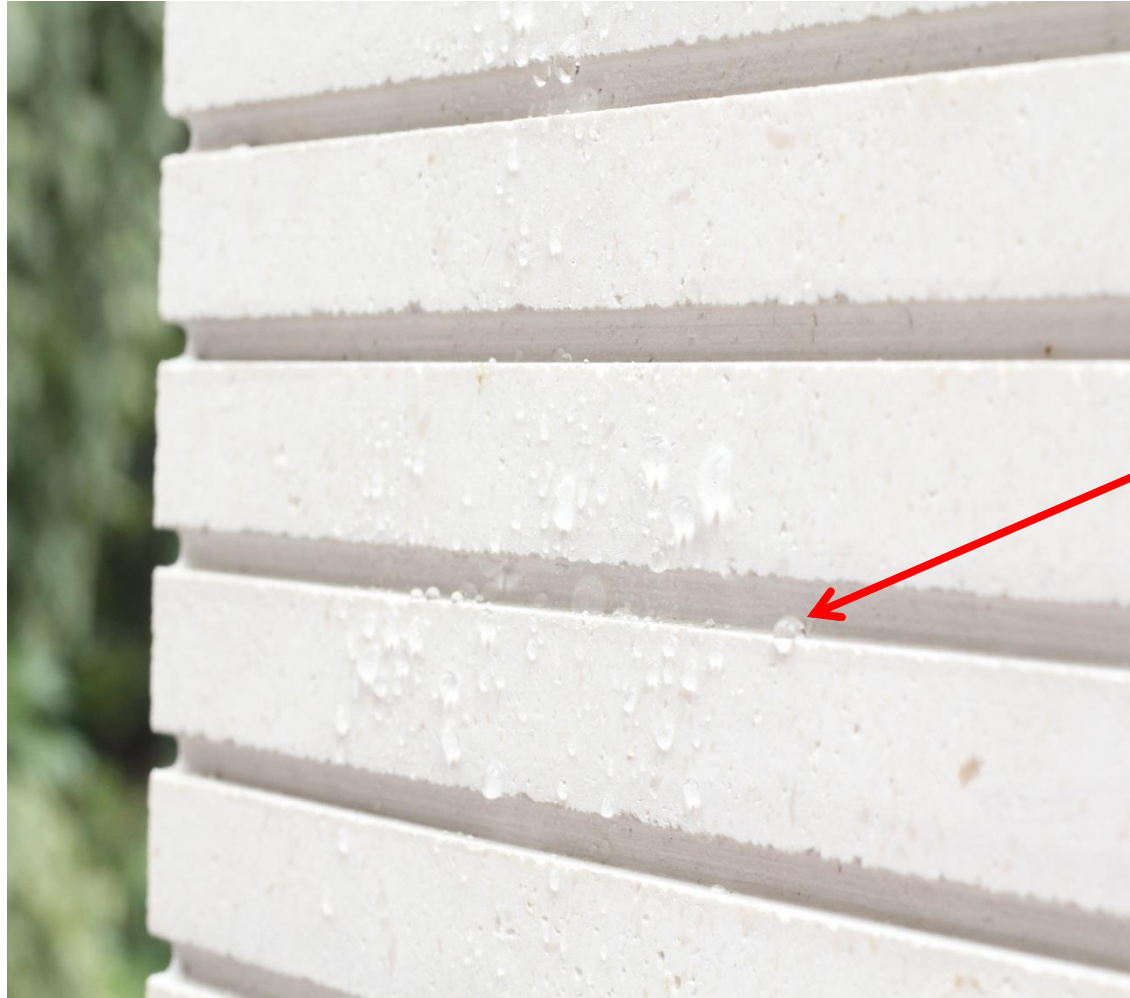
STONE WALL AFTER CLEANING AND COATING

After cleaning and coating , stone wall is noticeably brighter and cleaner. Nanofied High Performance Coating will provide extreme protection against molds, algae, scaling and staining.

Water is sprayed on coated stone wall. Water is being repelled by nanofied High Performance Coating.

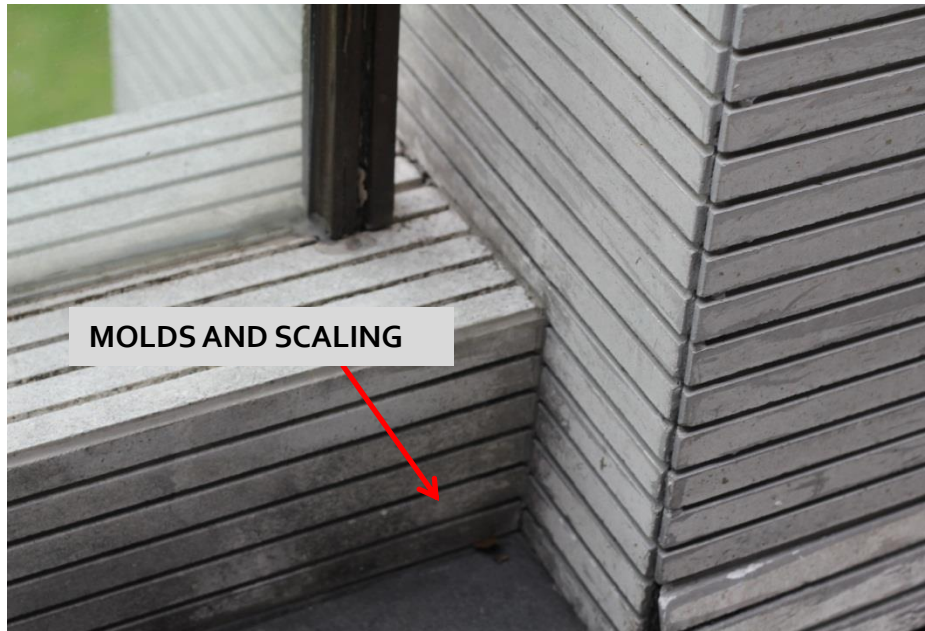
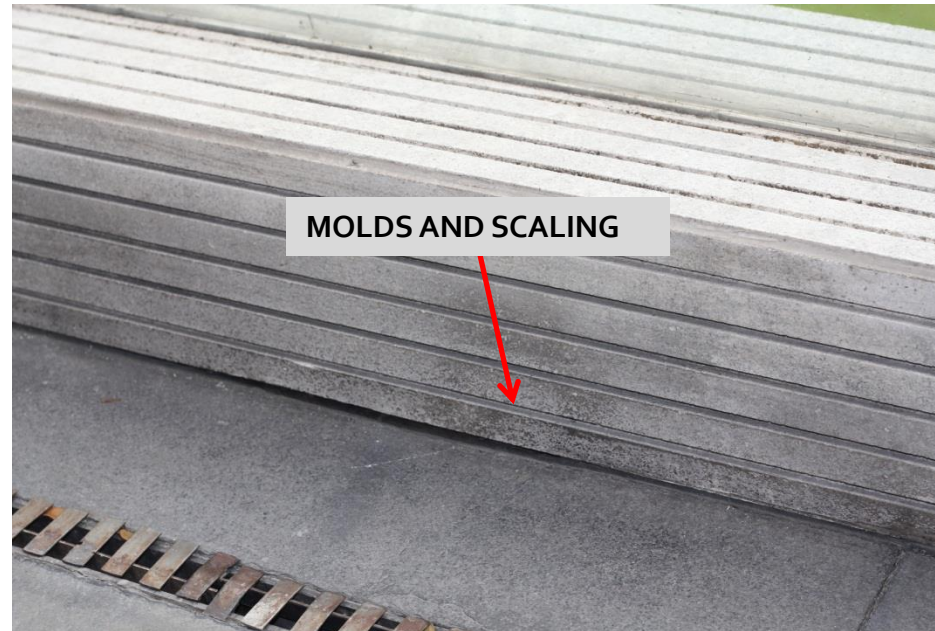
STONE WALL (Corner) RESTORATION AND PROTECTION

MOLDS, ALGAE, SCALING, STAINING AND DISCOLORATION ON STONE WALLS

Stone corrosions like molds, algae, scaling, and staining are result of moisture transmission through the stone that evaporates upon reaching the surface, leaving behind dissolved minerals and salts. Other causes of corrosions are UV Rays, acid rain, bird droppings, tree sap and pollution. Nanofied coatings helps prevent these kinds of stone corrosions by repelling the main causes of stone corrosions by protecting and sealing the stone.

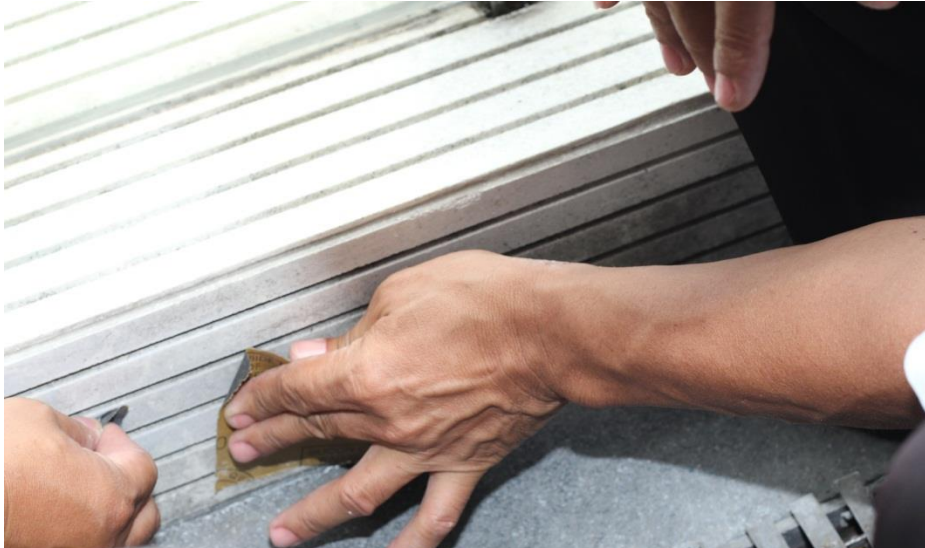
Staining and scaling is removed

Removing stone corrosions like watermarks and scaling is very time consuming, expensive, requires additional manpower and sometimes impossible to remove. Some stone corrosions requires special equipment and toxic chemicals to remove. Nanofied coatings helps prevent these kinds of stone corrosions by repelling the main causes of stone corrosions by protecting and sealing the stone.

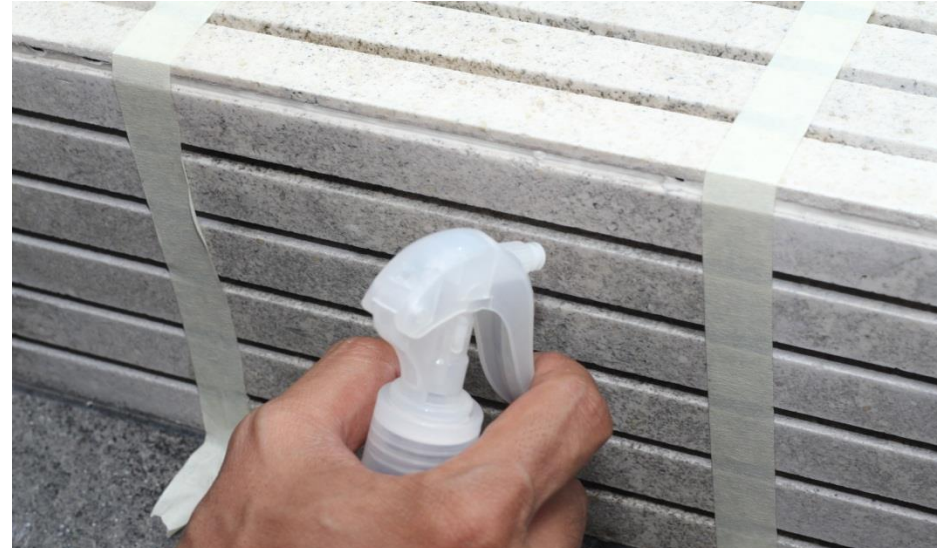
Application of Nanofied High Performance Coating

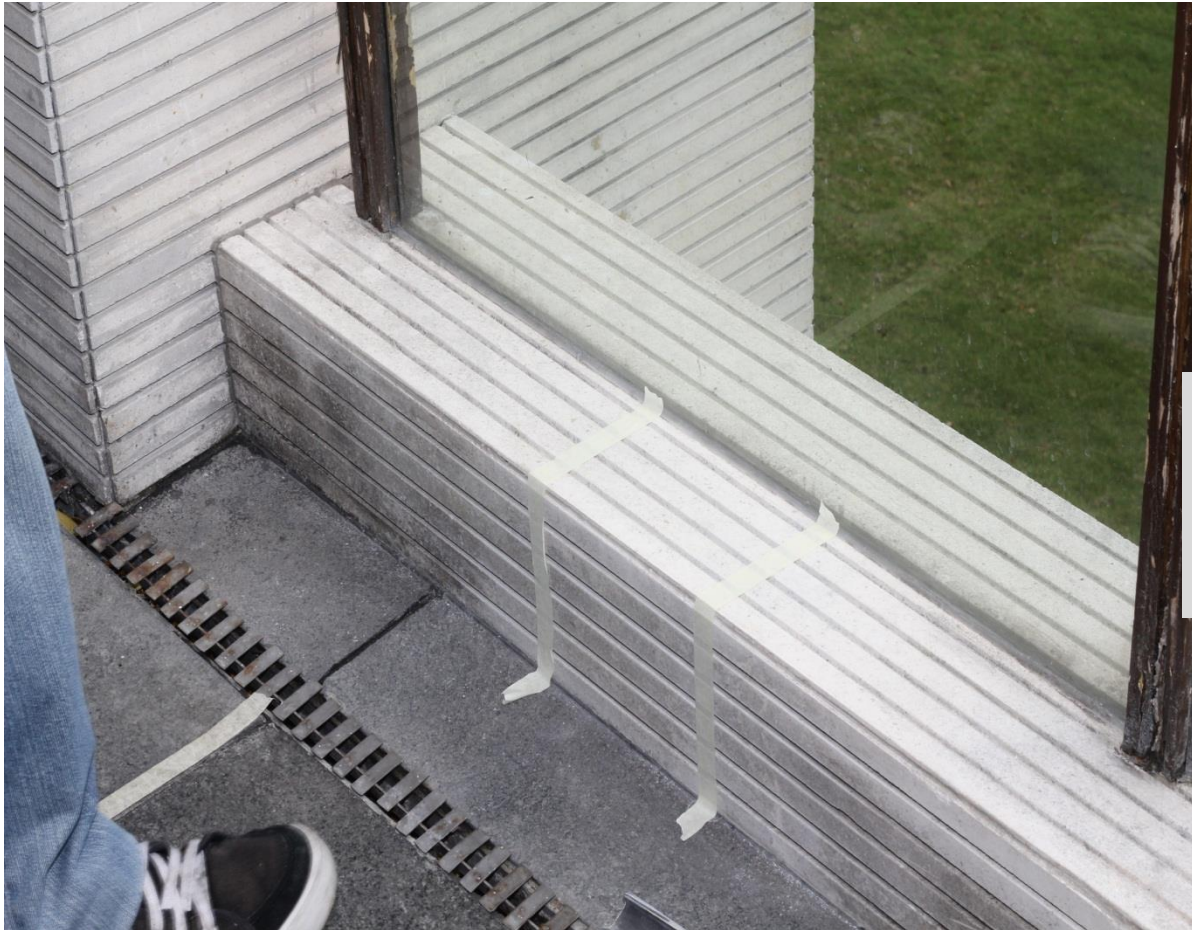
STONE WALL (Corner) AFTER CLEANING AND COATING

After cleaning and coating , stone wall is noticeably brighter and cleaner. Nanofied High Performance Coating will provide extreme protection against molds, algae, scaling and staining.

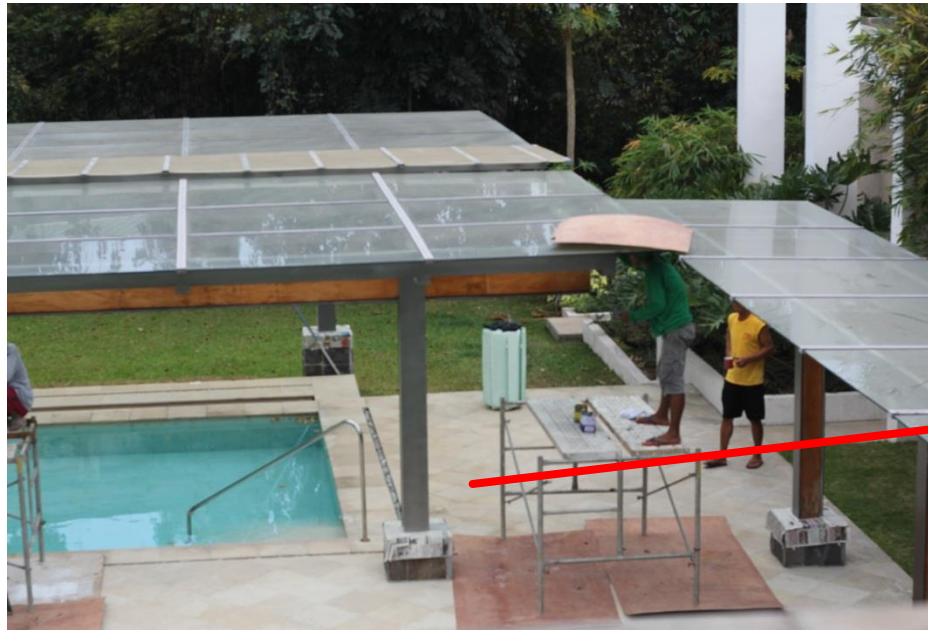
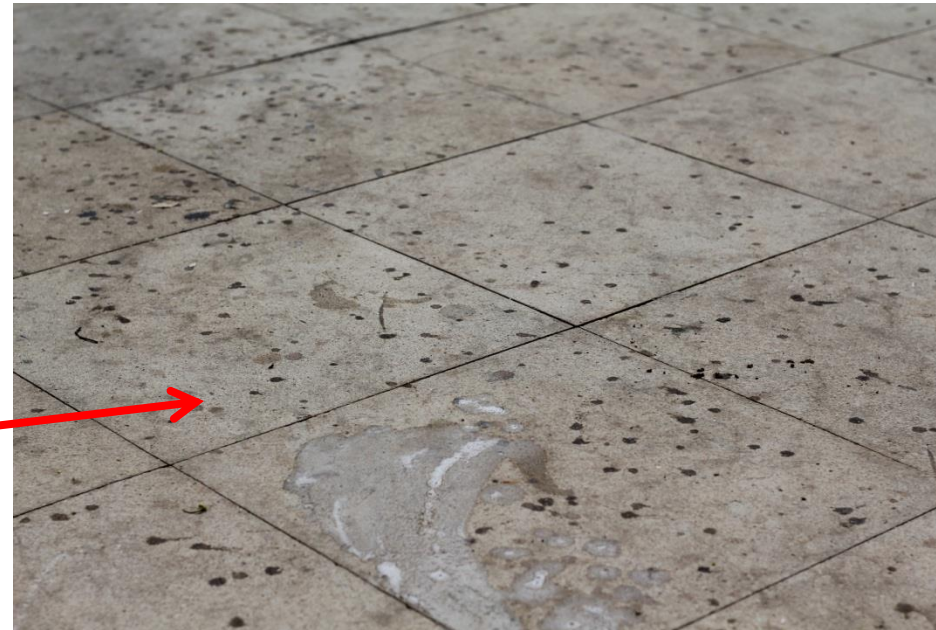
SANDSTONE FLOORING RESTORATION AND PROTECTION

STAINING ON SAND STONE FLOORING (POOL AREA)

Sandstone staining are from bird droppings and tree sap. Scaling, molds, and algae are from moisture transmission through the sandstone that evaporates upon reaching the surface, leaving behind dissolved minerals and salts. Nanofied coatings helps prevent these kinds of stone corrossions by repelling the main causes of stone corrossions by protecting and sealing the stone.

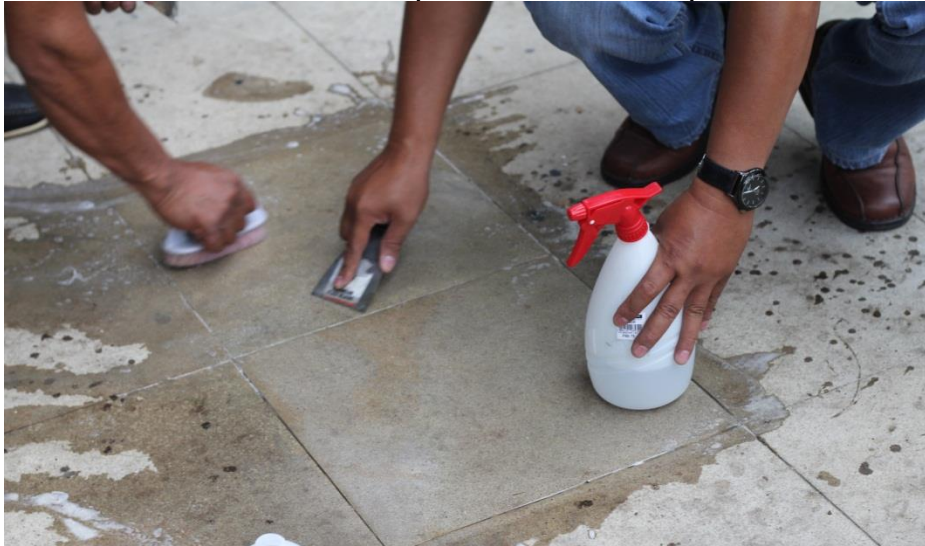
Staining and scaling is removed

Removing stone corrosions like watermarks and scaling is very time consuming, expensive, requires additional manpower and sometimes impossible to remove. Some stone corrosions requires special equipment and toxic chemicals to remove. Nanofied coatings helps prevent these kinds of stone corrosions by repelling the main causes of stone corrosions by protecting and sealing the stone.

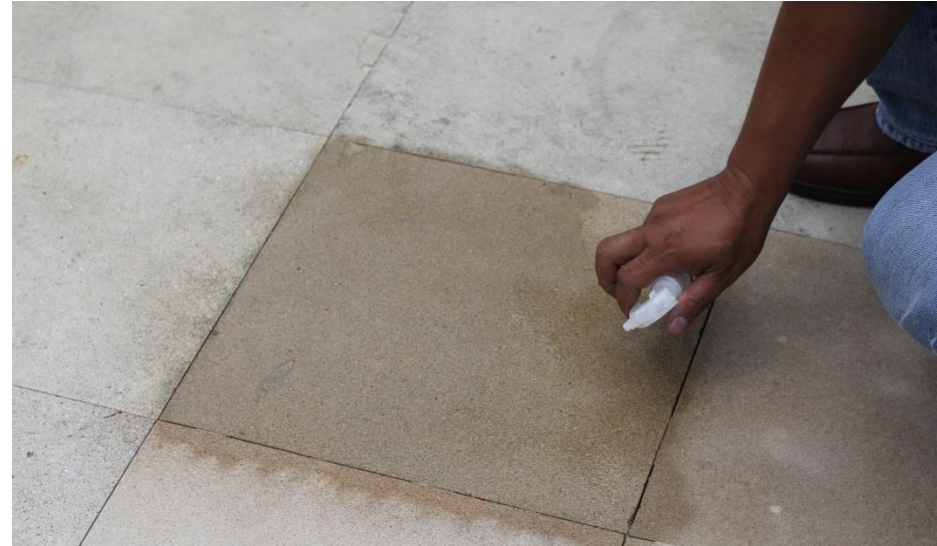
Application of Nanofied Specialized Coating for Stone

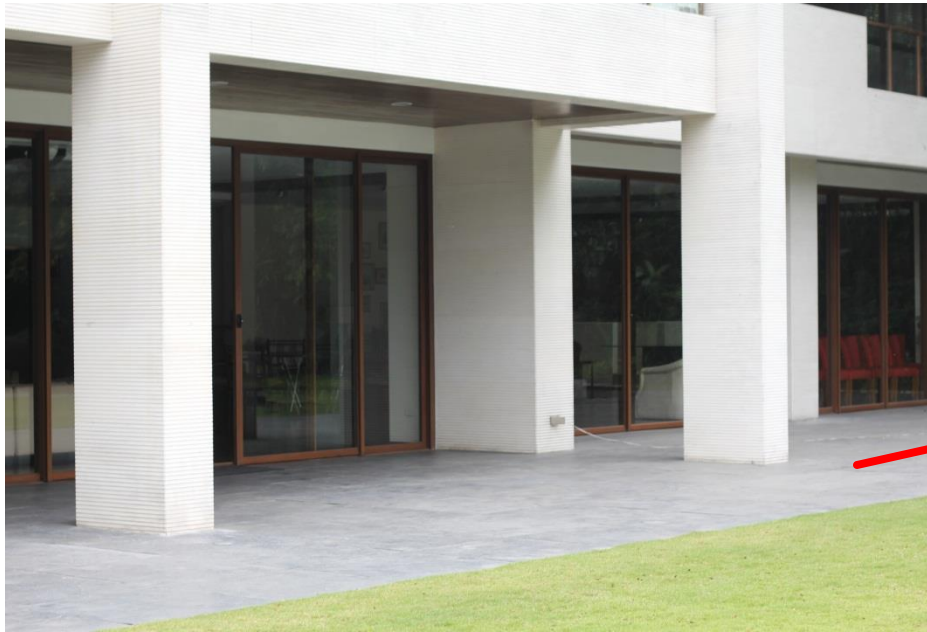
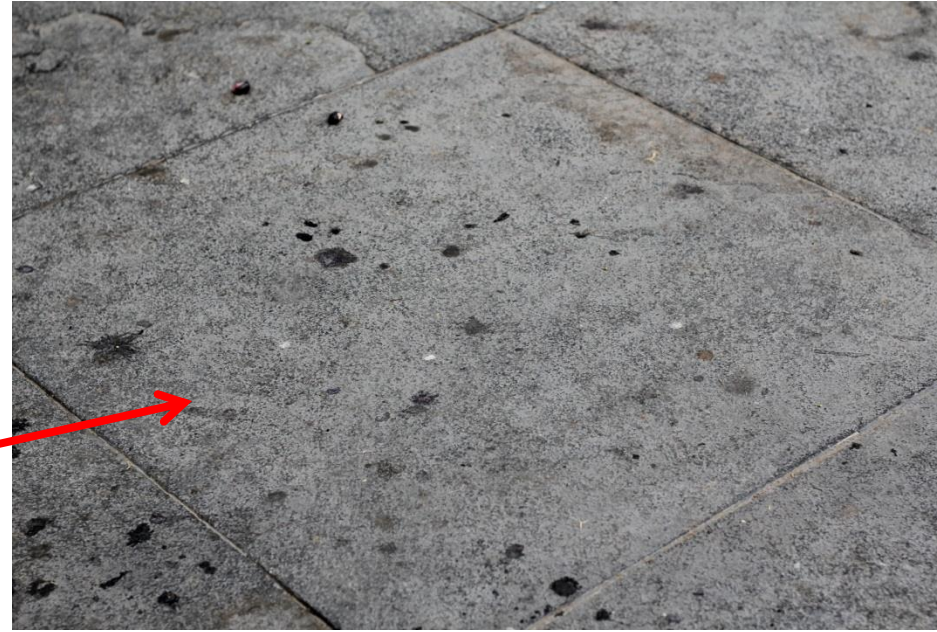
STONE FLOORING (Lanai) RESTORATION AND PROTECTION

MOLDS, ALGAE, SCALING, STAINING AND DISCOLORATION ON STONE FLOORING (LANAI AREA)

Stone corrosions like molds, algae, scaling, and staining are result of moisture transmission through the stone that evaporates upon reaching the surface, leaving behind dissolved minerals and salts. Other causes of corrosions are UV Rays, acid rain, bird droppings, tree sap and pollution. Nanofied coatings helps prevent these kinds of stone corrosions by repelling the main causes of stone corrosions by protecting and sealing the stone.

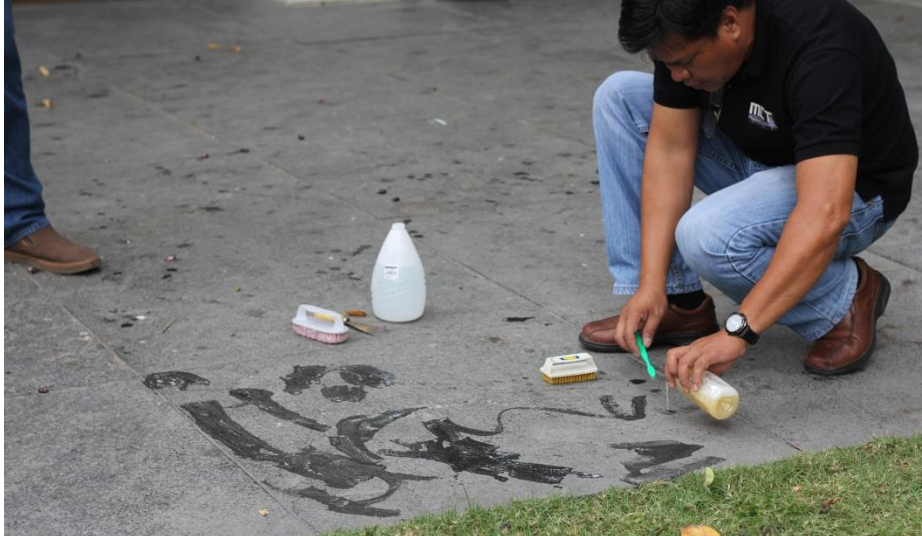
Staining and scaling is removed

Removing stone corrosions like watermarks and scaling is very time consuming, expensive, requires additional manpower and sometimes impossible to remove. Some stone corrosions requires special equipment and toxic chemicals to remove. Nanofied coatings helps prevent these kinds of stone corrosions by repelling the main causes of stone corrosions by protecting and sealing the stone.

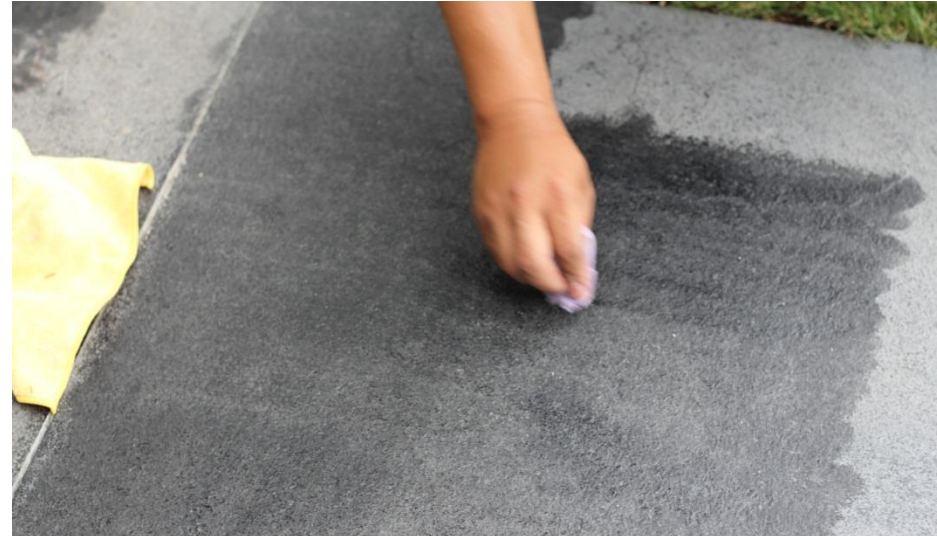
Application of Nanofied High Performance Coating

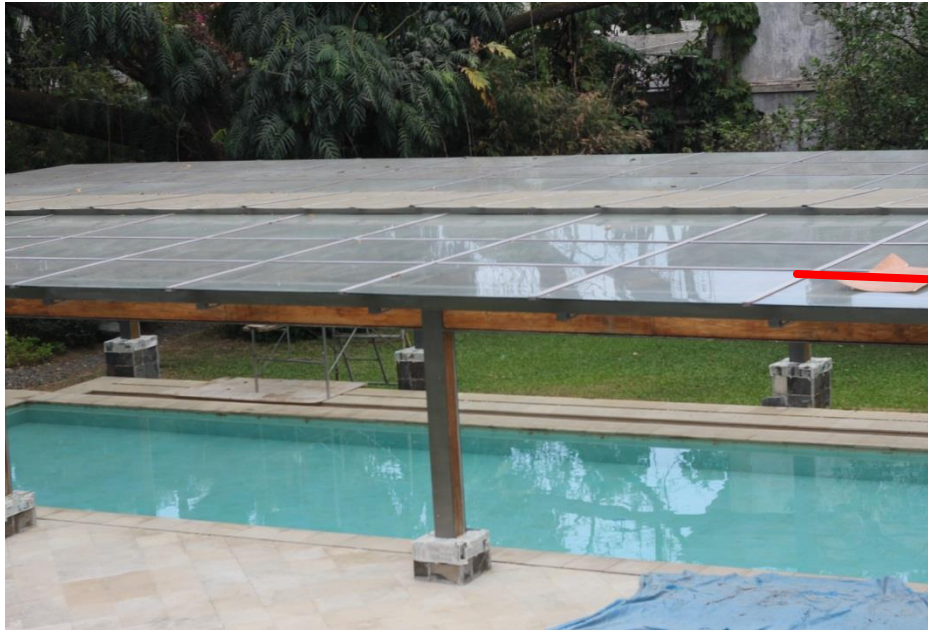
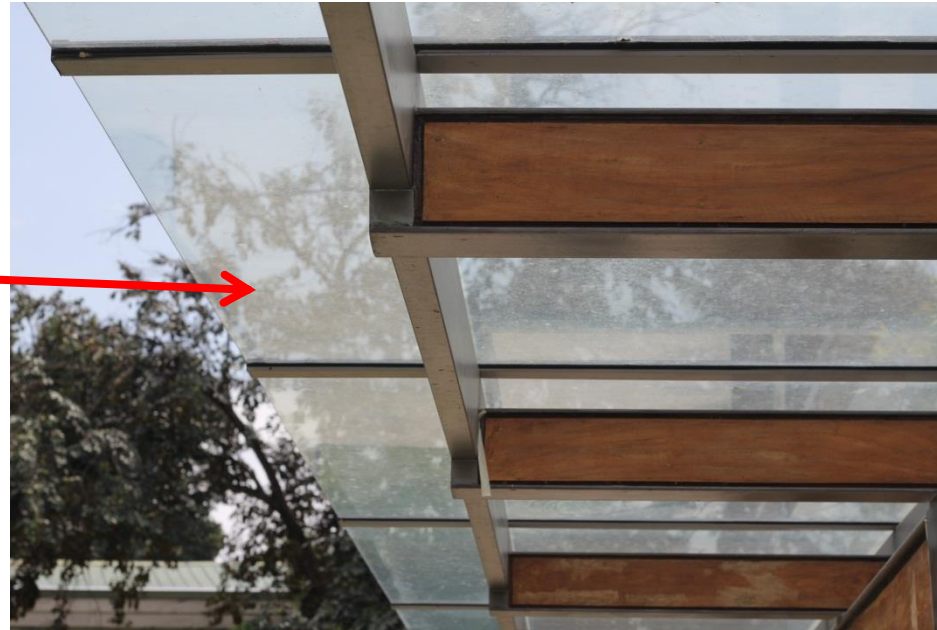
HOUSE RESTORATION AND SURFACE PROTECTION

HEAVY SCALING AND WATERMARKS ON GLASS ROOFING

Glass corrosions like watermarks and scaling are caused by calcium left behind by water after it evaporates. These watermarks and scaling when not given proper attention will be very difficult to remove or sometimes may cause damage to glass. Other causes of glass corrosions are : acid rain, bird droppings, tree saps and pollution. Removing watermarks and scaling is very time consuming, expensive and sometimes impossible. Nanofied coatings helps prevent these kinds of glass corrosions by protecting and sealing the glass by repelling the main causes of glass corrosions.

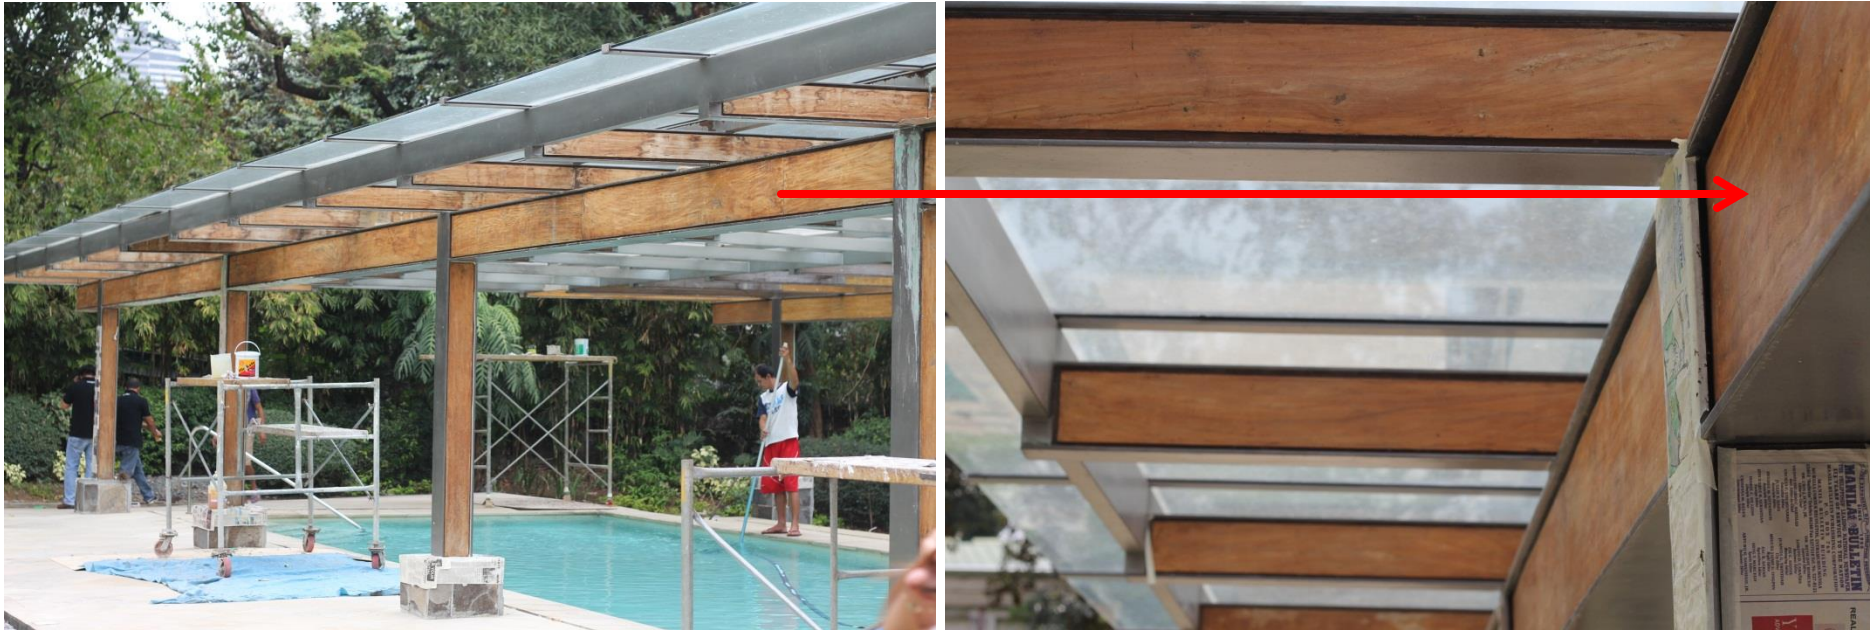
WOOD PANEL RESTORATION AND PROTECTION

Nanofied coatings helps preserve wooden structures by protecting and sealing the wood against moisture and other environmental hazards.

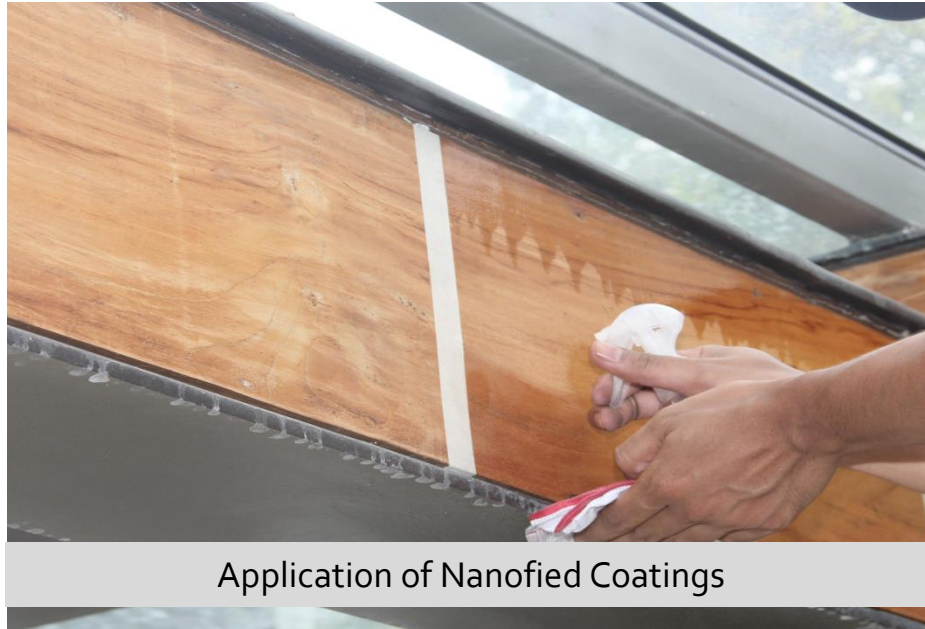
Application of Nanofied Coatings

Nanofied coatings helps preserve wooden structures by protecting and sealing the wood against moisture and other environmental hazards.

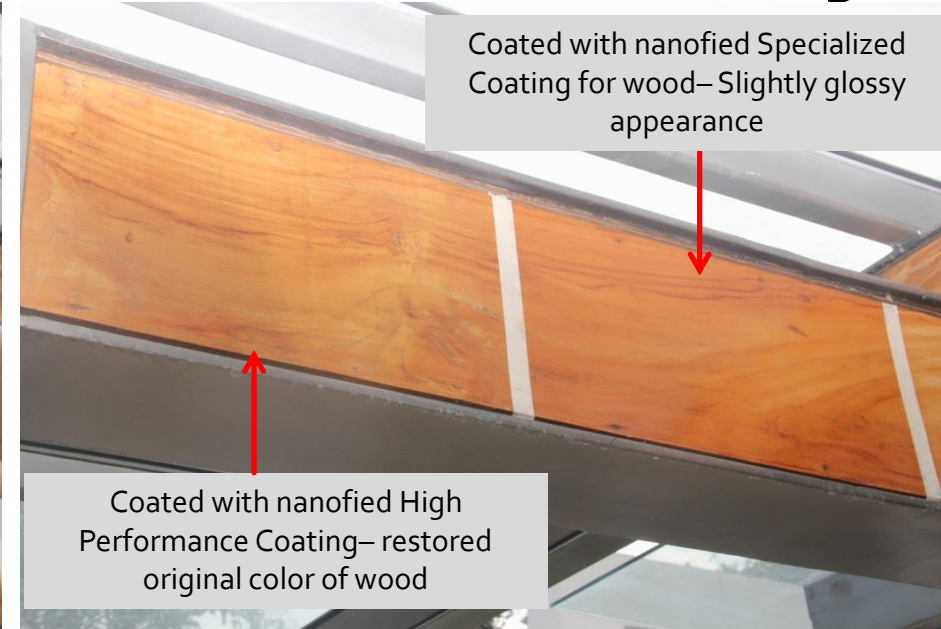
Coated with nanofied Specialized Coating for wood– Slightly glossy appearance

Coated with nanofied High Performance Coating– restored original color of wood
