Trial of SiO₂ Liquid Glass coatings at Next “The Fort” Birmingham

Overview.

- The aim of the trial was to evaluate the performance of the SiO₂ coatings within this specific facility.
- In all instances the application of the SiO₂ technology is very rapid but prior to application deep cleaning has to be undertaken.
- Ideally SiO₂ coatings are applied before surfaces become heavily soiled.

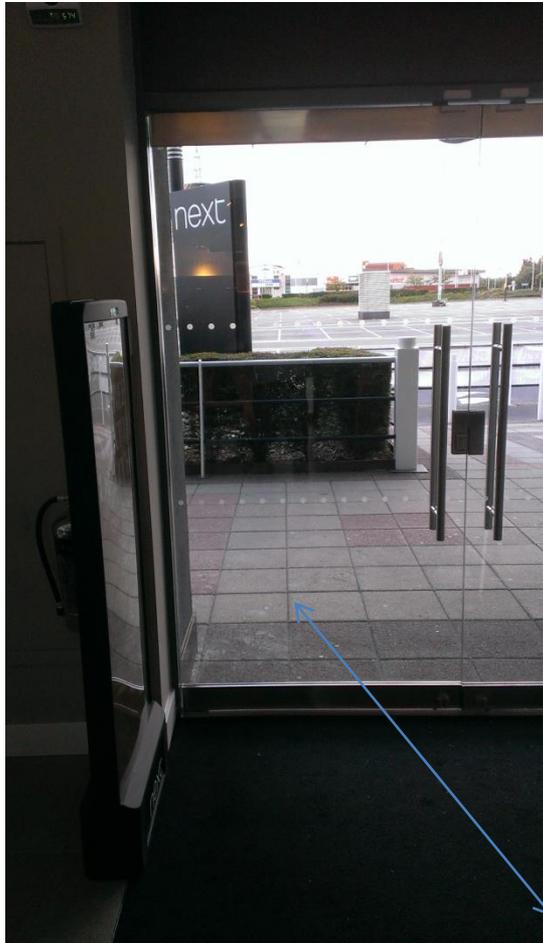
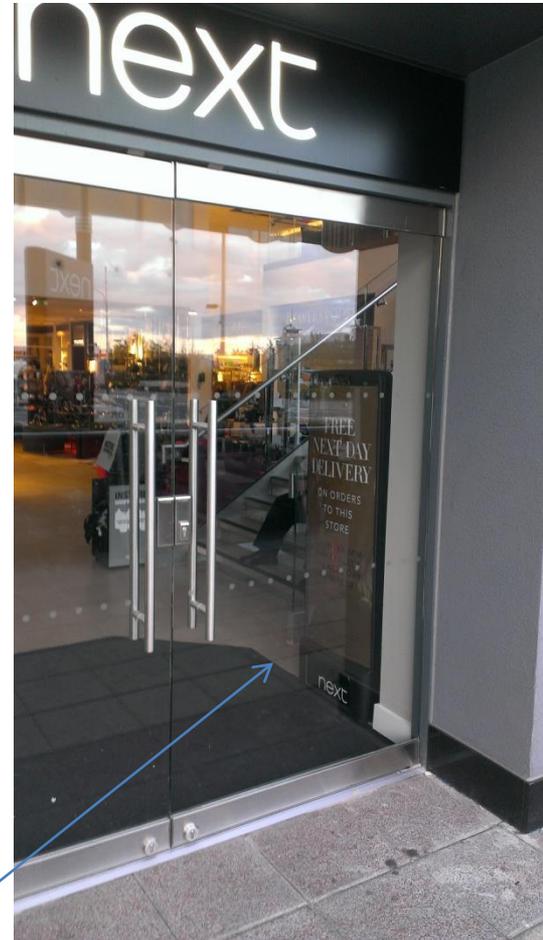
Front door

The interior and exterior surfaces , (including metal surfaces)were cleaned and coated. The door was heavily soiled. Only the RH side of the door was coated

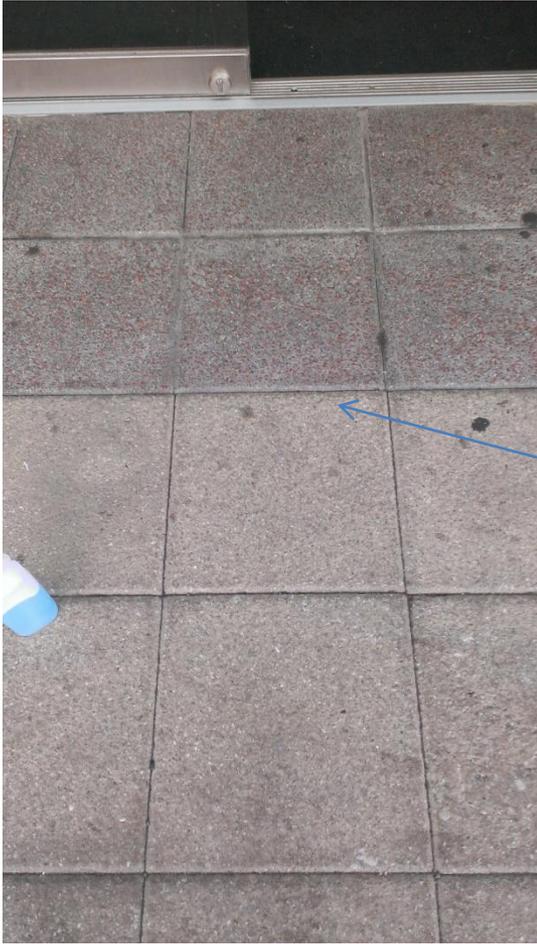
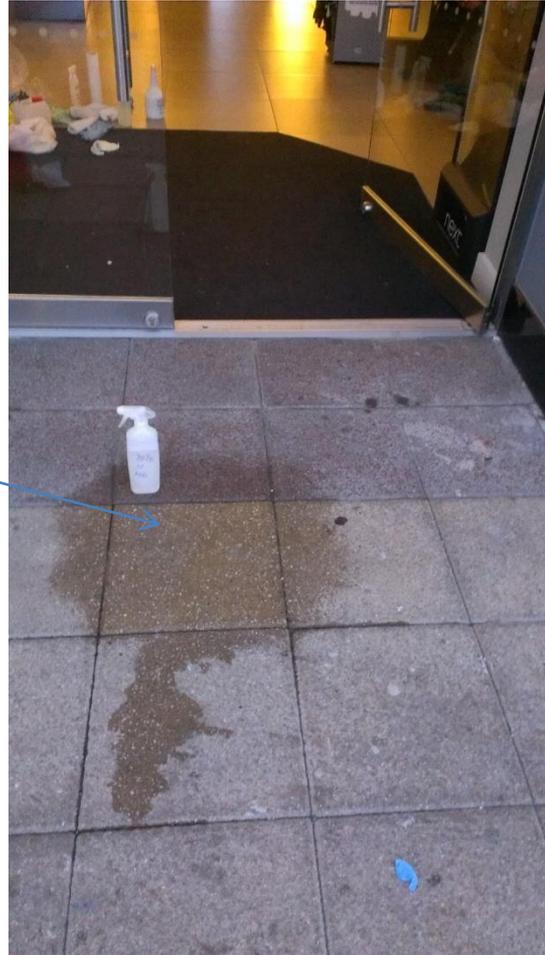
Stone

This tile was cleaned with Biosativa and then coated with SiO₂ for stone. This image was taken when the coating was newly applied. The coating will be invisible when dry. It will prevent soiling.

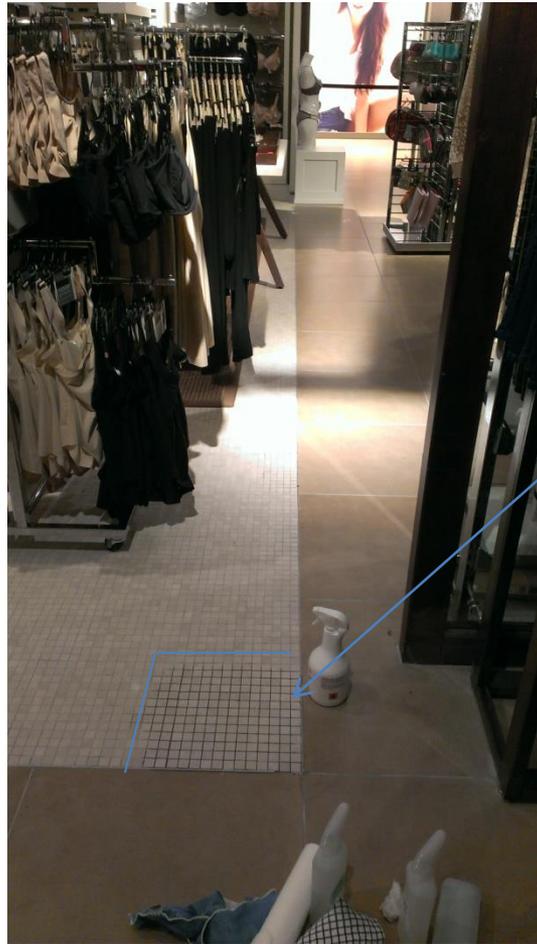
Ceramic Flooring

SiO₂ coatings are suited for protecting both tiles and grout.

The area was photographed when wet. The coating is undetectable when dry.

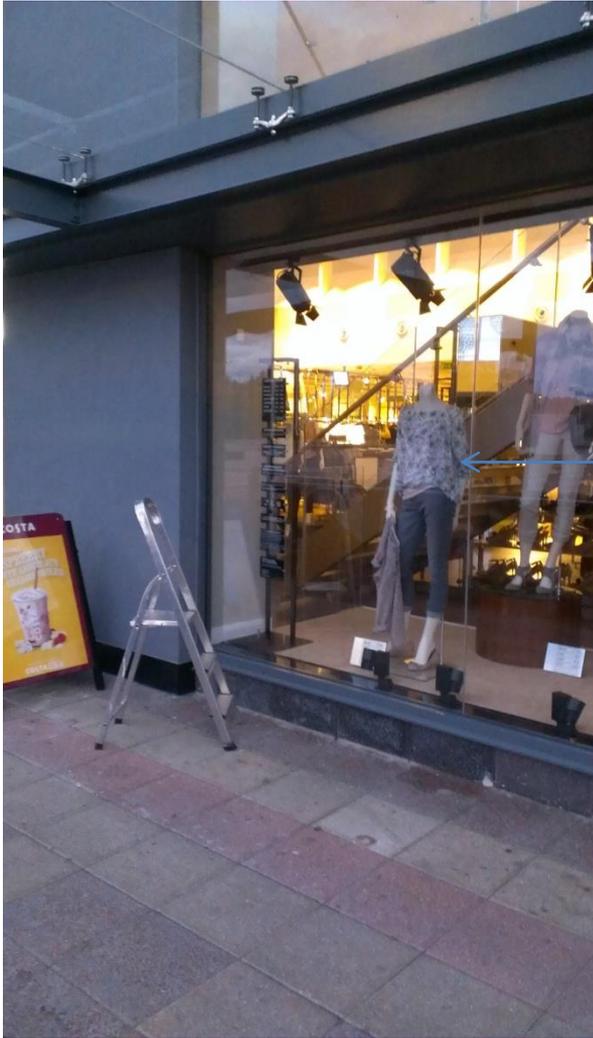
Exterior Window Surface

The window to the rh. side of the main entrance.
Coated with Universal Coating. The coating was applied to the exterior surface.

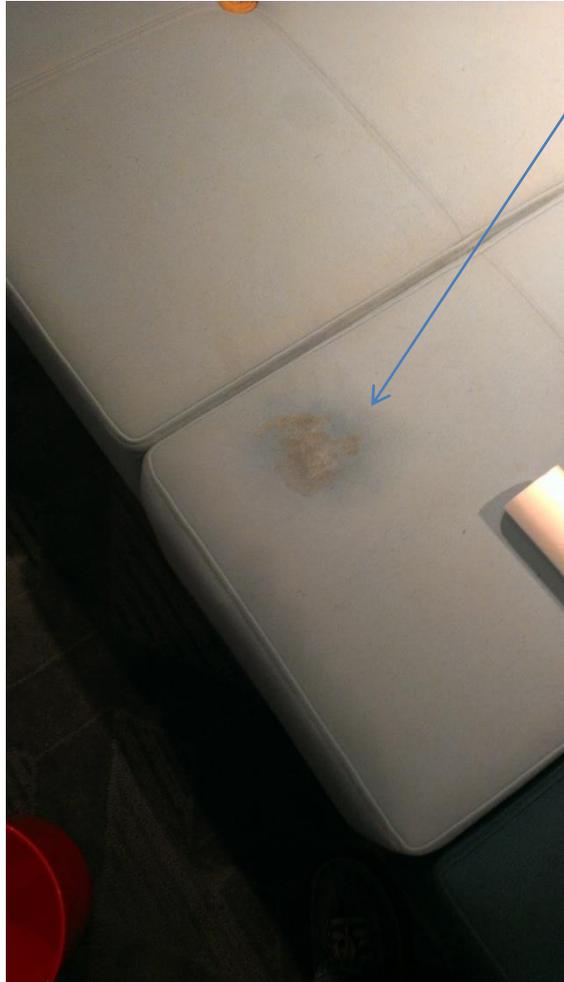
Fabrics stain removal and coating

During the previous visit to the store the store manager asked me to see if I could remove staining from this cushion. The cushion was much cleaner after washing with Biosativa. This image shows the start of the process.

This section has been coated with SiO₂. It was not possible to coat the newly cleaned section as it was too moist after cleaning. Ideally fabrics should be coated before they become soiled.

Note the lighter shade of the cleaned are

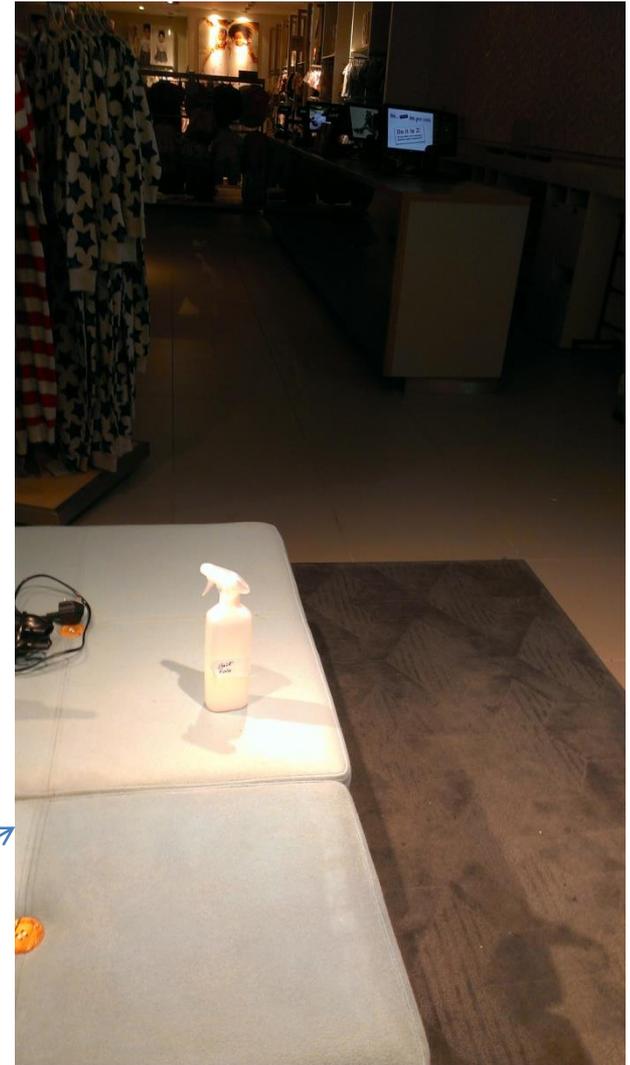
Carpet

This corner of carpet has been coated with SiO₂. The coating will become invisible when dried.

Evaluation with staining agents and soiling agents (after 24hrs of drying) will confirm stain resistance on this area of carpet.

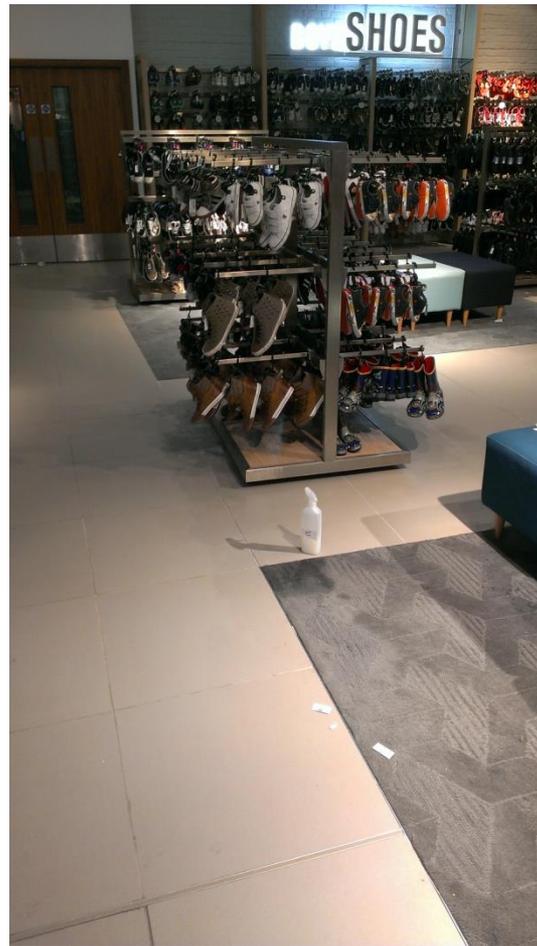
Test cleaning with Biosativa on the carpet in the main part of the store confirms that Biosativa can be used to remove staining prior to coating

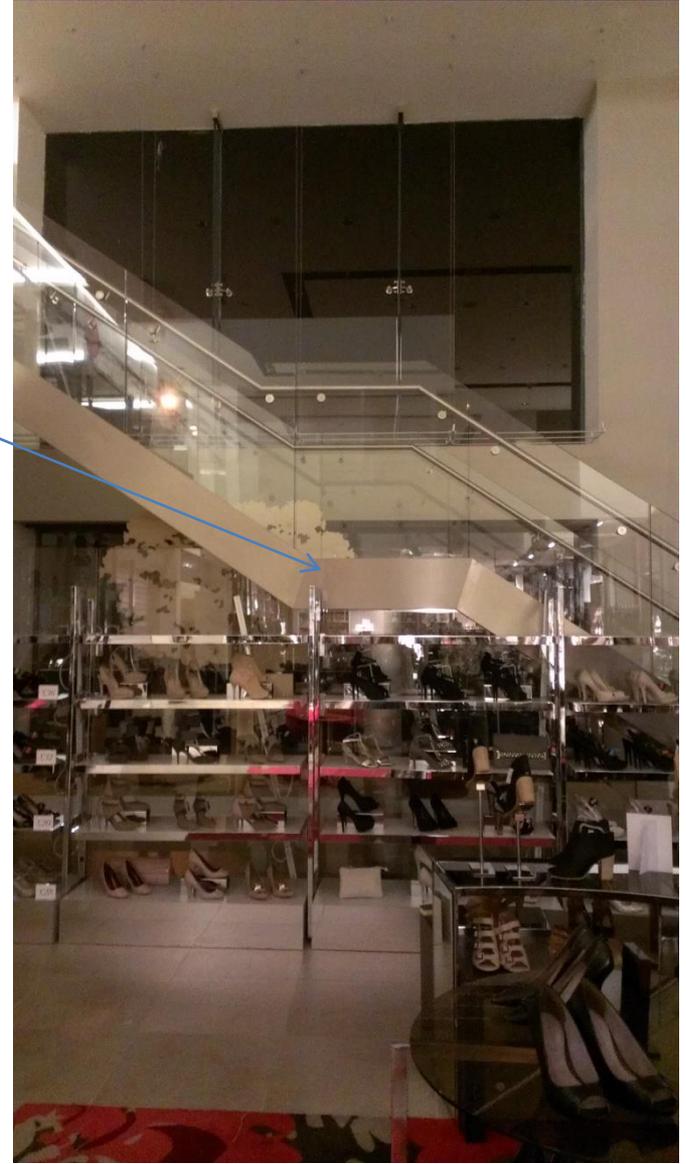
Side panel of staircase

The brushed alloy side panels were heavily soiled and the structure “holds” soiling agents. Coating with SiO₂ universal coating will significantly enhance the clean-ability and the aesthetics of this section.

Arrow shows test area

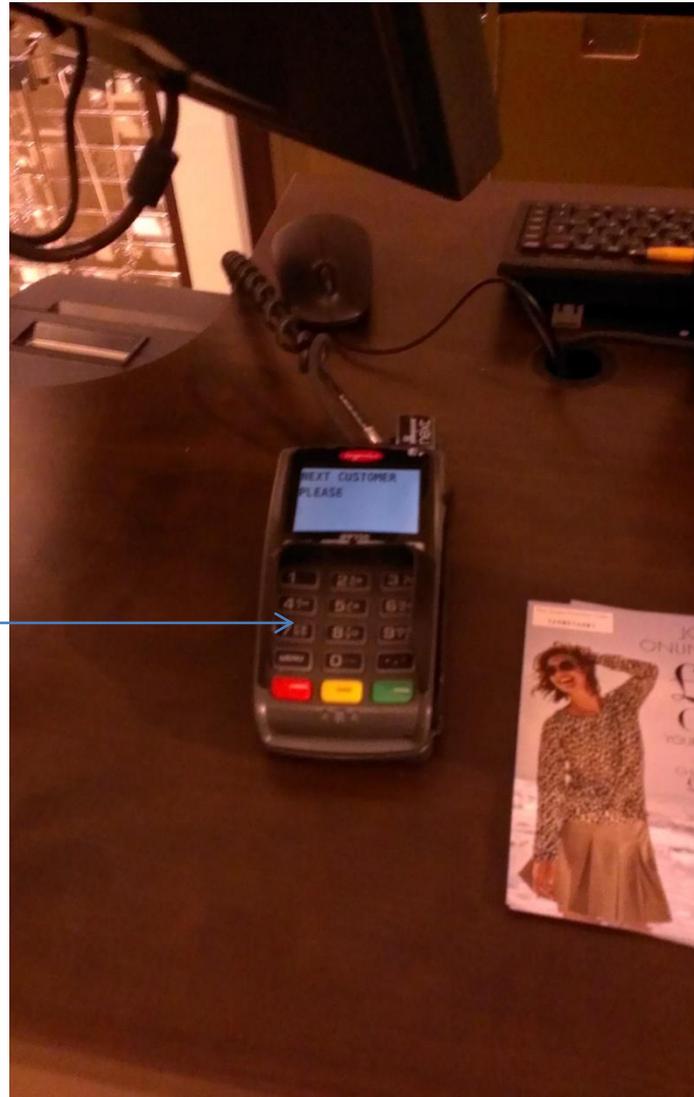
Check out area

It is recommended that card readers are coated with Bacoban anti pathogen SIO2 coatings.

Bacoban is a class 2 a CE marked medical device . Card readers are recognised as contamination hubs

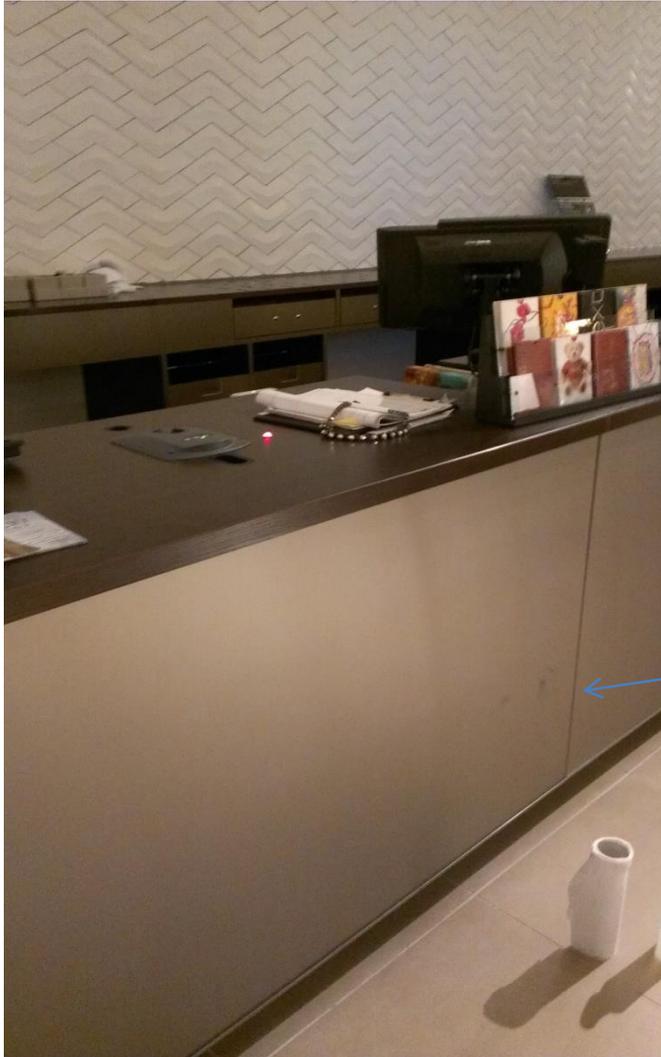
Check out area.

Soiling on panel (visible in image) was removed and then the area was coated with SiO₂ universal coating

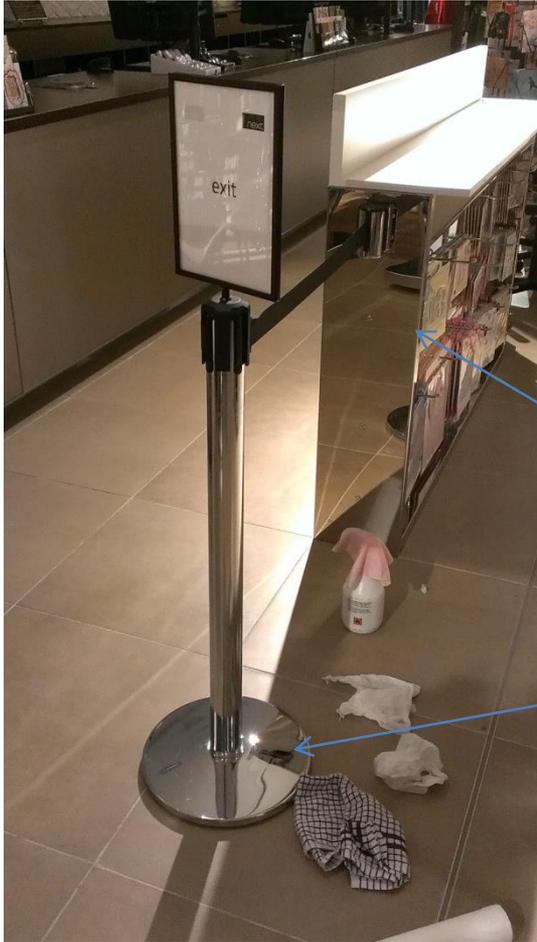
Chrome fittings

Chrome is inherently an “easy to clean” surface however SiO_2 enhances the appearance and the clean-ability of chrome.

The areas coated are the foot of the stand and the face of the stand.

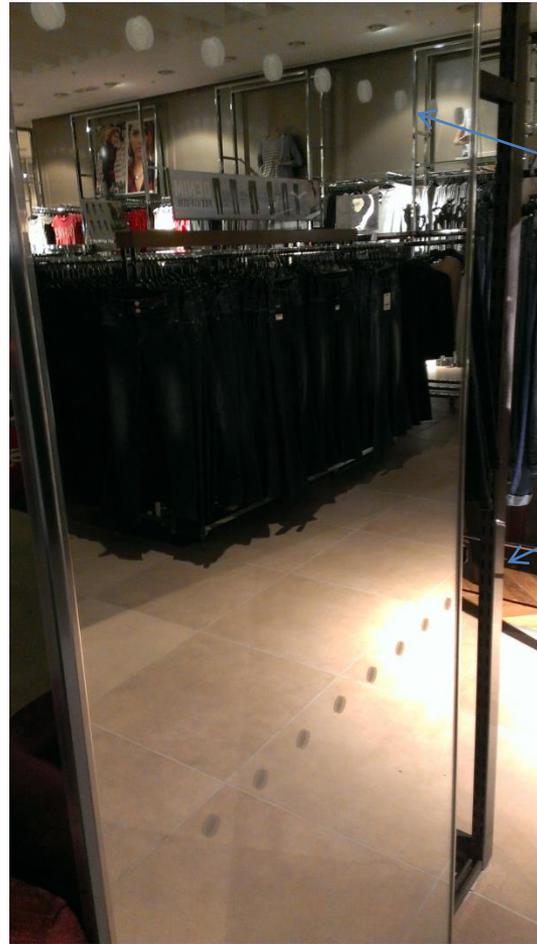
Mirrors

Experience informs us that it is best to coat 50% of a mirror in order to evaluate enhanced clean-ability. Liquid Glass for glass was used on this surface.

Mid section coated

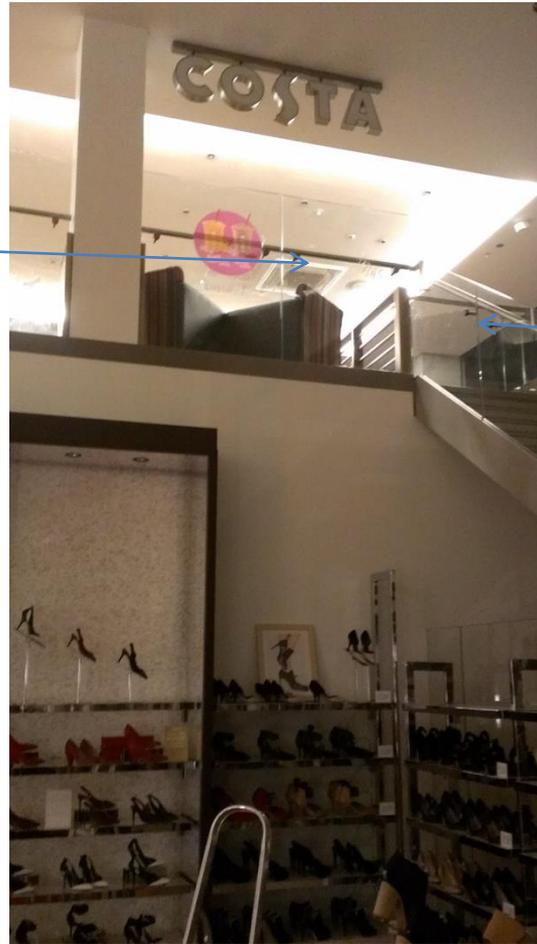
Glass panels

This glass panel was cleaned lightly on the exterior /store facing surface, The cleaning was “light” due to limited access. The Costa facing side was deep cleaned,

This panel at the top of the staircase was cleaned on both surface.

Both glass panels were coated with SiO₂ for glass.

Both glass panels were heavily soiled prior to cleaning.

The hand rails for each panel were also coated.

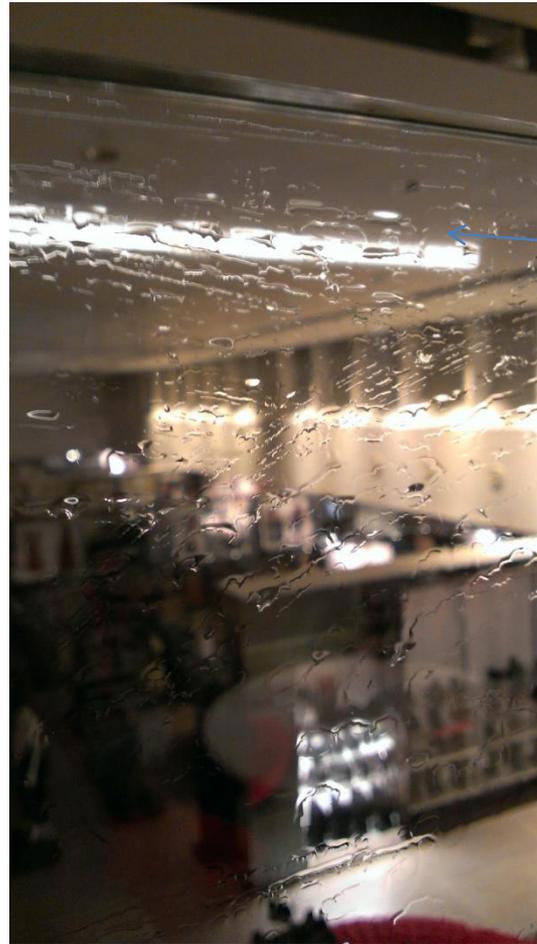
Some glass has been cleaned with an agent containing silicone, or a similar agent

This image shows that on certain parts of the glass a coating was in place. This inhibits adhesion of SiO₂ coatings. The lower section of the panel was not coated with this agent and it was relatively easy to clean.

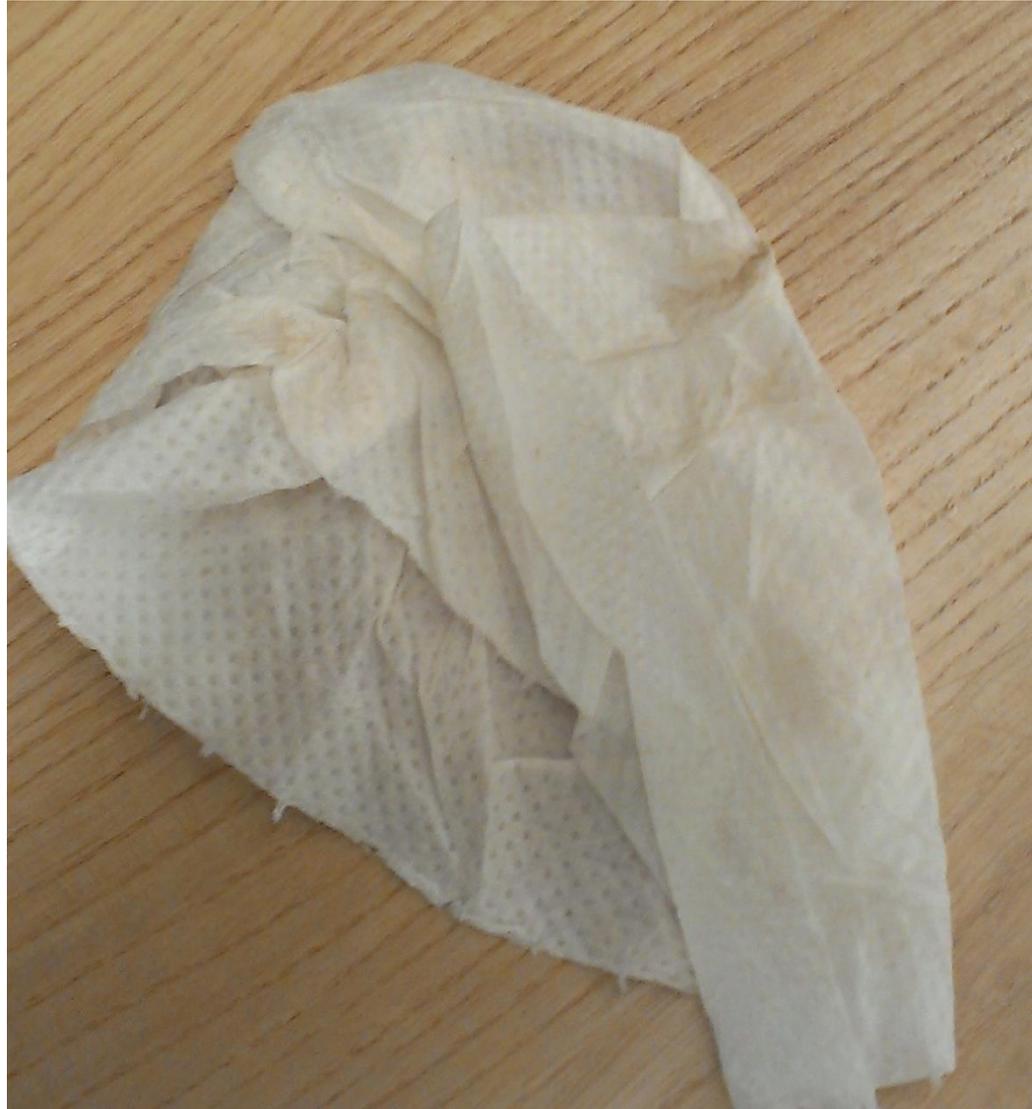
Soiling from table, prior to coating

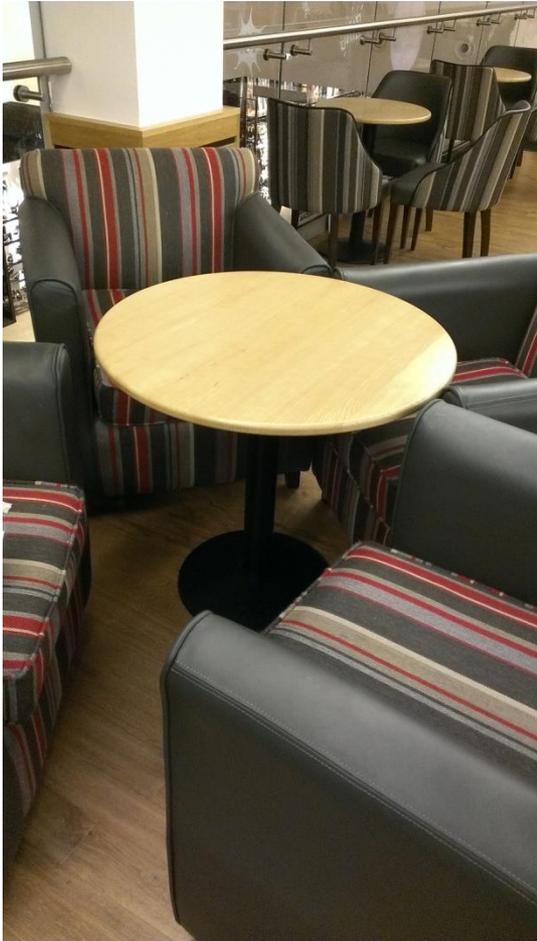
Table cleaned and coated with universal anti bac

This table is located at the top of the staircase ,on the left hand side as one ascends .

Cleaning and coating took approximately 2 min minutes.

Cleaning = approximately 1.minute 30 seconds. Coating 10 seconds.

Buffing 20 seconds.

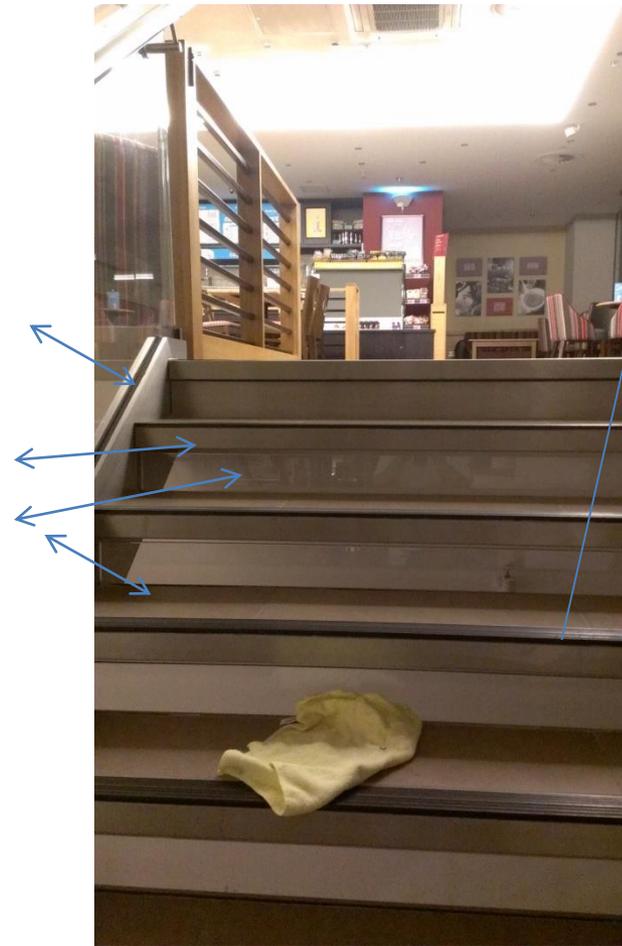
Stair case

Areas coated

The left hand section of the top 3 steps have been coated. The stainless steel was heavily soiled. The treads and the toe boards and the stainless steel sides and the adjacent hand rail were coated with the universal coating.

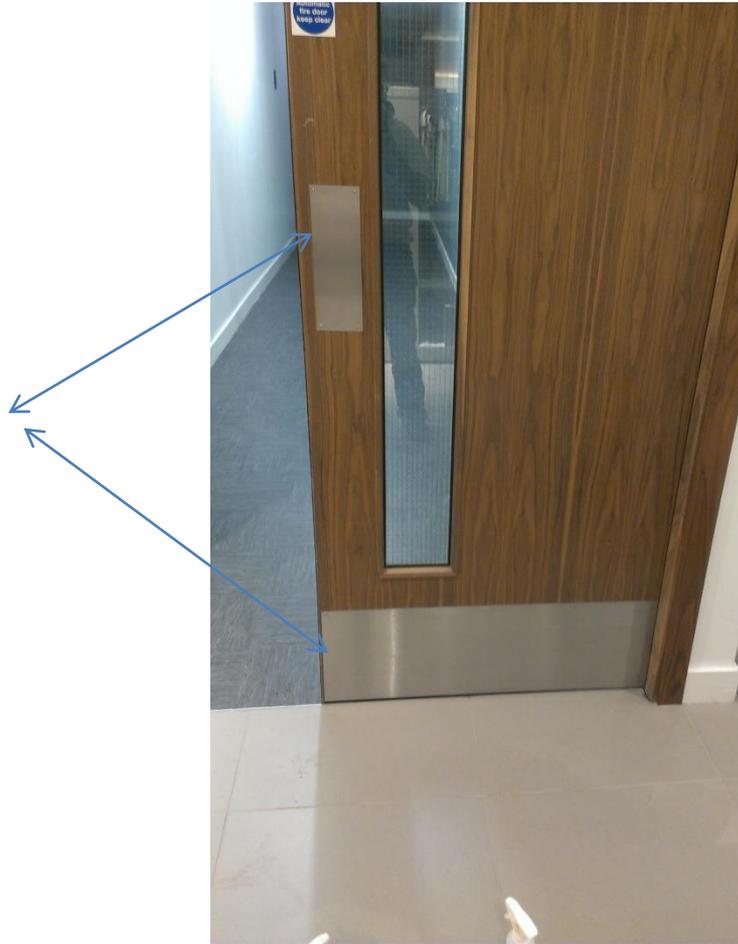
Doors- Finger Pads and Kick Strips

These areas were heavily soiled . The SiO₂ coatings will make subsequent cleaning significantly easier. Main doorway to staff area from store.

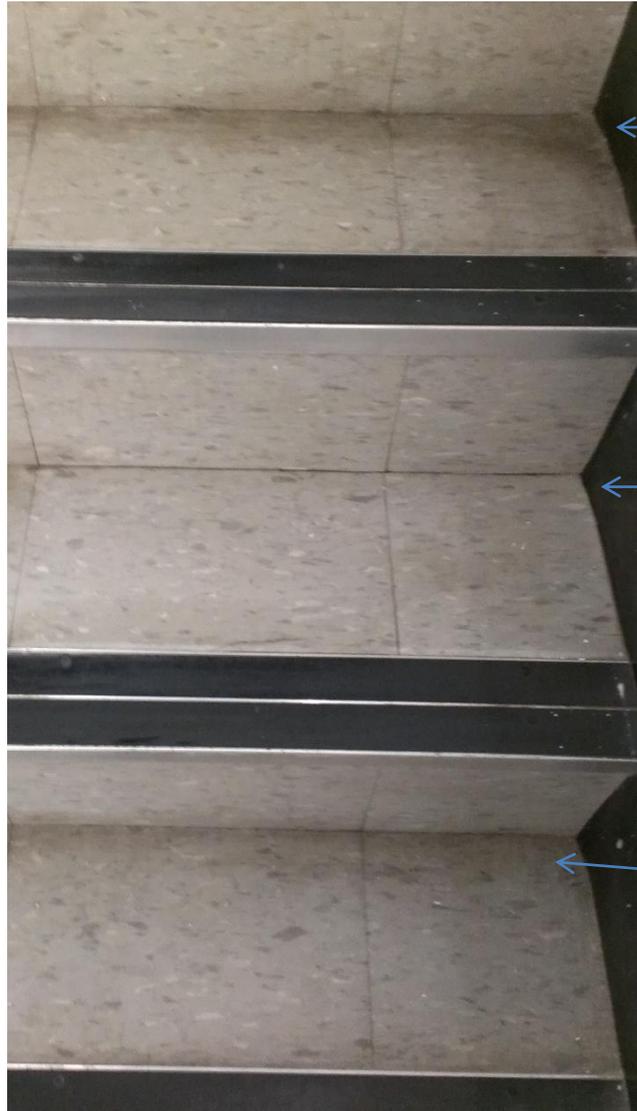
Cleaning and coating stairs

This part of the trial was conducted on the first rise of steps from ground level to the staff area. The test area is clearly visible.

Soiled area

Cleaned with
Biosativa within 30
seconds. Coated
with universal
coating

Soiled area.

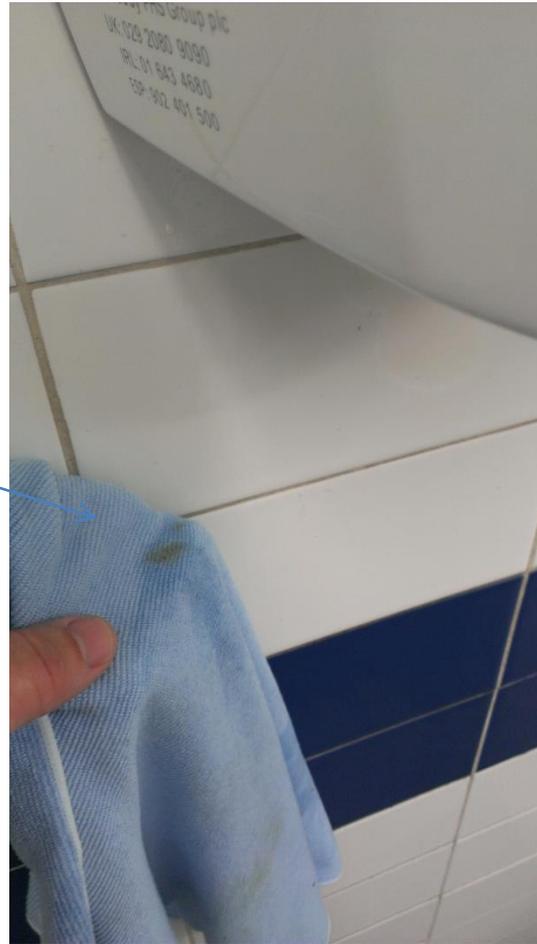
Toilet area

Soiling from grout underneath hand dryer.

The area under the dryer was coated with universal anti bac coating after cleaning.

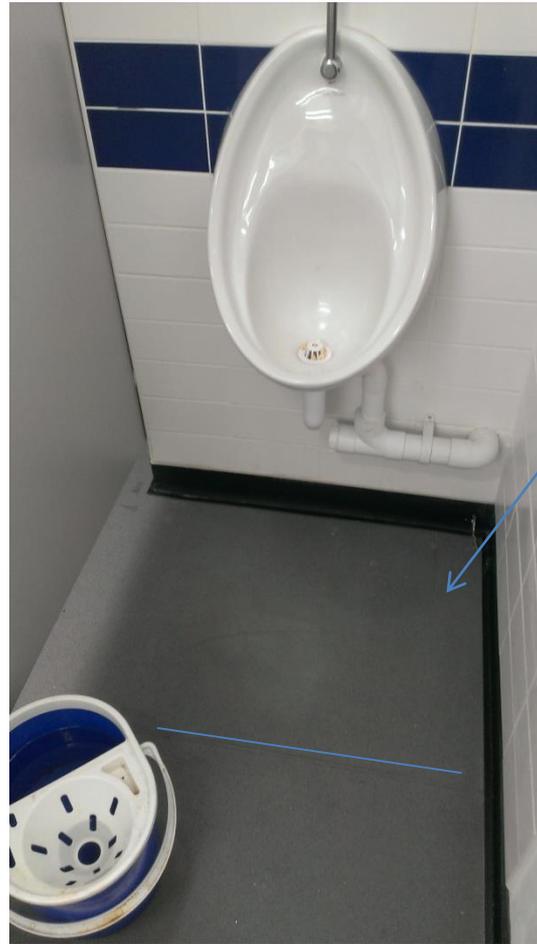
Cleaning and coating under urinal

This area was heavily soiled.
After cleaning universal anti
bac was applied

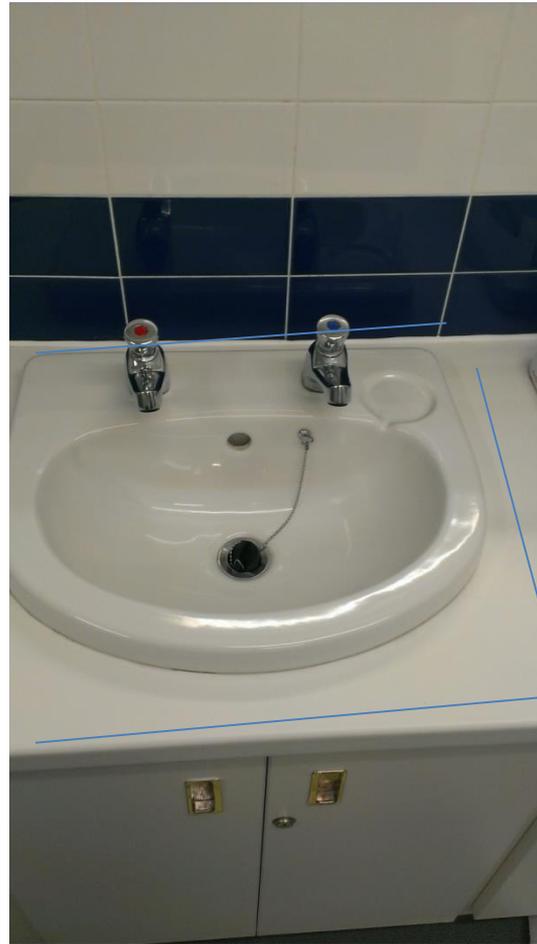
Wash basins

All areas were coated with the universal anti bac. This unit is adjacent to the entrance. Normally the most heavily used.

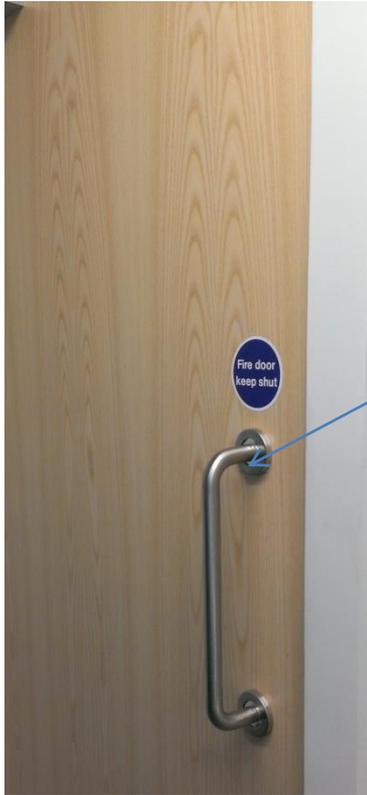
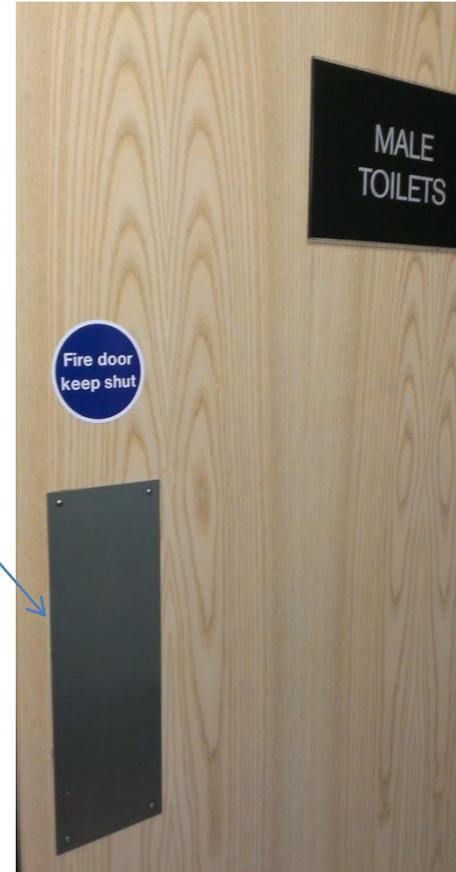
Toilet door furniture

Cleaned then coated with universal anti bac coating. Total time 2 minutes. This is the coating which is used within NHS hospitals.
