7624 CCM[®] ACTIVATED* STONE PROTECTION

*Anti-Mould Coating (SiO₂+TiO₂), suitable for stones and porous painted surfaces.

CCM[®] facade protection is a ready-to-use solution for the impregnation of all kind of mineral facades & terraces in outdoor areas.

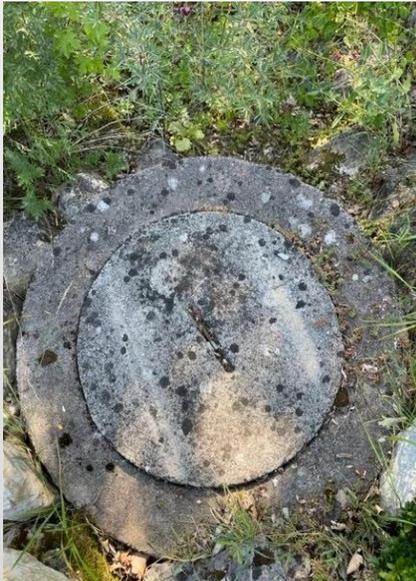
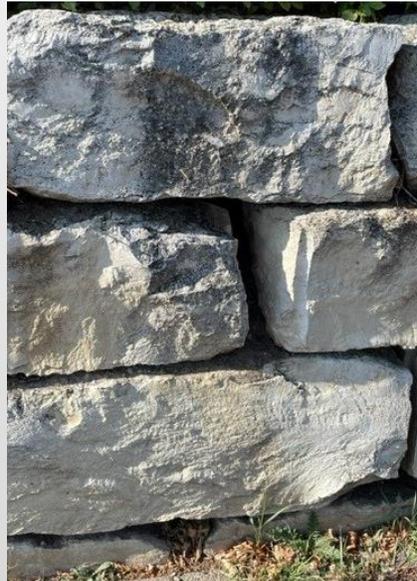
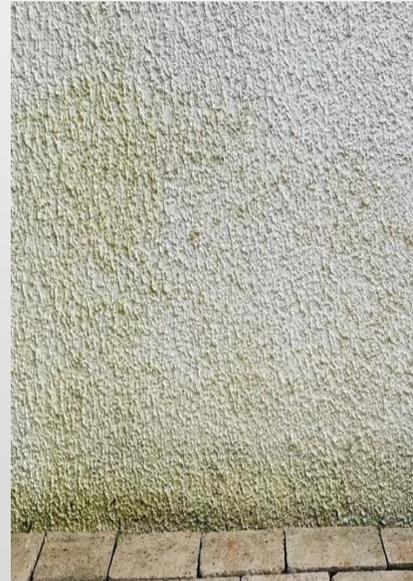
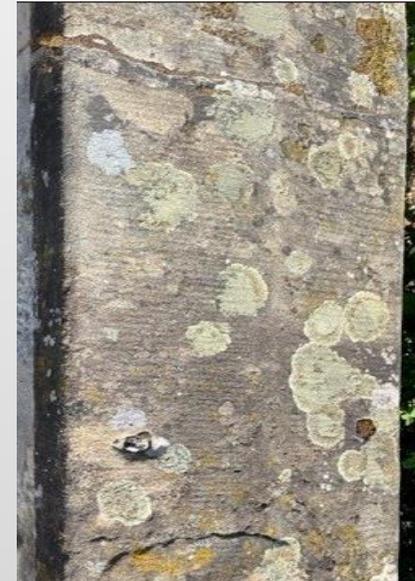
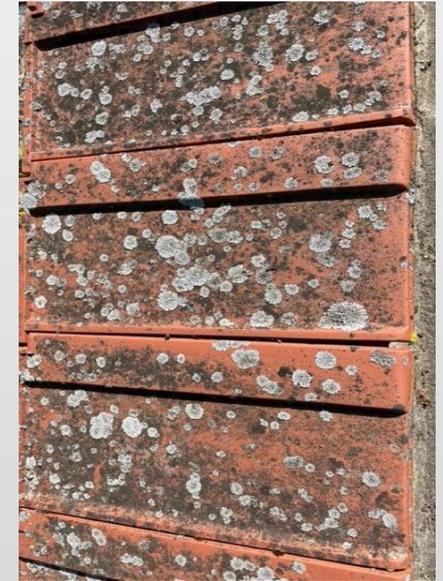
All mineral building materials are conquered by nature over time. Algae, lichens and moss grow the surfaces and make them look dirty, and can also destroy the asset without taking action:

concrete

natural stone

rough plaster

sandstone

bricks / roof tiles

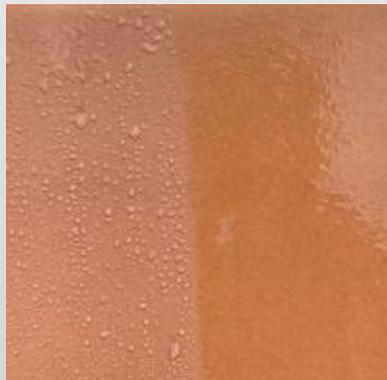
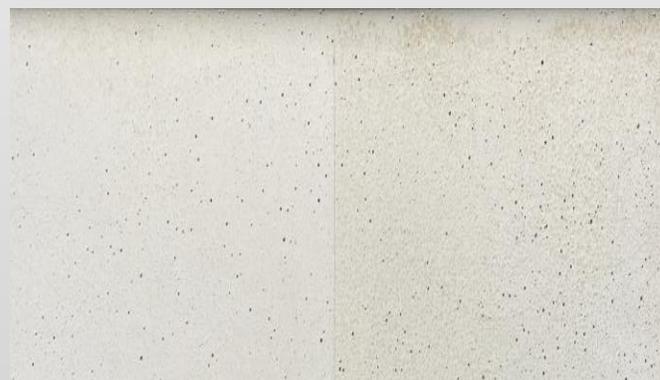
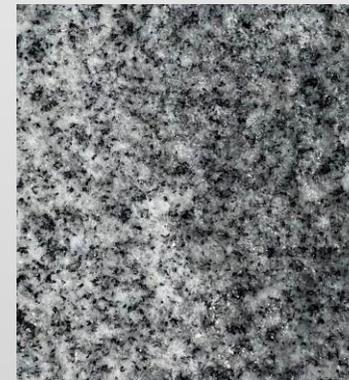
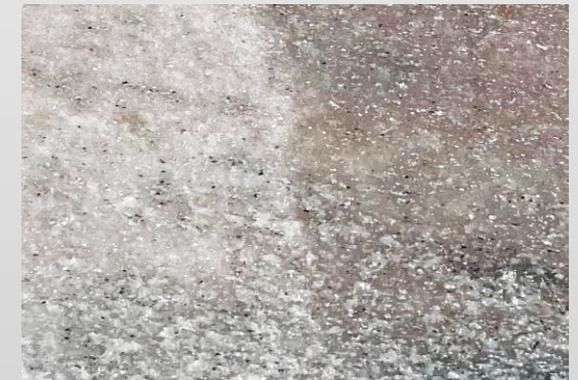
- Different materials are sprayed with [CCM® 7624 Stone Coating](#) and allowed to dry for 24 hours.
- Then they are moistened with water with the help of a pump spray.

roof tile

treated untreated

limestone

granite

quartzite

- ⇒ **The capillary-narrowing effect prevents moisture from penetrating the material.**
- ⇒ **Due to the hydrophobation of the surface, the water pearls off the surface.**
- ⇒ **The original colour is preserved and protected once treated!**

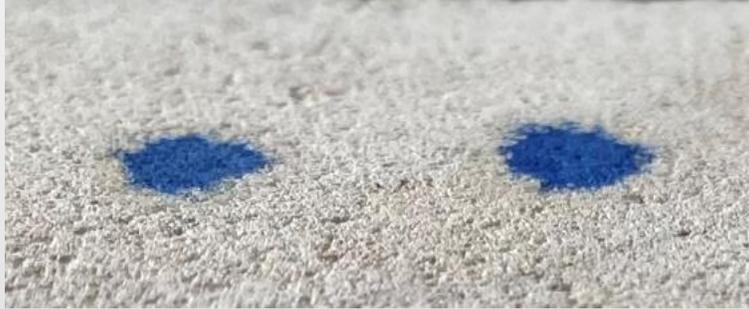
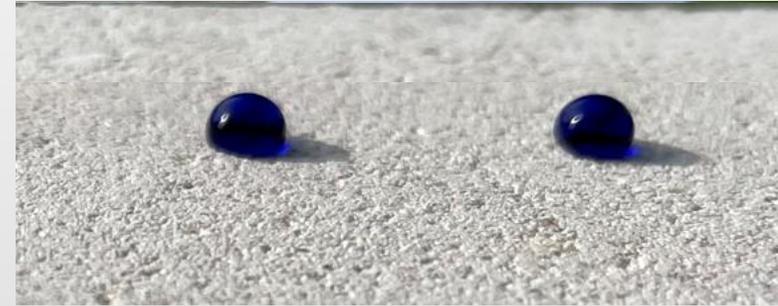
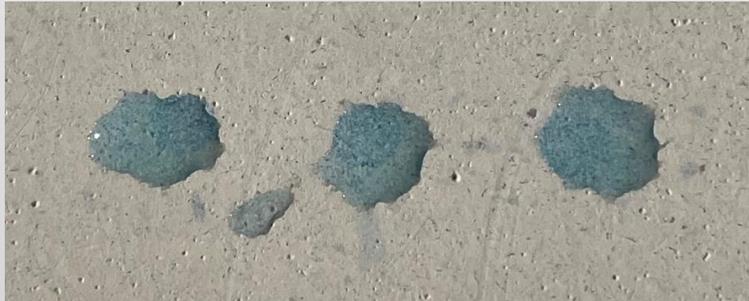
untreated

CCM® 7624 Stone Coating

Competitive product (market leader)

- The open pore stone absorbs the moisture with the dye.

- The capillary tightening effect prevents moisture from penetrating the stone.

- ⇒ Surfaces are protected from penetration of dirt!
- ⇒ Surface dirt can finally be removed by cleaning or rainwater.

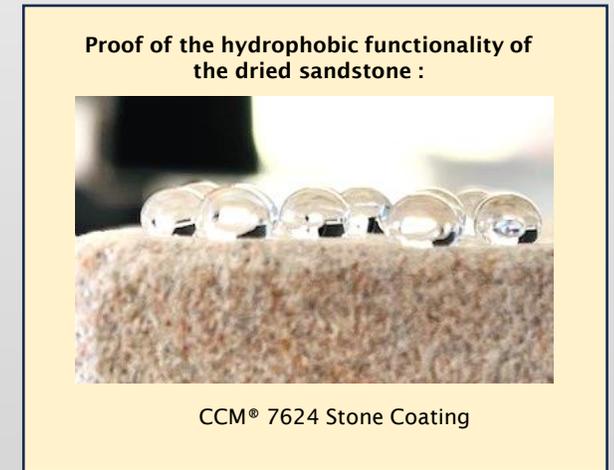
Approach: Sandstone is soaked in water for 1 hour, then dabbed with a cloth and finally brushed with CCM® 7624 Stone Coating.

⇒ The treated surfaces are open to diffusion and allow natural moisture exchange!

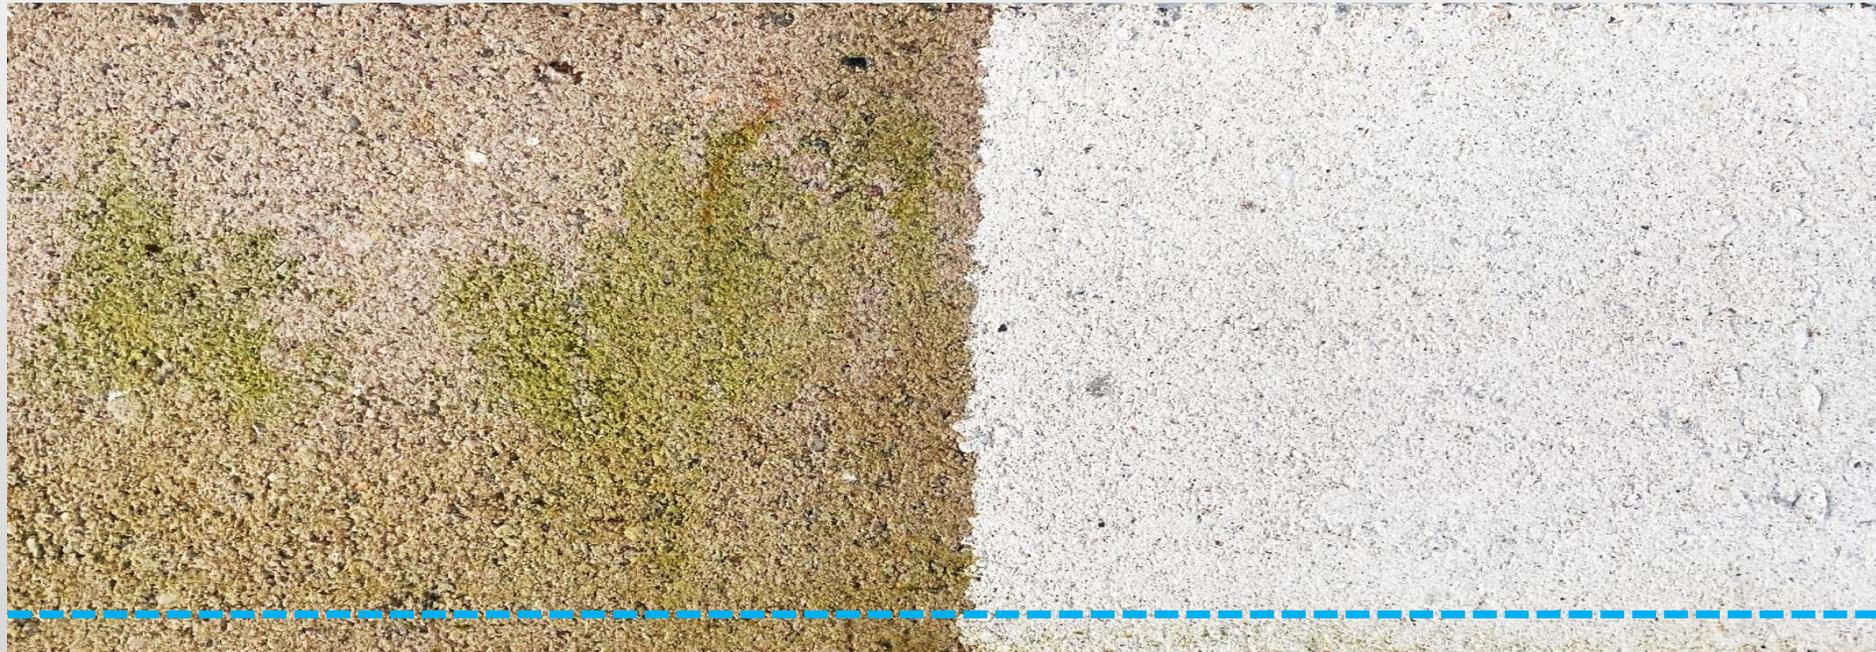
Test with open-pore limestone in pond water (3 months study in 100% room humidity):

Zone with permanent water contact

On untreated surfaces, moisture & organic particles provide an ideal breeding ground for the growth of algae (green shavings).

Treated surfaces remain clean due to the interplay of capillary uptake retain & beading effect.
⇒ No breeding ground for algae!
⇒ The limestone looks like new and fresh!

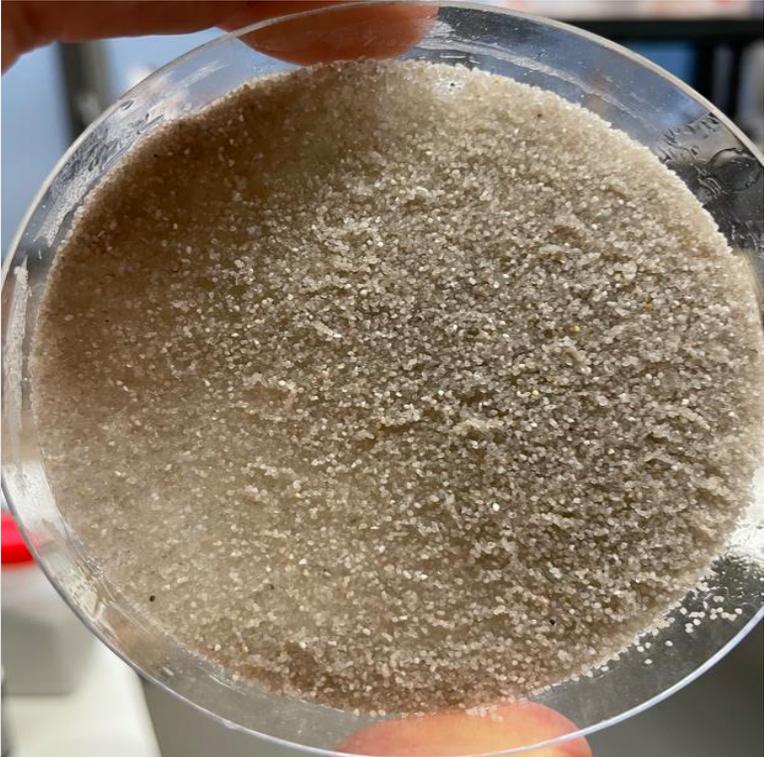
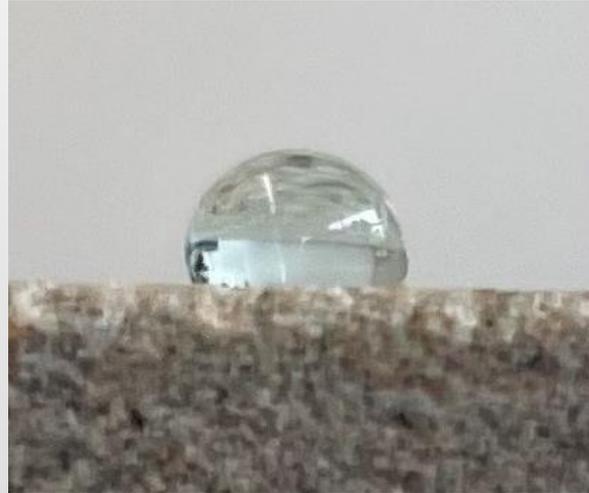
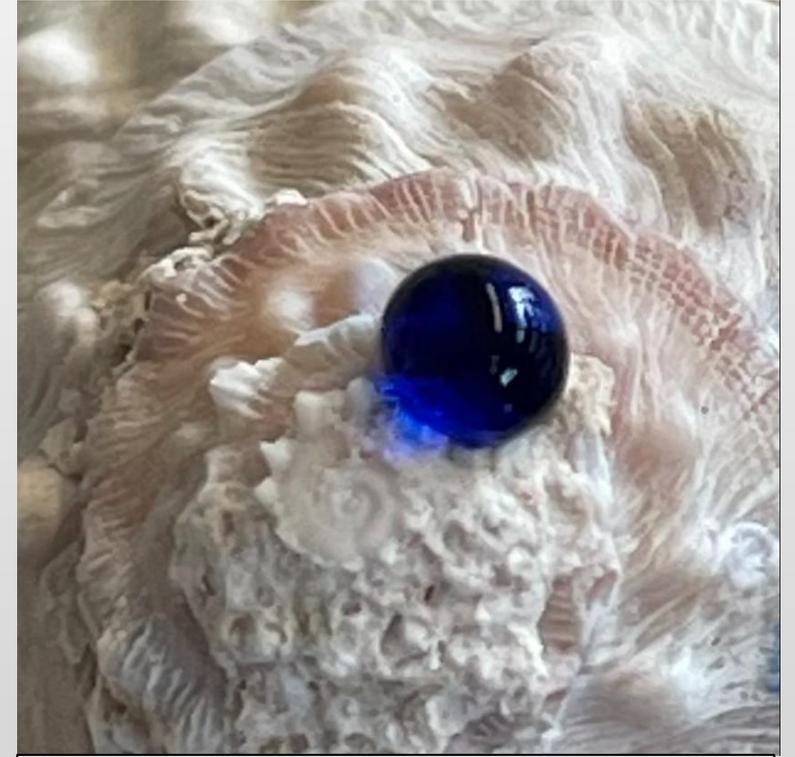
loose sand solidifies in 6 - 12 hours

hydrophobia + rough surface
structure
=> „Lotus effect“

fossils can be conserved

- ⇒ Treated surfaces are solidified while retaining the material colour!
- ⇒ Due to the diffusion permeability, it is possible to use it in cellar vaults.

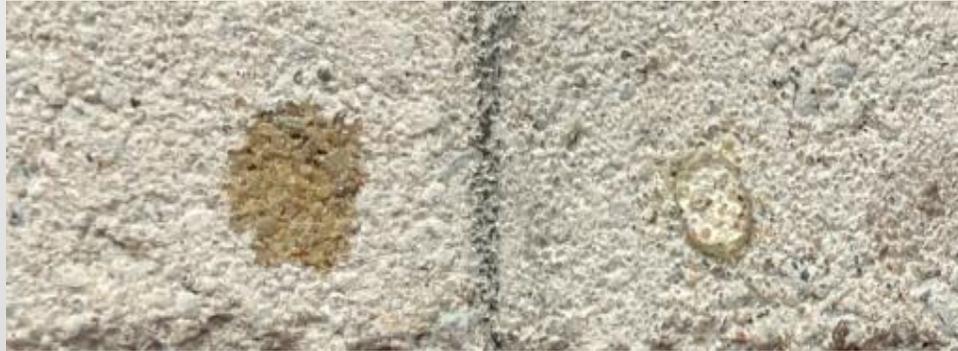
untreated

CCM® 7624
Stone Coating

+25% HCl
(pH 1)

-> penetration into the stone,
& spontaneous CO₂
formation

-> beading effect,
no CO₂ formation!

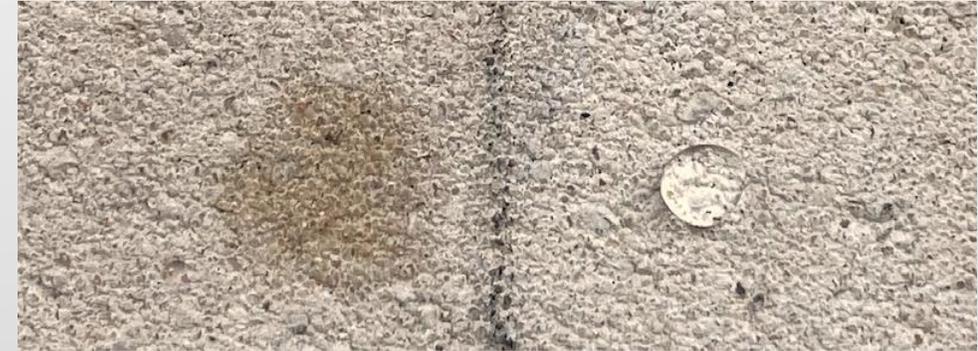
untreated

CCM® 7624
Stone Coating

+1 n NaOH
(pH 14)

-> penetration into the stone

-> beading effect!

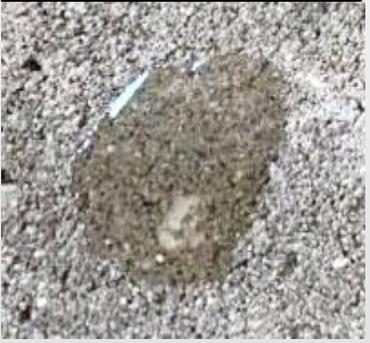
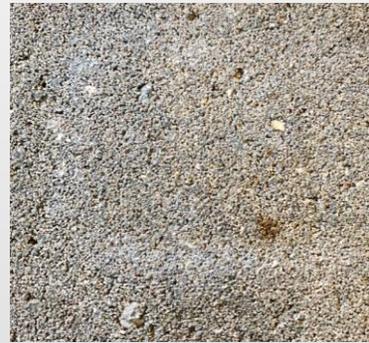
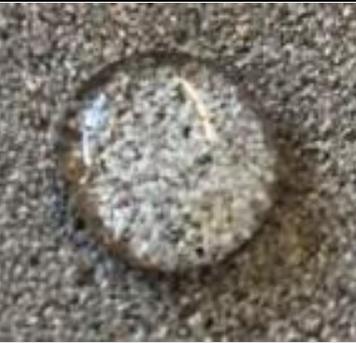
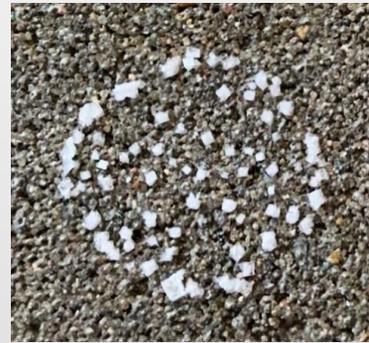
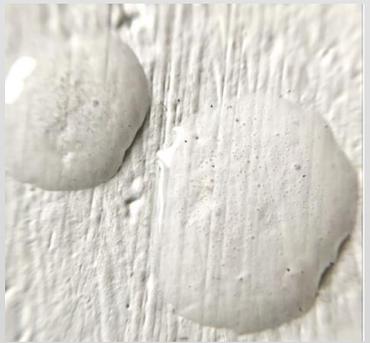
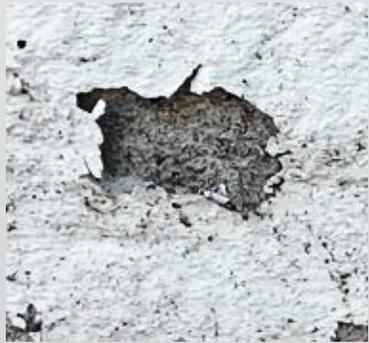
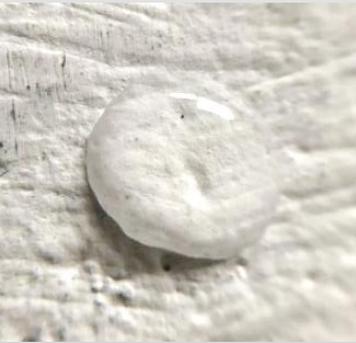
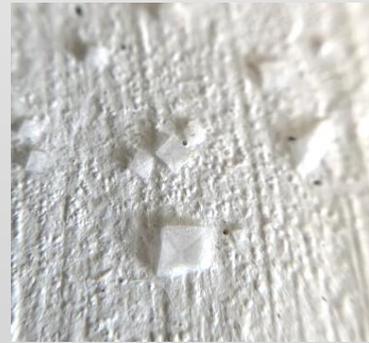
+5% salt water

untreated

CCM® 7624
Stone Coating

→ Salt water penetrates
In the stone / paint.

→ The salt crystallizes
in the stone / under the paint
and damages the facade!

→ beading effect
→ no penetration!

→ Formation of salt crystals
on the surface, which
can be easily removed.

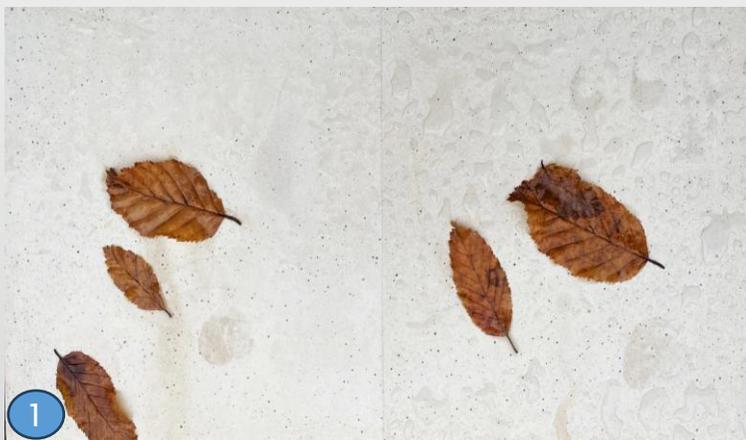
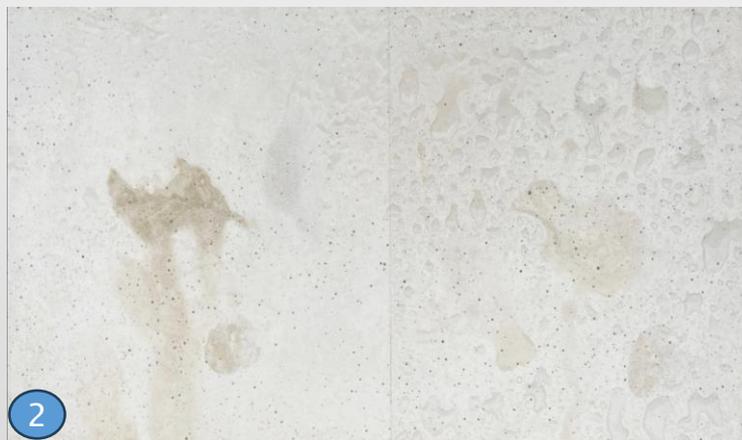
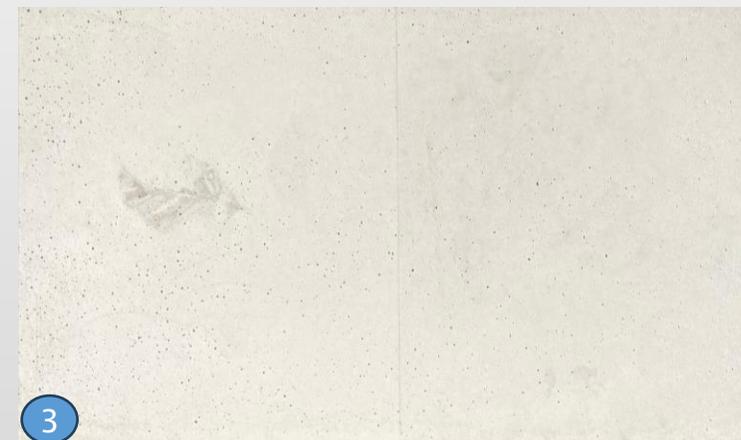
Wet leaves fall on an open-pored limestone slab (1).

Appearance after 2 days of rain and wind (2), and finally after returning sunshine on day03 (3).

1
competitor
product

2
competitor
product

3
competitor
product

- ⇒ **Highly sensitive stones are protected against natural pollution from the environment.**
- ⇒ **This is ensured by the combination of rain / mild cleaning and photocatalysis.**

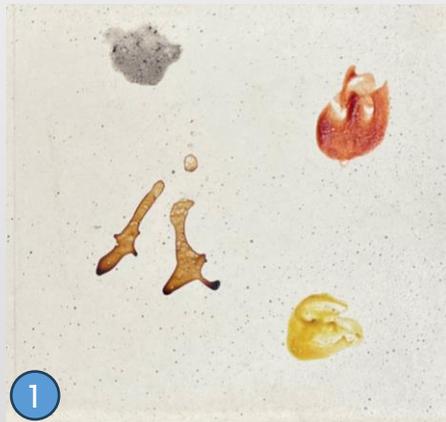
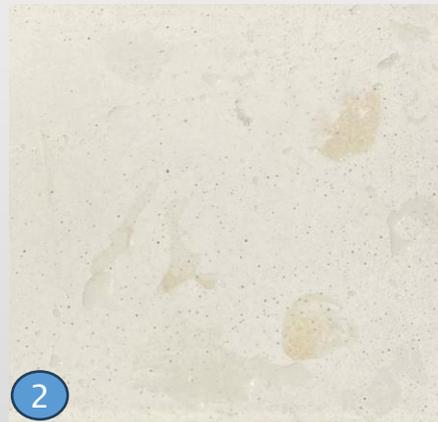
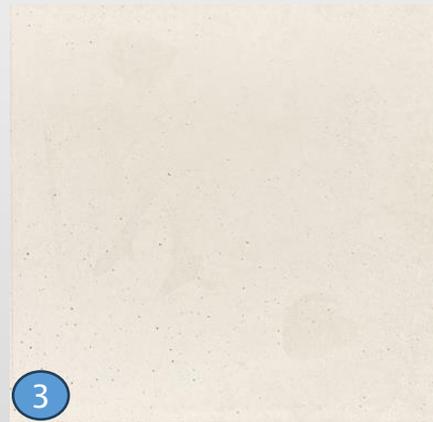
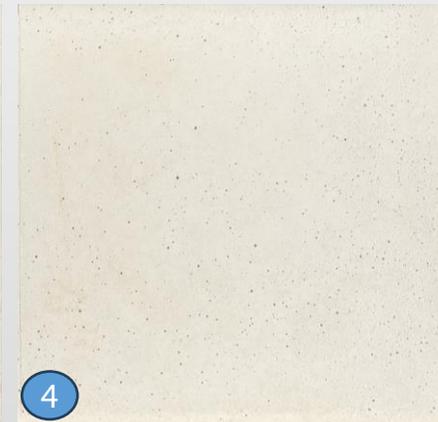
- An open pore limestone slab is soiled with ash, coffee, ketchup & mustard (1).
- After drying for 18 hours, the plate is first cleaned with water and a hand brush (2), and then left in the sunlight for 3 hours (3), and 24 hours (4).

1 Soiling

2 after brushing

3 after 3 h in the sun

4 after 24 h in the sun

- ⇒ Sensitive stones are protected very efficiently against the ingress of food dyes.
- ⇒ Soiling can be removed with mild & environmentally friendly cleaners.
- ⇒ Remaining paint residues are resolved with the power of photocatalysis.

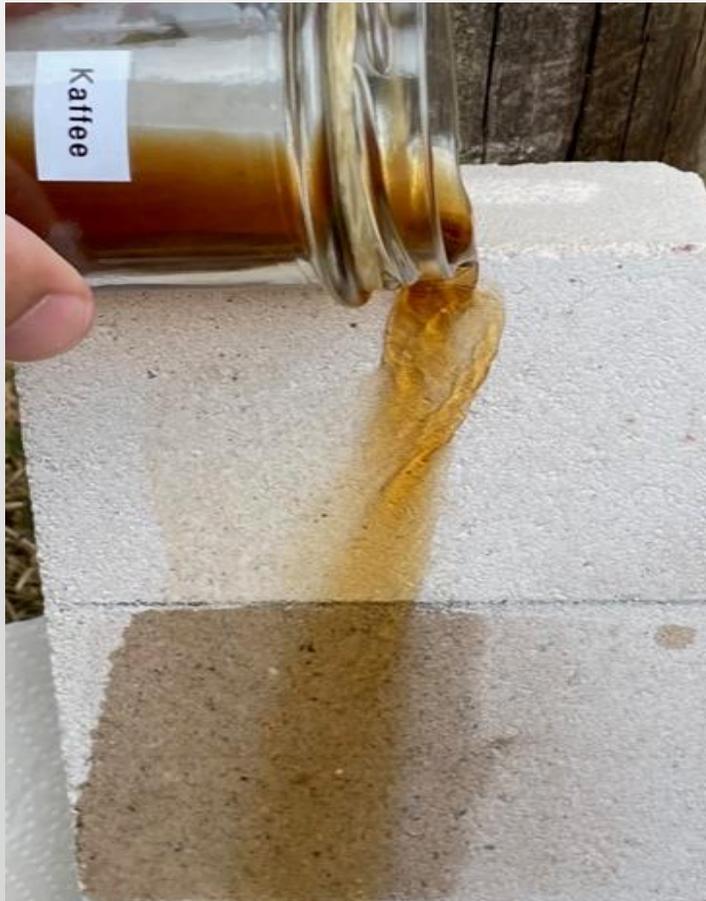
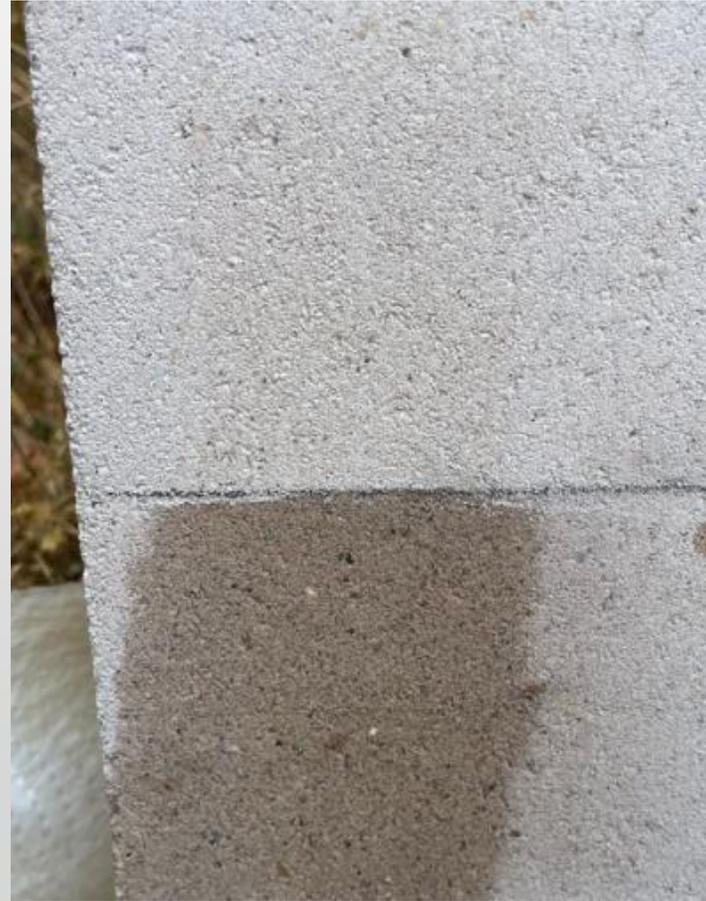
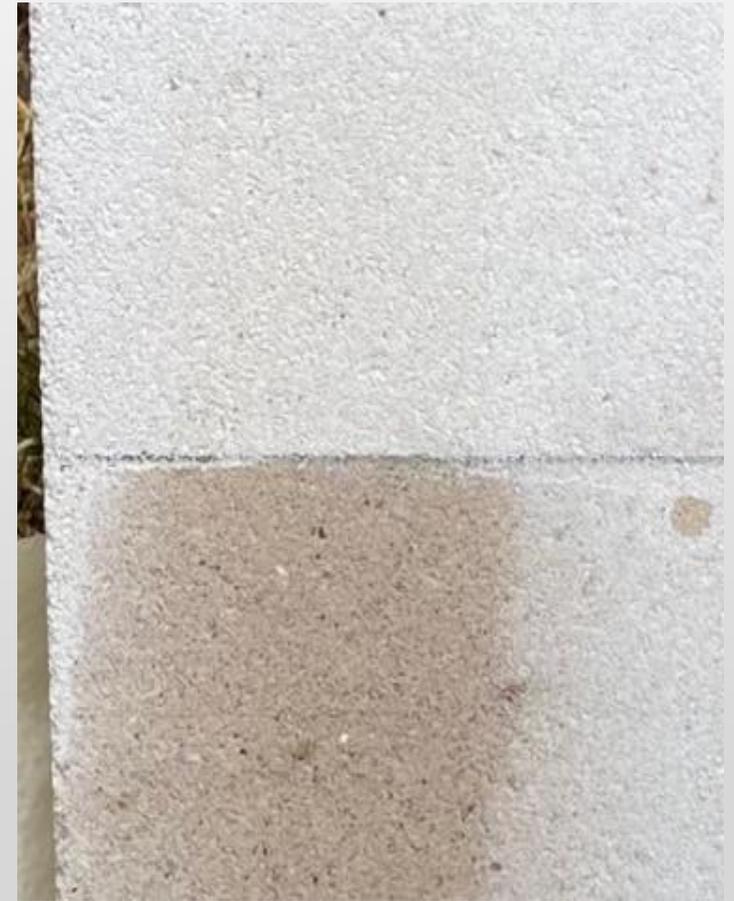
COFFEE-TEST

⇒ Even open-porous materials are protected against discoloration with organic dyes!

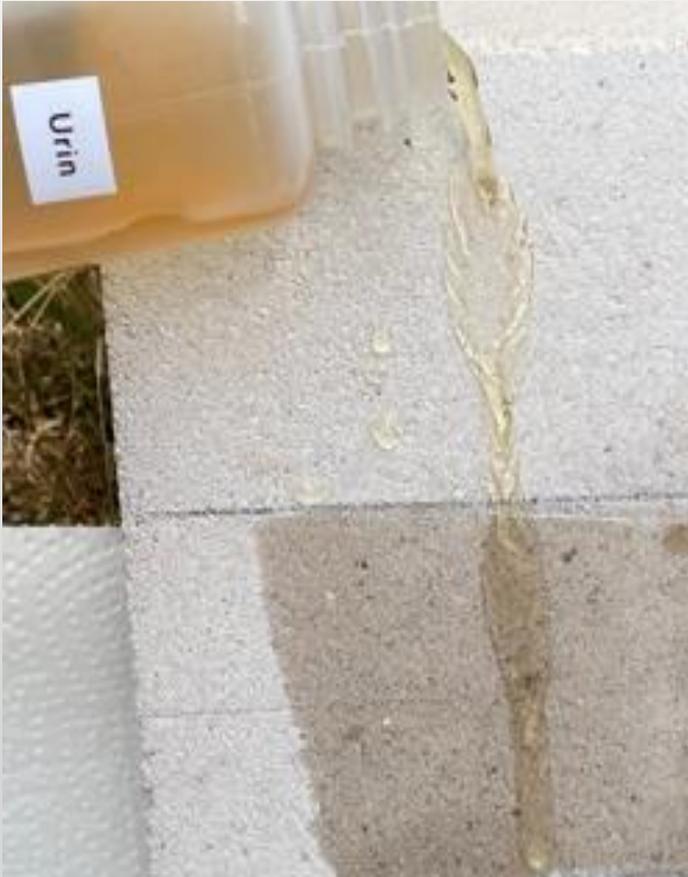
CCM® 7624 Stone Coating:

- ⇒ Urine peels off and is prevented from entering the stone.
- ⇒ The development of the typical “urinary odour” is thus prevented.

Untreated:

- ⇒ Urine moisturizes the stone and penetrates deep into it.
- ⇒ As a result, an unpleasant “urinary odor” develops.
