## TRIAL OF 7620 EVALUATION OF ANTI MOLD EFFECT

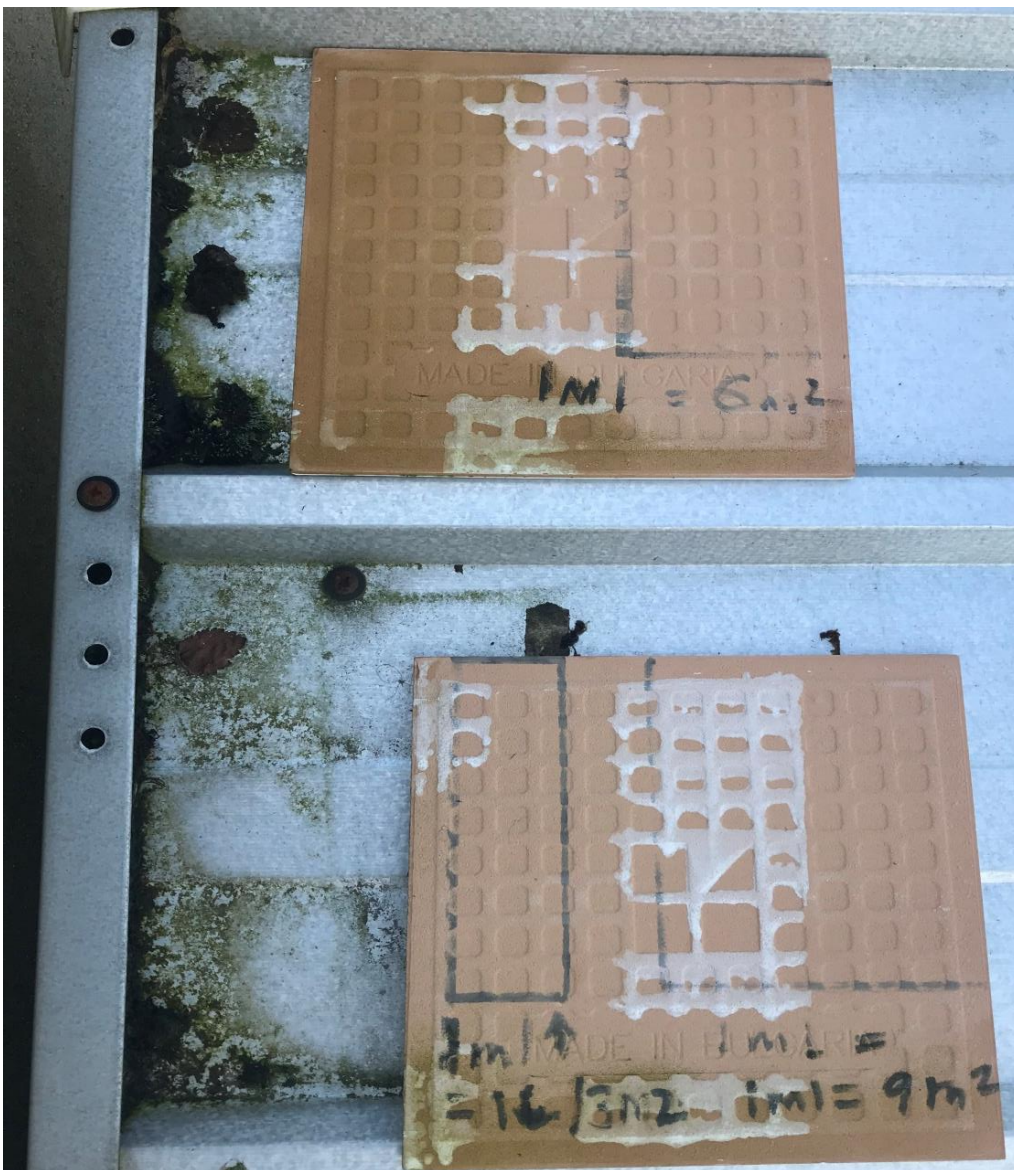
This image was taken after 100 days after the coating was first applied.

The 7620 penetrative coating was applied to the boxed area but as it is a penetrating coating it migrates. The level of migration is shown by the blue line. The area beyond the blue line is now saturated and mold is established within the stone. The coated area is completely dry and mold free.

The migration of the 7620 coating is clearly evident as the liquid has moved to all areas of the substrate, except for the lower region where the blue line indicates the limit of penetration. Mold is fully established within this lower "saturated area".

Tiles A and B were coated within the marked areas with **7620 Stone Coating**.

The coating was applied at a coverage rate of 6 m<sup>2</sup> per litre to tile A.

Tile B was coated at a ratio of 9 m<sup>2</sup> per litre in one sector and 11m<sup>2</sup> per litre in the sector to the left.

The test pieces were laced on a garage roof in the UK.

**This simple trial proves that the 7620 coatings prevent mold growth on coated stone.**
